## **Resistograph Tree Report**

**Vivid Housing Limited**

**54 & 25,**

**Prepared by  
Richard Daubeney Our Ref 0624-RD  
28th June 2024**

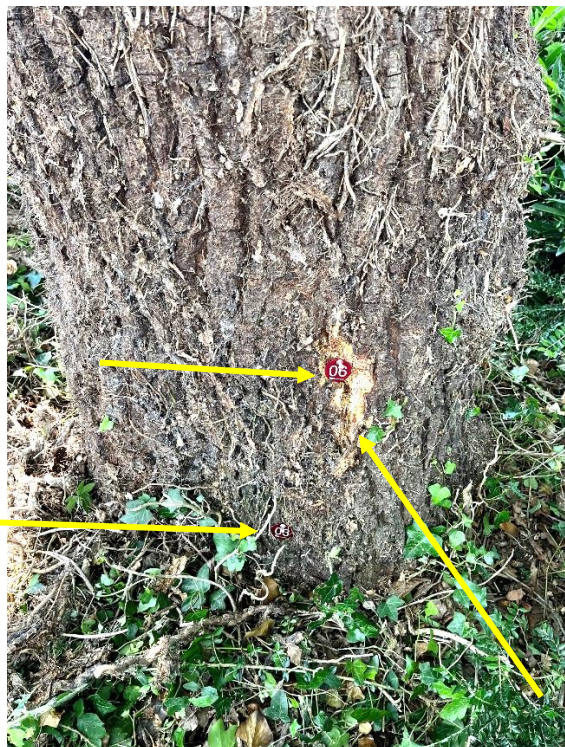
- 5.3 Following the resistograph testing of the tree T3787.5 English oak, the testing showed a moderate area of decay present to the North side within reading No.3, this is likely considered to be linked to the external stem decay to the North side also. The reading no. 2 also showed small minor area of decay present within the stem to the West side. However, it is reading no.1 which showed good areas of live sound wood present to the South side of the stem. The external stem wound to the North side at 43cm will continue to deteriorate over time, this will require regular monitoring to ensure there is further change to tree health and condition. The tree is heavily dense with Ivy clad stem and canopy, unable to fully inspect the stem and canopy. The crown is also low and overhanging the road and car park, including the public footpath. Deadwood over 100mm throughout canopy.

**T3787.5 English oak looking South towards Drill no. 3 and 6. and stem wound location.**

- 6.1 Following the results of T3787.5 and T3787.8 English oak trees mentioned within this report, we now provide our conclusions.
- 6.2 The readings gathered from the testing of T3787.5 English oak show there is moderate areas of dysfunctional decayed wood within the stem, but based on the overall results of the testing, there is still suitable sound and live wood remaining within the stem, however the tree does have significant canopy over the road and car park, with low branches over these areas. With this in mind this is likely creating loading to the lower stem and rooting area of the tree. The tree is in area of high risk with targets such as road, car park and public footpath all within striking distance of tree. Therefore, we recommend a crown reduction of 2m all round, with a crown lift of 6m over roadside. And crown lift over car park and public footpath to 3.5m. We also advise removal of deadwood over 50mm throughout canopy, sever Ivy at ground level to allow for future inspections of stem and canopy.

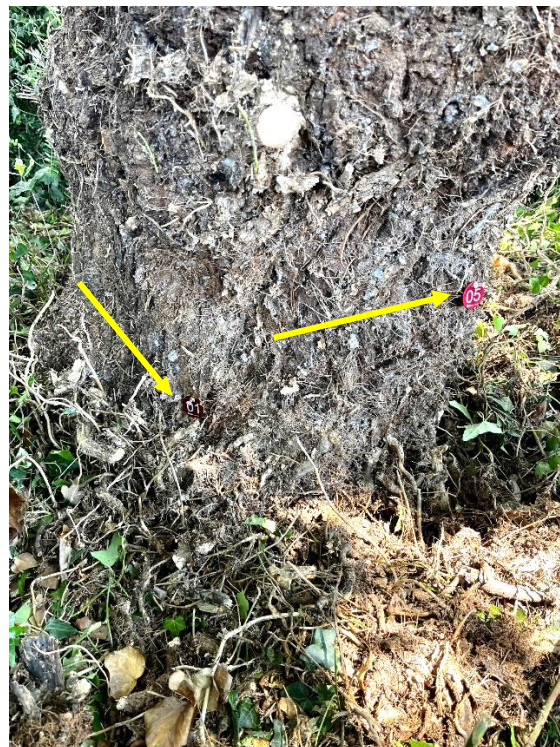
**T3787.5 Looking Northeast to Drill locations No.1 and No.5**

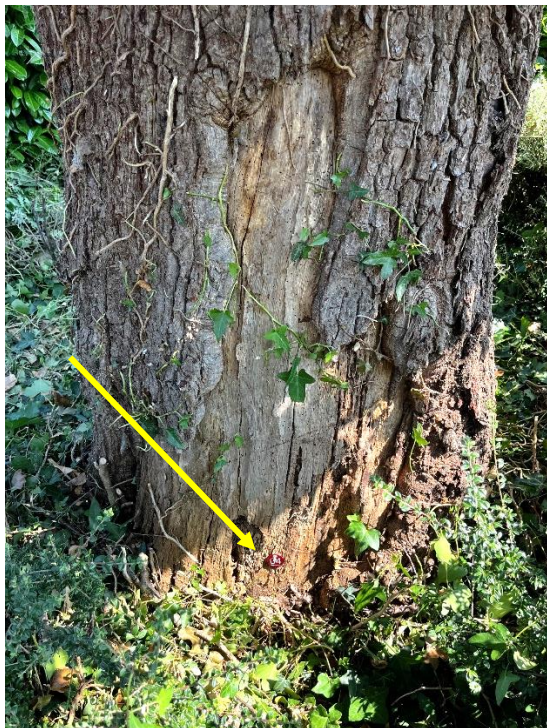
- 5.4 Following the resistograph testing of the tree T3787.8 English oak, the testing showed areas of moderate decay present within readings No. 1 to the West and 4 to the South, this is considered likely a large column of decay has formed within those readings, which is considered likely linked to the large external basal wound to the South side. However, it is reading no. 2 which showed some residual sound wood present to the North side of the stem. The tree has previously been tested following the initial inspection of the tree back in 2021, the results conclude that the decay within the stem has decreased the sound wood available throughout the stem diameter of the tree. The tree has significant epicormic growth throughout the canopy and stem. The tree has been crown reduced as part of the previous testing to the tree. The stem is heavily clad with Ivy.

**T3787.8, English oak looking North towards drill location No. 4 and Basal and stem wound.**

- 6.3 The testing taken from T3787.8 English oak tree showed areas of dysfunctional and decayed wood within the stem, however, the tree still showed some moderate signs of sound residual wood remaining within the stem, but the large basal wound to the South side is and will continue to be an ongoing concern, which over time will lead to further decreased residual sound wood within the stem. The tree location has targets such as buildings, road, public footpath all within striking distance of tree. Therefore, given the above information we recommend a crown reduction of 3m all round, this will ensure the loading to the lower section of the stem and rooting area is reduced. We also advise that the Ivy is severed to allow for future inspections of the stem and crown, including removal epicormic growth to 4m above ground level.

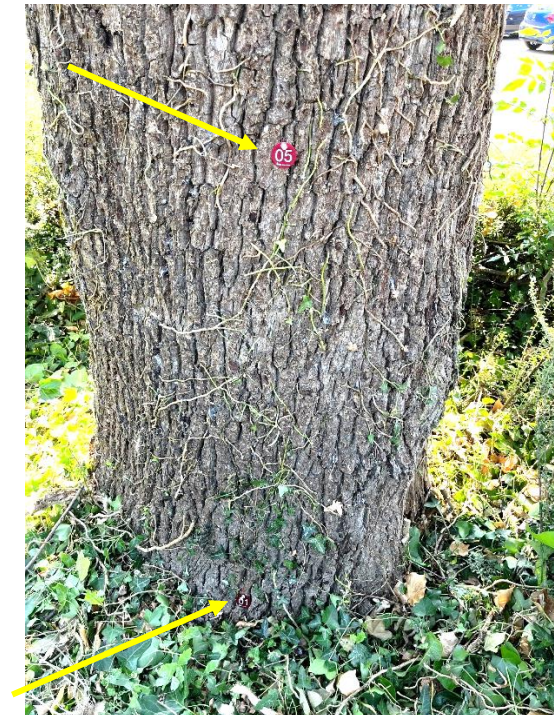
**T3787.8 English oak tree Looking to Drill locations 1 and 5.**

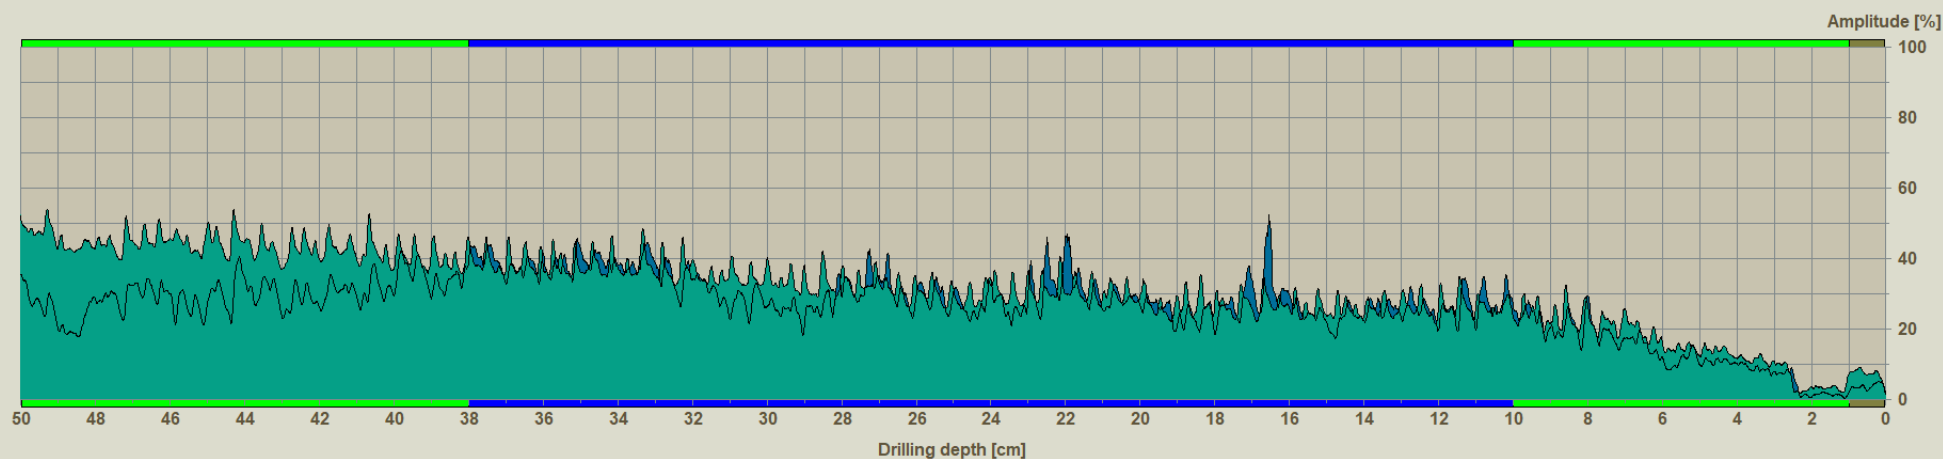
### T3787.5 English oak measurement 1

| From | 0,00 cm to | 1,00 cm | : Bark |
| From | 1,00 cm to | 10,00 cm | : Sound wood |
| From | 10,00 cm to | 38,00 cm | : Reaction wood |
| From | 38,00 cm to | 50,00 cm | : Sound wood |

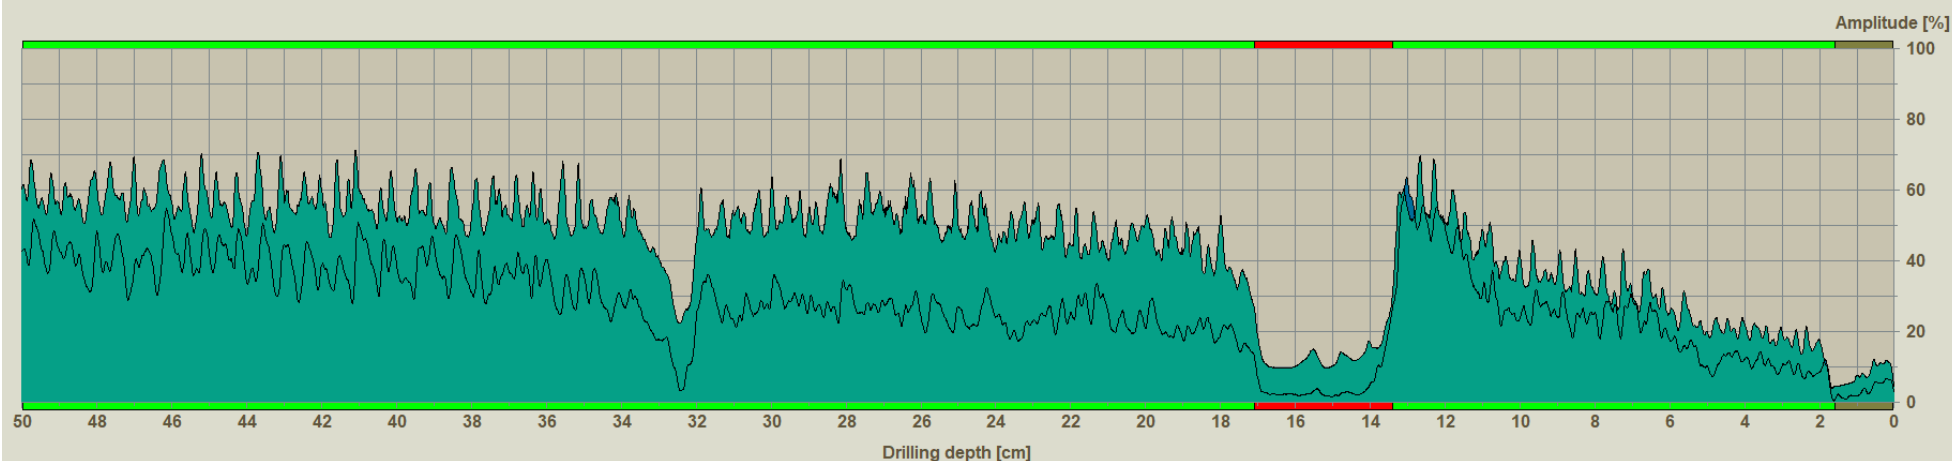
T3787.5 English oak measurement 2

| From | 0,00 cm to | 1,60 cm | : Bark |
| From | 1,60 cm to | 13,40 cm | : Sound wood |
| From | 13,40 cm to | 17,10 cm | : Decay |
| From | 17,10 cm to | 50,00 cm | : Sound wood |

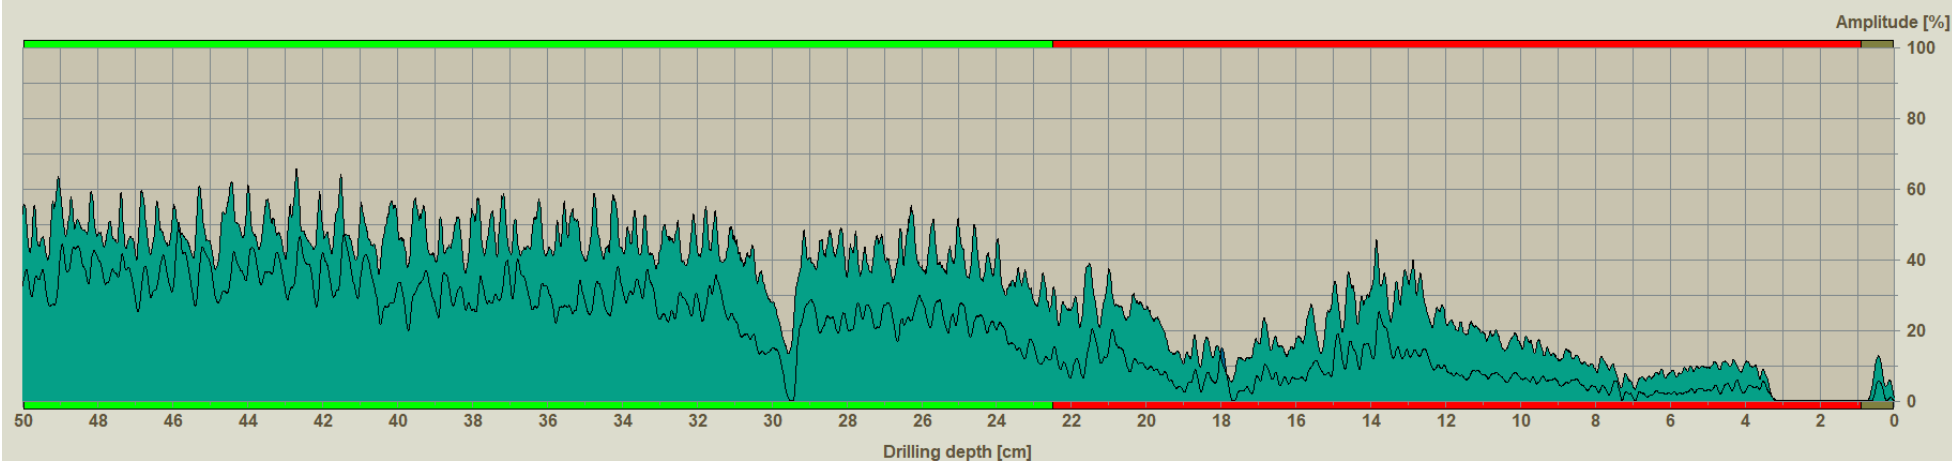
T3787.5 English oak measurement 3

| From | 0,00 cm | to | 0,90 cm | : | Bark |
| From | 0,90 cm | to | 22,50 cm | : | Decay |
| From | 22,50 cm | to | 50,00 cm | : | Sound wood |

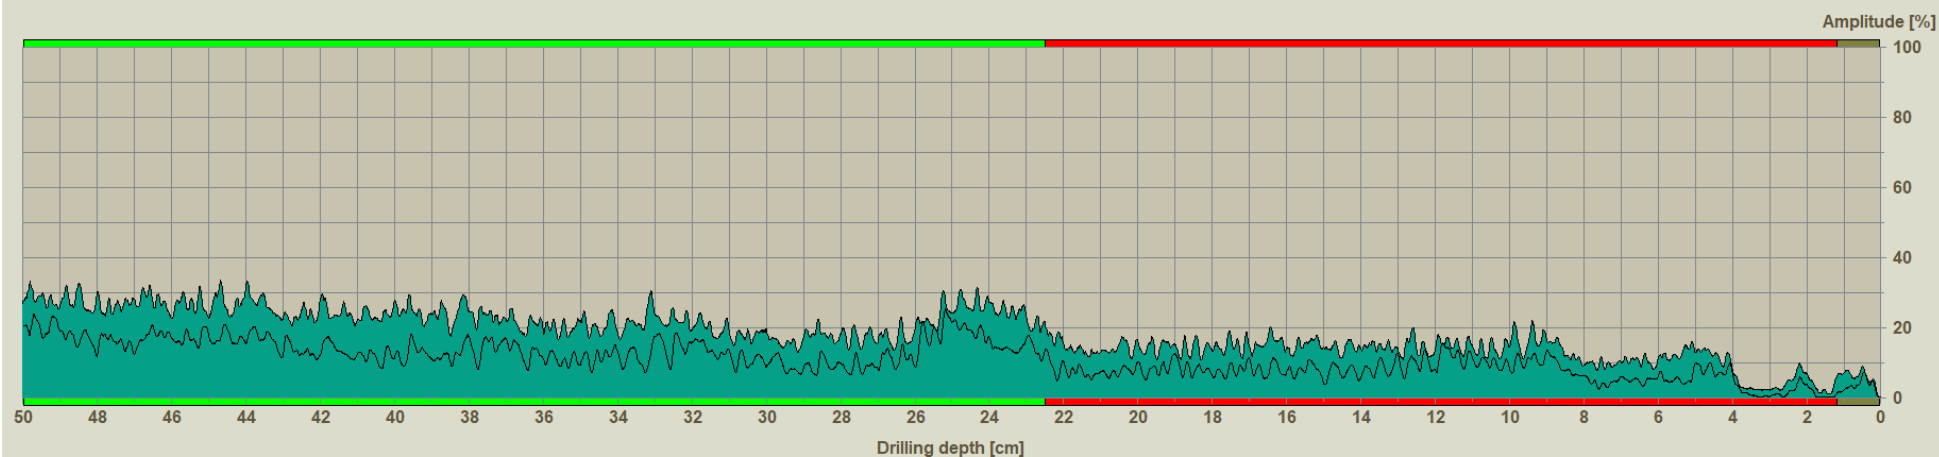
## T3787.8 English oak measurement 1

| From | 0,00 cm to | 1,20 cm | : Bark |
| From | 1,20 cm to | 22,50 cm | : Decay |
| From | 22,50 cm to | 50,00 cm | : Sound wood |

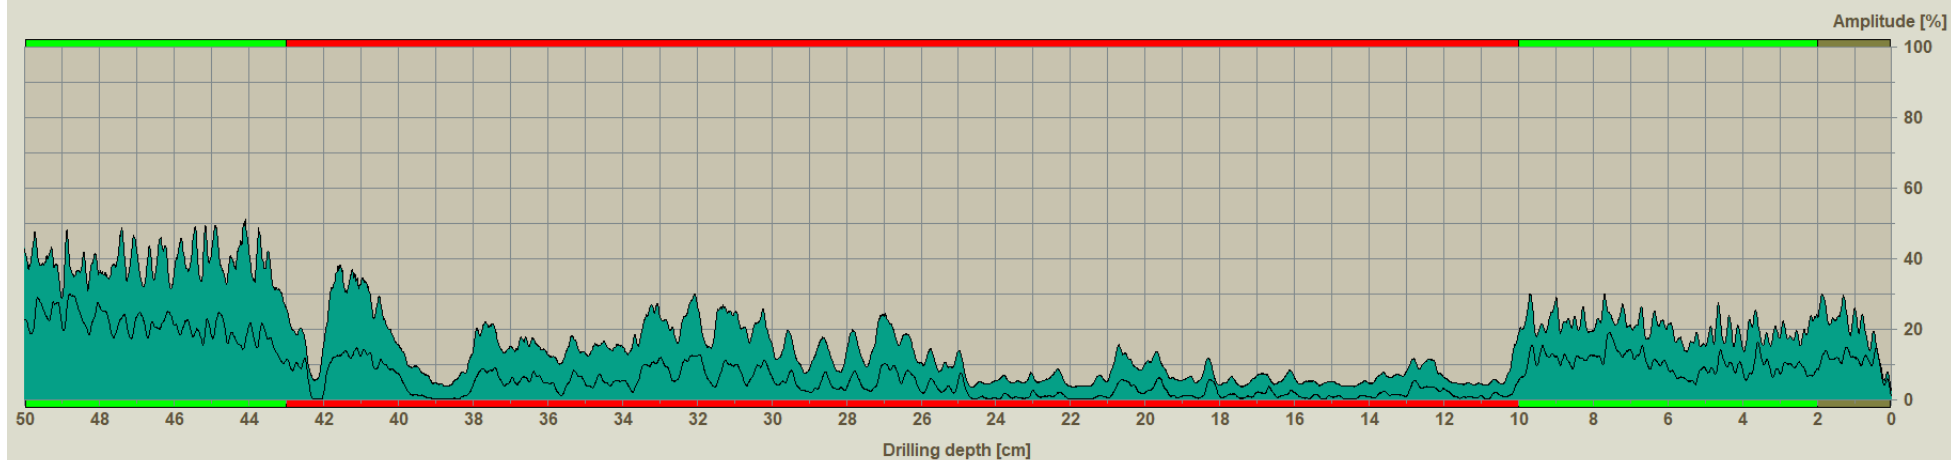
T3787.8 English oak measurement 3

| From | 0,00 cm to | 2,00 cm | : Bark |
| From | 2,00 cm to | 10,00 cm | : Sound wood |
| From | 10,00 cm to | 43,00 cm | : Decay |
| From | 43,00 cm to | 50,00 cm | : Sound wood |
