### **3.0 BARN B**

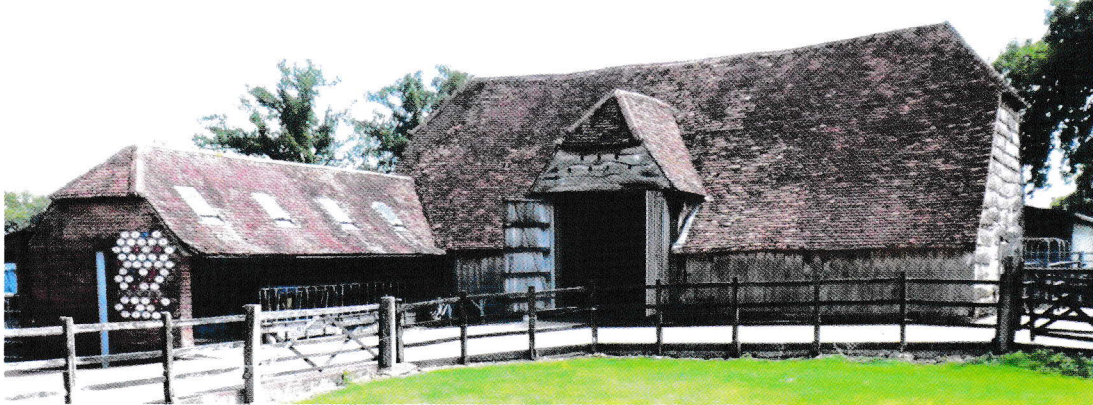
**3.1** Barn B comprises two buildings joined together.

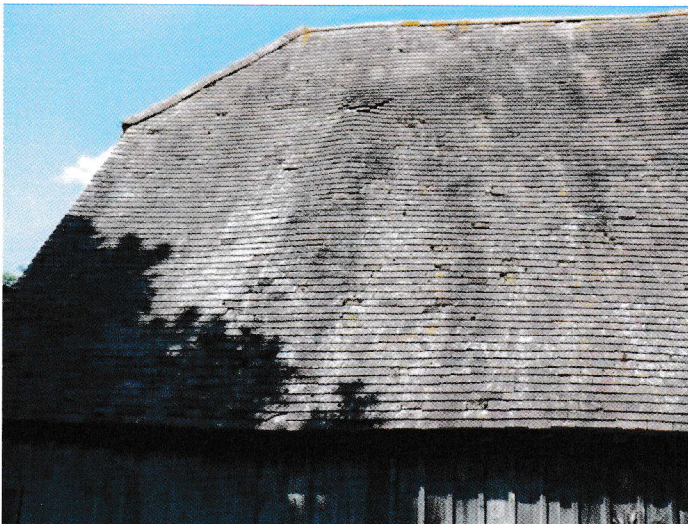
**3.3** Externally the roof is covered with tiles. The roof is quite uneven, as is to be expected with a building of this type and age, but there is no evidence of any significant recent structural movement or problems from the external view. A number of tiles have slipped or are missing.

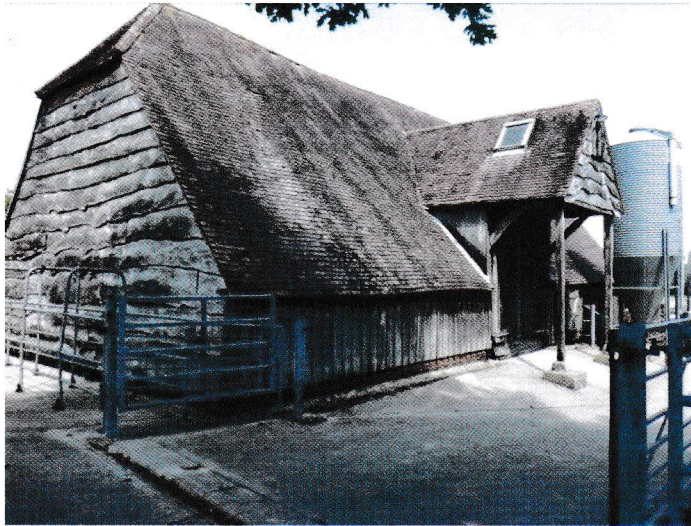
- 3.4 To the rear a loft area projects out over the rear entrance. It is supported by tall slender timber posts, but these appear to be functioning and are structurally satisfactory.

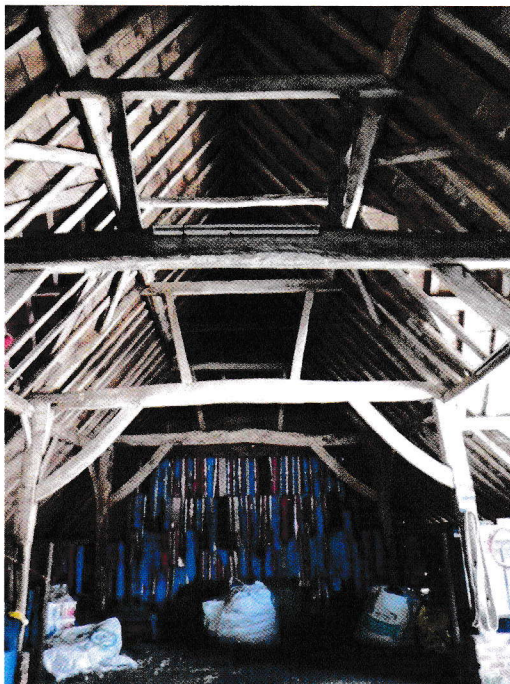
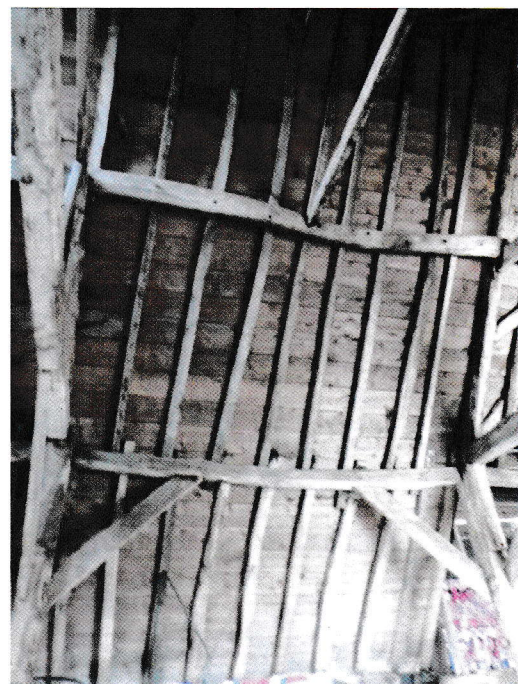
- 3.5 Internally the timber frames are exposed. They are worn, partly decayed in places and have been subject to scuffing and impact over the years. The frames have racked over slightly, but not degree which would give rise to structural concern. The purlins and other members are not entirely straight, but this is normal for a building of this type and age. The structural frame appears to be performing satisfactorily.

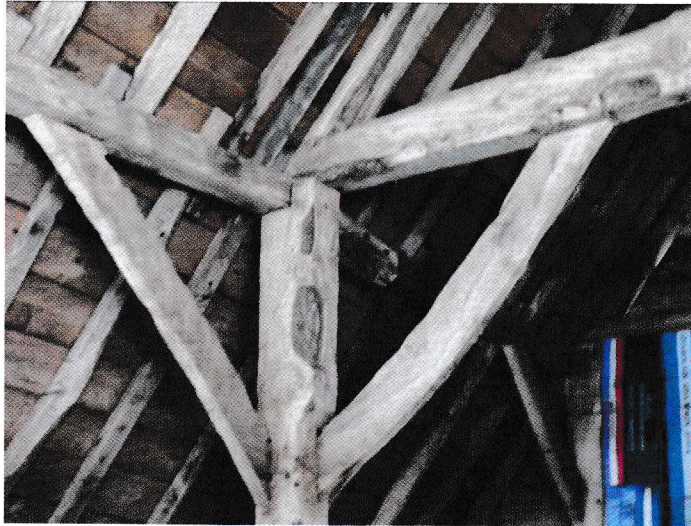
- 3.6 Various areas of repairs and strengthening can be seen but no significant current structural problems or concerns were noted.

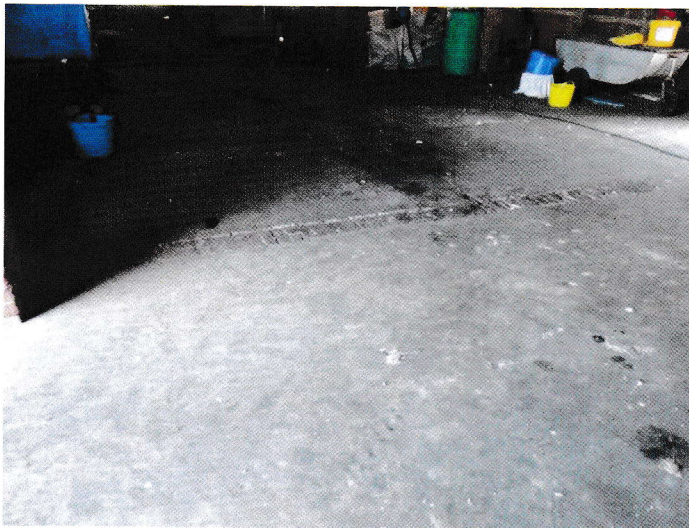
- 3.7 The floor is a concrete slab in various parts with some bricks embedded to divide the bays off. Overall the slab is reasonably true and level with no significant cracks or signs of structural movement.

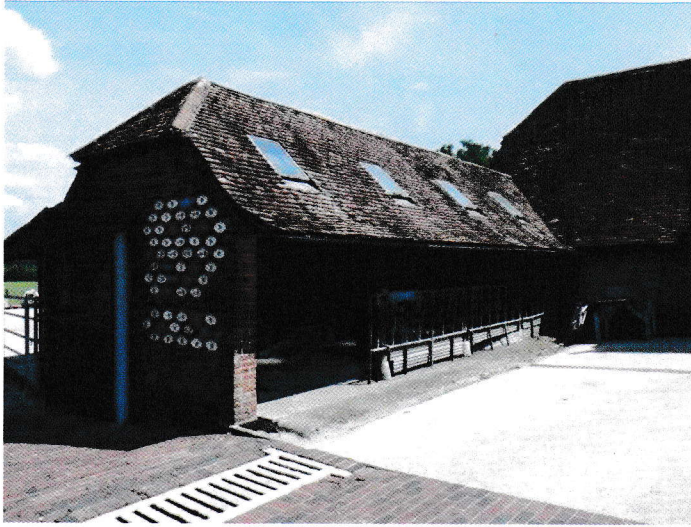
- 3.8 The smaller abutting building is open fronted divided into 4 bays.

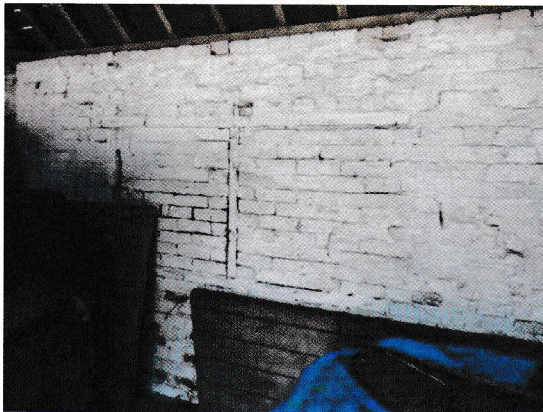
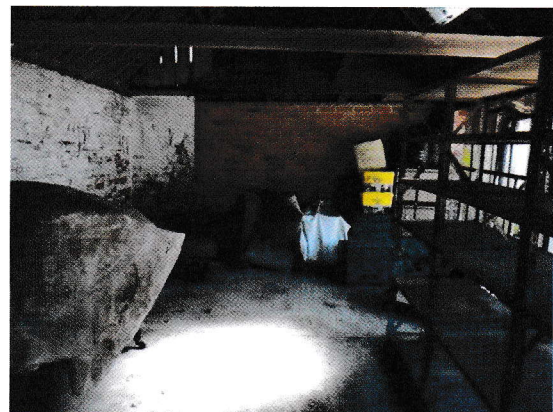
- 3.9 It has solid 9-inch brick walls to both sides and rear. Horizontal lines are reasonably true and level, verticals are reasonably true and plumb, there are no cracks or other signs of structural movement.

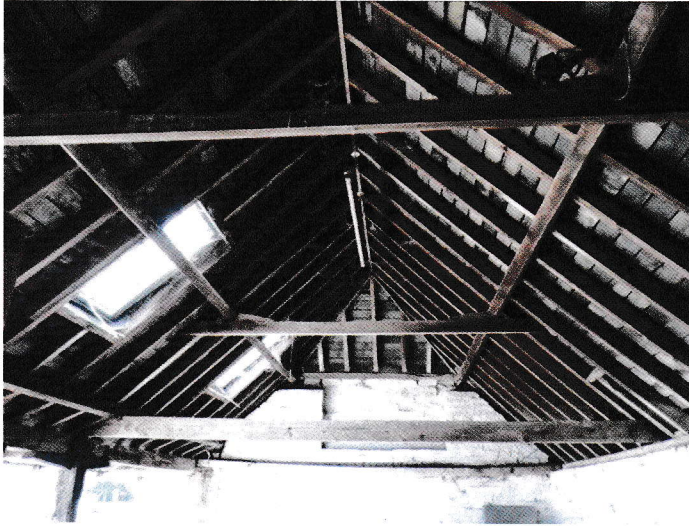
- 3.10** The roof structure is timber with purlins, collars and rafters. These are boarded over and then tiled. There are roof lights to the front roof slope. The roof structure all appears structurally satisfactory, there is no significant sagging of the ridge or roof slopes and no spreading of the eaves.

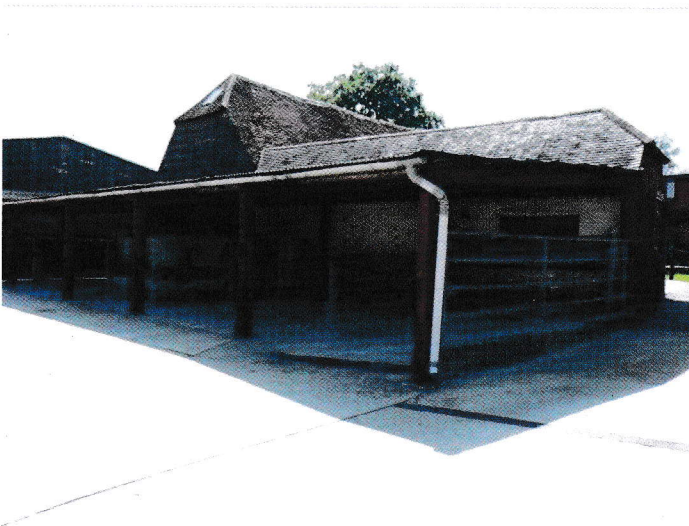
- 3.11** To the rear there is a lean-to structure. It is intended to remove this.
