**Project Name:** 1 - 3 Market Street\_ SO50 5RL  
**Project Description:** Building Works  
**Project Number:** JSD7105  
**Project Status:** Complete  
**Project Date:** 19/03/2024  
**Inspection Standard:** MSCC4 Sewers & Drainage GB (SRM4 Scoring)

1 - 3 Market Street, SO50 5RL

## Section Inspection - 13/03/2024 - Red.Gully1X

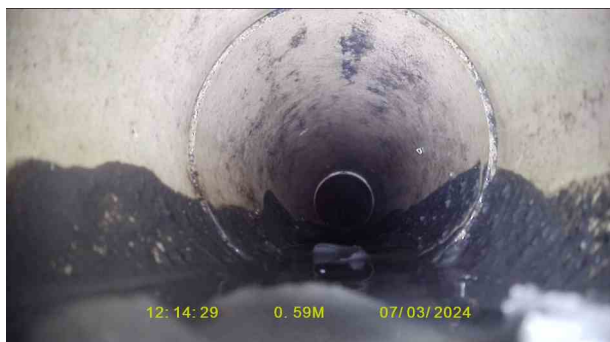
RWDP  
1X\_3506b5ce-8ea7-4fcb-83c2-2ef88a9bda95\_20240319\_154  
547\_734.jpg, 00:00:13, 0.59 m  
Settled deposits, coarse, 15% cross-sectional area loss

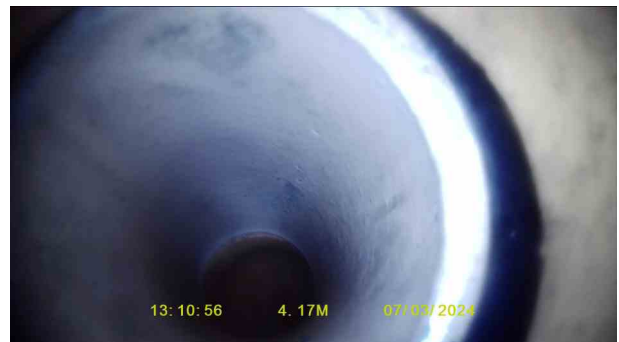
RWDP  
3X\_078e67e5-12dc-4ee0-9bfd-81994ebd52dc\_20240319\_164  
158\_713.jpg, 00:00:52, 4.17 m  
Open joint, large

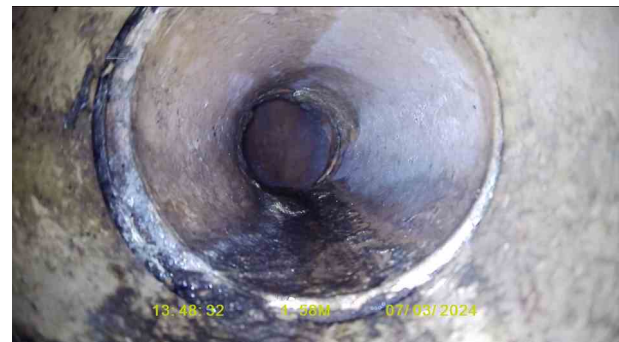
SVP  
2X\_a88911fc-7bdd-4968-9c5c-85725a0da2c7\_20240320\_100  
809\_241.jpg, 00:00:26, 1.49 m  
Open joint, medium

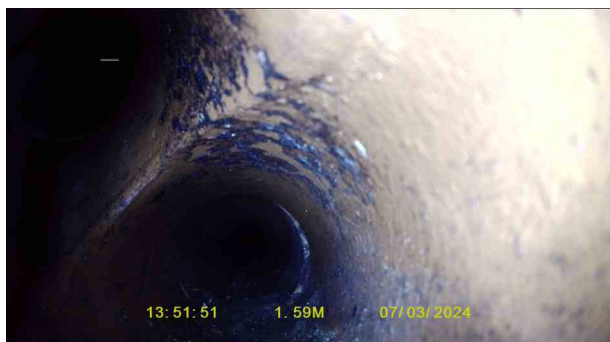
| Scale: | 1:50 | Position [m] | Code | Observation | MPEG | Photo | Grade |
|---|---|---|---|---|---|---|---|
| | | 1.59 | JXD | Defective junction, damaged at 10 o'clock, diameter: 100mm | 00:00:44 | Gully<br>1X_699bef<br>15-4056-4f | |

Gully  
1X\_699bef15-4056-4fa3-b40e-d84956fbfb8c\_20240320\_1026  
27\_547.jpg, 00:00:44, 1.59 m  
Defective junction, damaged at 10 o'clock, diameter: 100mm

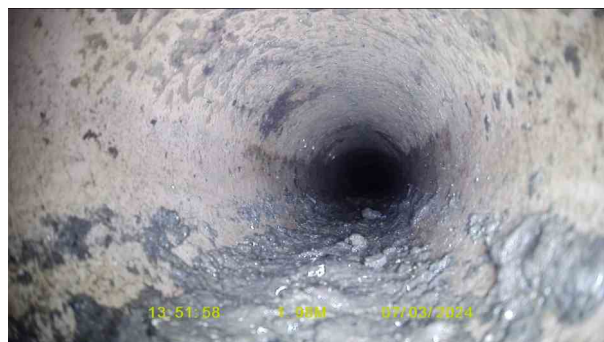
Gully  
1X\_f2b99e48-db12-4270-8dcd-34b28e4c4d14\_20240320\_102  
654\_591.jpg, 00:00:51, 1.93 m  
Settled deposits, fine, 10% cross-sectional area loss

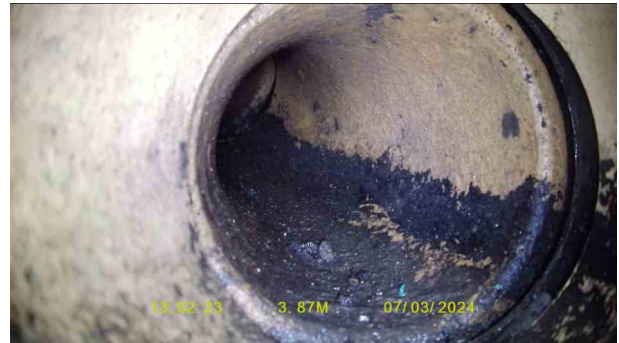
Gully  
1X\_b7f24a29-3480-45ed-9ae3-af38404f719a\_20240320\_102  
758\_513.jpg, 00:01:16, 3.87 m  
Open joint, large

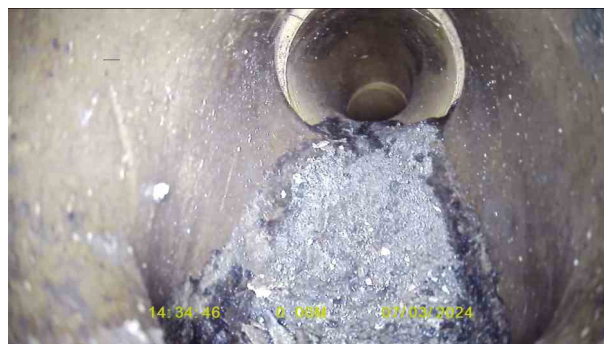
| Scale: | 1:50 | Position [m] | Code | Observation | MPEG | Photo | Grade |
|---|---|---|---|---|---|---|---|
| | | 0.25 | REM | General remark: Back of interceptor is cracked | 00:00:10 | Manhole 5X_119f0b8f-6544-4a | |

Manhole  
5X\_119f0b8f-6544-4a8a-a0b1-066a48cf28c2\_20240320\_1114  
55\_101.jpg, 00:00:10, 0.25 m  
General remark, Back of interceptor is cracked

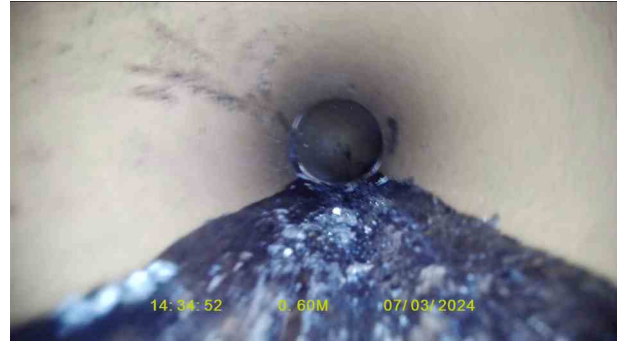
Manhole  
5X\_3f23308d-15b8-4f79-88ec-e9cb87715556\_20240320\_111  
522\_771.jpg, 00:00:16, 0.60 m  
Settled deposits, coarse, 10% cross-sectional area loss

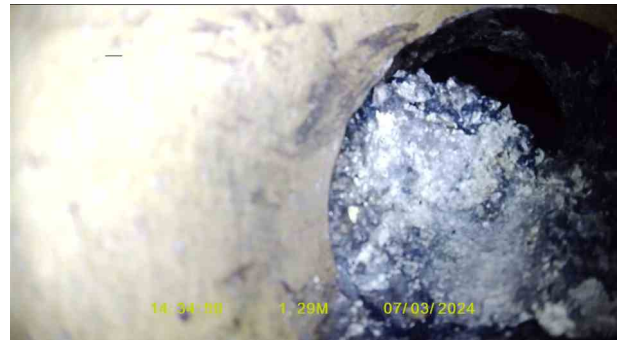
Manhole  
5X\_04b28b9d-c3d2-443d-8588-5e3fe19a8ddf\_20240320\_111  
612\_778.jpg, 00:00:23, 1.29 m  
Attached deposits, encrustation at joint from 4 o'clock to 10 o'clock, 35% cross-sectional area loss

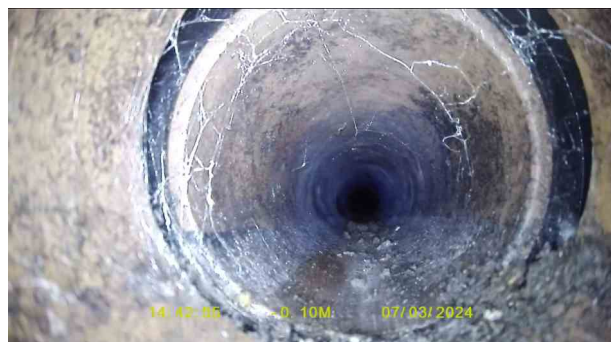
SVP  
5X\_39484c3e-6a53-41c7-8c2a-171520fb3b7e\_20240320\_112  
028\_103.jpg, 00:00:08, 0.10 m  
Open joint, large

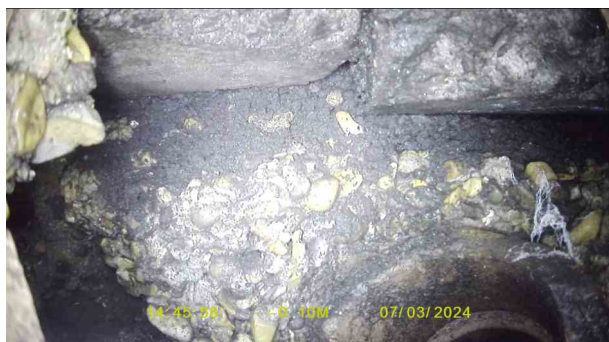
Manhole  
6X\_fb349593-b3ee-4de9-bb3f-f9efa26295b7\_20240320\_1236  
05\_857.jpg, 00:00:08, 0.10 m  
Void visible beyond defect

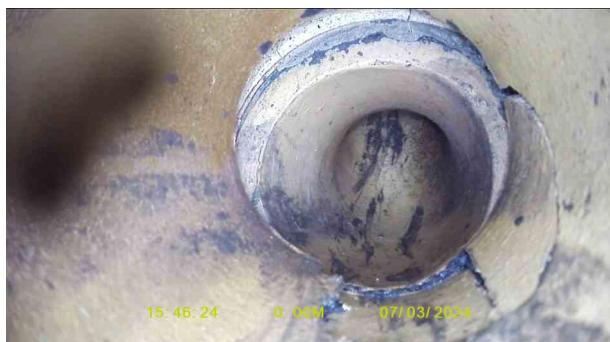
| Scale: | 1:50 | Position [m] | Code | Observation | MPEG | Photo | Grade |
|---|---|---|---|---|---|---|---|
| | | | | B | Broken pipe from 2 o'clock to 7 o'clock | 00:00:08 | Redundant<br>X_df7325c<br>a-5cf0-495 |

RedundantX\_df7325ca-5cf0-495b-8a73-e4da87f2bfc5\_20240  
320\_134254\_147.jpg, 00:00:08, 0.02 m  
Broken pipe from 2 o'clock to 7 o'clock

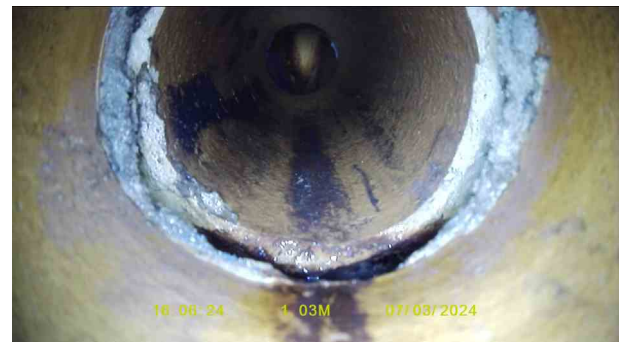
RedundantX\_92cd8f92-8206-4401-ba8a-5e0bad02faff\_20240  
320\_134948\_097.jpg, 00:00:25, 1.03 m  
Open joint, medium

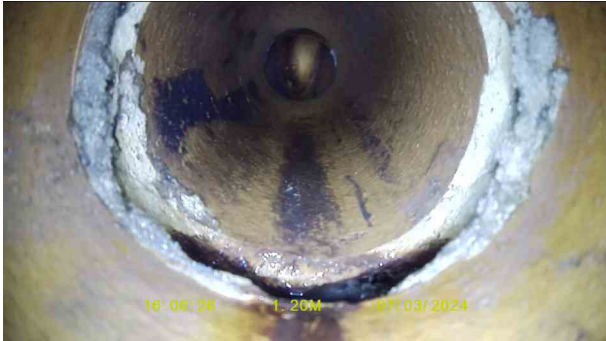
| Scale: | 1:50 | Position [m] | Code | Observation | MPEG | Photo | Grade |
|---|---|---|---|---|---|---|---|
| | | 1.20 | VV | Void visible beyond defect | 00:00:27 | Redundant<br>X_b57be1<br>dc-841a-4 | |

RedundantX\_b57be1dc-841a-45df-9221-9fad4aa04acc\_2024  
0320\_135006\_143.jpg, 00:00:27, 1.20 m  
Void visible beyond defect
