**VERIFICATION REPORT**

**BLOCK B & PLOTS 22-28, 83-85 & 92-94,**

**BARGATE HOMES**

| Reference: | GE20045/VR/BLOCK B & PLOTS 22-28, 83-85 & 92-94/JAN23v2 |

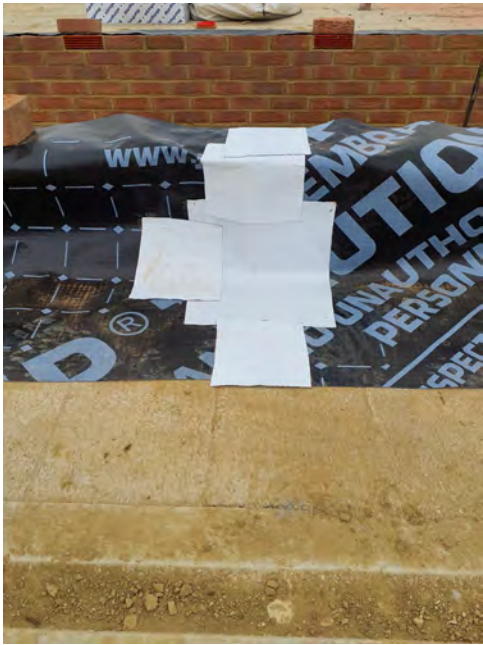
| | Plot 23 repair |

One defect was noted during the validation inspection undertaken on 11<sup>th</sup> October 2022 within Plot 23. A small roughly square area of membrane had not been sealed as the surface beneath the membrane comprised rough concrete that required removal prior to the membrane being installed above. The site manager informed the engineer from Geo-Environmental that the gas membrane installer did not want to install the membrane above this rough surface as it had the potential to damage the membrane. The site manager confirmed that he would arrange for the rough concrete to be removed, and the sealing of the membrane with butyl tape. Photographs of this repair and the fully sealed membrane were provided by the Bargate site manager and are presented within Appendix B. Whilst no defects were noted in the photographs provided, Geo-Environmental did not undertake inspection of this repair.

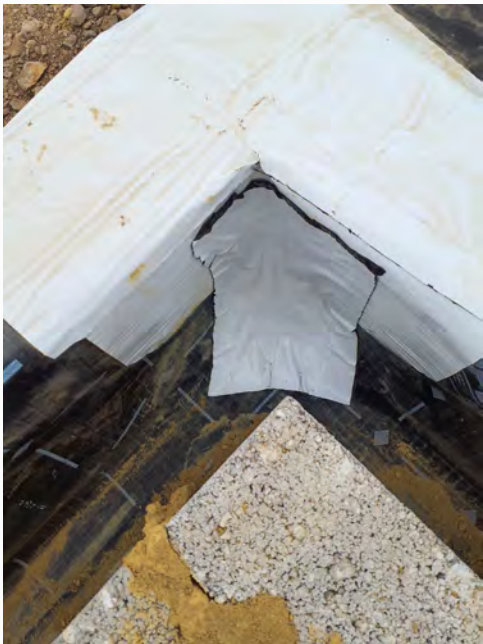
| | Plot 83 repair |

| 1.3 Gas membrane condition | One defect noted in the corner of Plot 83, this was repaired in the presence of the engineer and deemed suitable, otherwise no visible defects but mortar around edges |

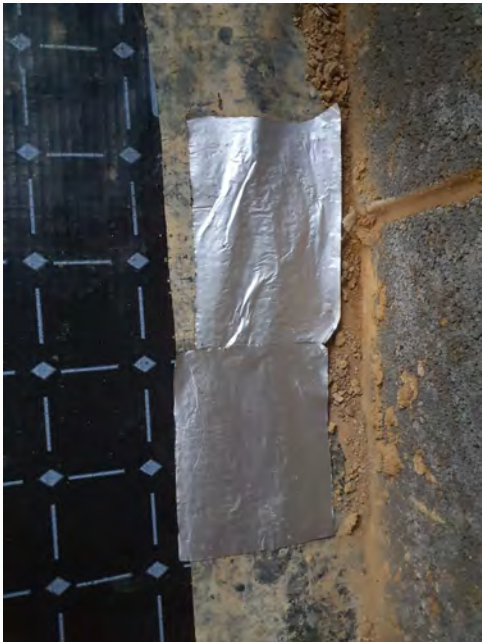
Plot 26 patch repair

| 1.6 Laps, welds and joints seals | All membrane joins heat sealed, patch repairs are butyl detailing strip. All joins well sealed |
