## **Resistograph Tree Report**

**Vivid Housing Limited**

**No.75 & No.79**

**Prepared by  
Richard Daubeney Our Ref 0724-RD  
8th of July 2024**

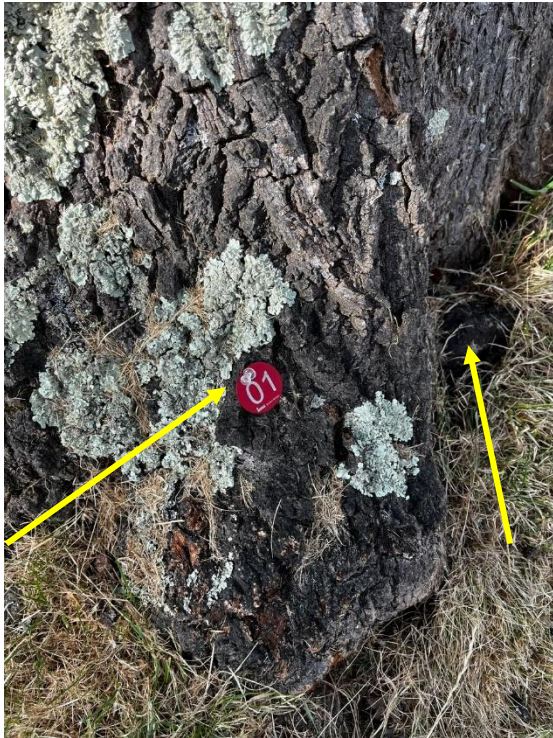
- 5.3 T4052.4 English oak tree has shown following the testing, evidence of moderate areas of decay present within the stem, this decay is considered to be linked to the fruiting bodies *Ganoderma australe* brackets at the base of the stem to the East and West sides at ground level. Readings No.1 to South demonstrated evidence of decay including readings 2 and 4 to the Southwest and West sides, although it is shown within the other readings 3, 6 and 8 there is still moderate and residual sound wood present within the stem. However, when looked from a distance the crown shows areas of dieback to 10-20%, this in turn suggests the tree is in decline. The concern of the known characteristics of these fruiting bodies will impact the tree, based on the decay process of fungus *Ganoderma australe* which effects the stem and the underside of the rooting area, although the readings show limited areas of decay at this time, this will in time further increase the decay and dysfunctional wood within the stem, leading to significant hollowing and a decline in structural root stability.

| Tree No.<br>Tree Tag. | Tree Species | Hgt (m) | Past Management | Age Class | Risk Target | Defects | Works | Work Priority |
|---|---|---|---|---|---|---|---|---|
| T4052.<br>4 Tree tag: 1339 | English oak | 15-20m | Subject to past management | Mature | High/<br>reinspect in 2027 | Gross Defect Noted.<br>Fruiting bodies <i>Ganoderma australe</i> brackets x 3 located to East and West side at ground level. 2 fresh and one old in appearance. No hollow sound when tapped to those sides. Further investigation required by means of decay detection.<br>Some minor wounds to buttresses to East and South sides.<br>Multiple pruning wounds on main stem. Below average shoot extension.<br>Crown dieback of 10-20%<br>Deadwood. | Crown reduce by 4m all round.<br><br>Remove deadwood over 100mm throughout canopy.<br><br>(All tree works to be carried out to BS3998 2010) | Urgent within 3 months |

T4052.4 English oak looking Northeast towards Drill No.1 and old *Ganoderma australe* fruiting body.

6.2 The testing to T4052.4 English oak tree has concluded that although the results show some areas of moderate sound wood present within the stem, however the presence of the *Ganoderma australe* fruiting bodies at the base of the tree will continue to further weaken the tree from a structural stability standpoint, this will continue to decrease the residual sound wood within the stem and rooting area, due to the known decay process of these fruiting bodies. It is clear future decline of this tree raises concerns of risk for potential stem or whole tree failure, with targets such as buildings, communal area, public footpath, main road all within striking distance of tree. Based on the above information, we advise the English oak T4052.4 is crown reduced by 4m all round, this includes the removal of deadwood over 100mm throughout the canopy. By doing these works will ensure that the risk is reduced to the immediate area, but still retaining a smaller and compact canopy. We recommend these tree works is carried out within 3 months from date of this report.

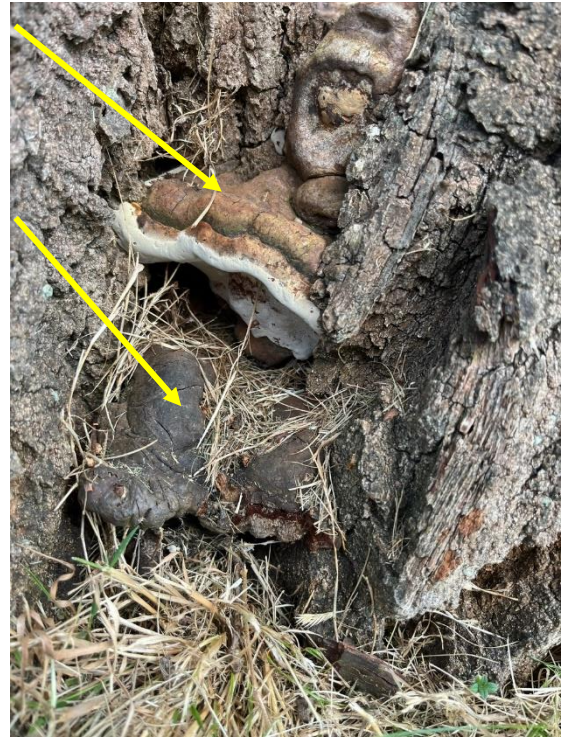
T4052.4 English oak tree looking to East towards *Ganoderma australe* fruiting bodies on stem.

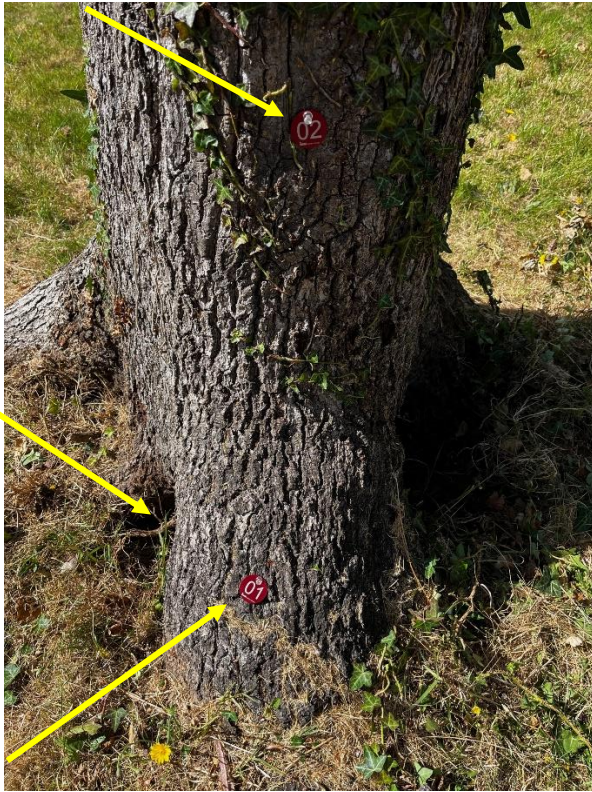
5.4 T4052.6 English oak tree, following the testing carried out to this tree, the results have concluded that although there are basal cavities to the West side, there is still good sound wood present within the stem and buttresses, although there is minor areas of decay present within reading no. 1 to the South side. Despite the basal cavity, the buttresses are shown to still have moderate sound wood present. The tree has had recent crown reduction carried out following the previous testing to this tree T4052.6 in 2021, which in turn has reduced the potential risk of whole tree failure to the immediate area.

| Tree No.<br>Tree Tag. | Tree Species | Hgt (m) | Past Management | Age Class | Risk Target | Defects | Works | Work Priority |
|---|---|---|---|---|---|---|---|---|
| T4052.<br>6 Tree tag: 1952 | English oak | 10-15m | Recent reduction to crown. | Mature | High/<br>reinspect in 2027 | No Gross Defect Noted.<br>Ivy Covered stem unable to fully inspect.<br>Basal cavity to West side, depth is 30cm approx. No hollow sound around that area when tapped with sounding hammer. Further investigation required by means of decay detection.<br>Multiple pruning wounds on main stem.<br>Recent crown reduction to crown. | No works. | N/A |

**T4052.6 English oak looking Southeast towards Drill location No. 1 and 2 and basal cavity**

- 6.3 Testing to T4052.6 English oak has shown that although there is a basal cavity to the West side, the evidence produced from the testing shows moderate areas of sound wood present within the stem and buttresses. The tree has recently undergone a heavy crown reduction following the previous testing to the tree in 2021, this in turn is reducing the risk to the immediate area with targets such as buildings, public footpath, and communal area all within striking distance of tree. Based on the above evidence, we do not recommend any works at this time for T4052.6 English oak tree.
- 6.4 All works to date is to be undertaken within the requirements of the tree table works schedule. The trees listed in this report to be reinspected as outlined within the tree tables.
