## **Resistograph Tree Report**

**Vivid Housing Limited**

**1-26**

**Prepared by  
Richard Daubeney Our Ref 0724-RD  
5th of July 2024**

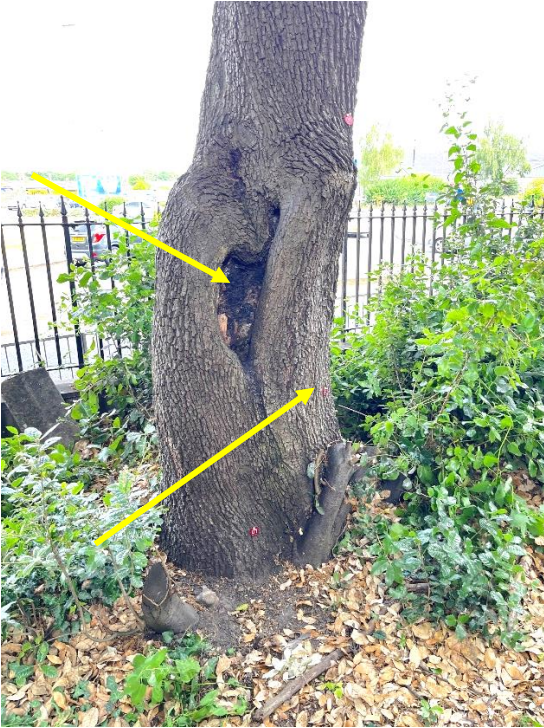
- 5.3 T4176 Holm oak tree has highlighted areas of sound wood present within the stem, despite the large cavity formation to the West side. The tree has put on moderate reaction wood surrounding the cavity. This is the trees response to mechanical loading around the cavity area of the tree. There is one of the readings No.6 to the Northwest side which focuses on the residual wood surrounding the cavity, this was shown to have small areas of decay present but not significant at this time. Although all the readings are not fully conclusive, this is due to the tension within the wood fibres and the hard wood nature of these species, however results do show overall a moderate sound wood within the readings taken. Further up in the tree are two cavities located on the stems, these are small in size. The cavities will need to be inspected to ensure both do not have significant defects. The tree has been reduced previously as part of the last testing to the tree carried out in 2021. T4176 Holm oak has put out good response growth from the previous pruning points all round. The tree is in a prominent position close to the boundary wall, with main road, public footpath, communal area and building all within striking distance of tree.

**T4176 Holm oak looking Southeast towards Drill location No.5 and cavity on stem.**

- 6.1 Following the results of T4176 Holm oak tree mentioned within this report, we now provide our conclusion.
- 6.2 The testing to T4176 Holm oak tree showed that there is still moderate sound holding wood within the stem despite the inconsistent readings given, The cavity has not significantly decreased the residual and live sound wood remaining within the stem when in comparison to the previous testing in 2021, however the concern is the cavities further up on the stems which require further investigation, and the current height and spread of the crown. The tree has put on good response growth since the last crown reduction, with the position of the tree being in an area of high risk, with this in mind, we advise that the T4176 Holm oak is to have the cavities on the stems inspected, if found not to be significant then proceed with crown reduction back to previous points of pruning. By doing so will ensure that the tree is kept to a compact shape, including minimising the risk to the immediate area around the tree. We recommend these tree works is carried out within 6 months from date of this report.

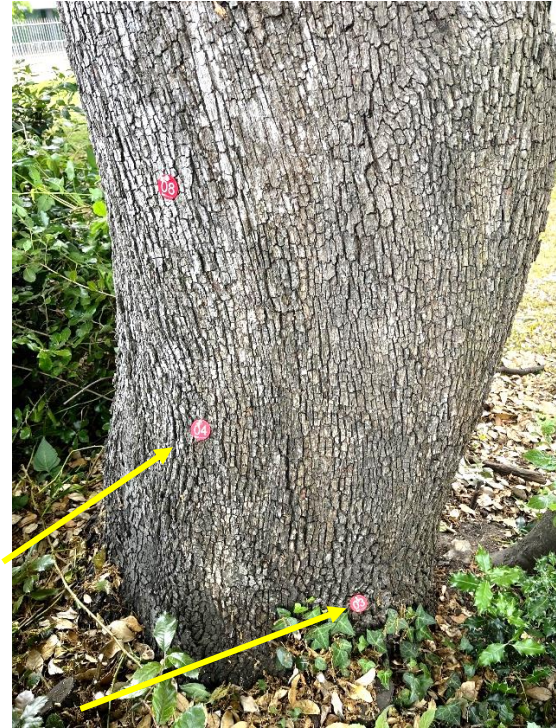
**T4176 Holm oak tree looking to West towards drill location No. 4 and No.3**

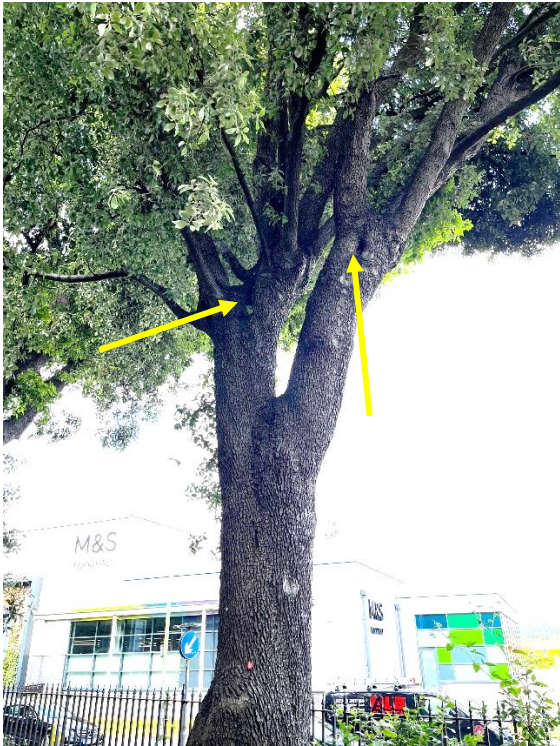
| Tree No.<br>Tree Tag. | Tree Species | Hgt (m) | Past Management | Age Class | Risk Target | Defects | Works | Work Priority |
|---|---|---|---|---|---|---|---|---|
| T4176<br>Tree tag:<br>1580 | Holm oak | 15-20m | Recent reduction to crown. | Mature | High/<br>reinspect in 2027 | No Gross Defect Noted.<br>Dense basal vegetation, unable to fully inspect. Cavity to West side, 1m above ground level. Depth is approx. 30cm. Multiple pruning wounds on main stem. Two small cavities located at 4m and 5m to the West side of stem. Historic reduction carried out to crown. Slightly asymmetric canopy. | Check cavities on stem at 4m for detailed investigation and report back on findings. If found not significant then proceed to crown reduce to previous point of reduction.<br><br>(All tree works to be carried out to BS3998 2010) No pruning wounds to exceed 50mm in dia. | High within 6 months |

**T4176 Holm oak tree looking east towards stem cavities**

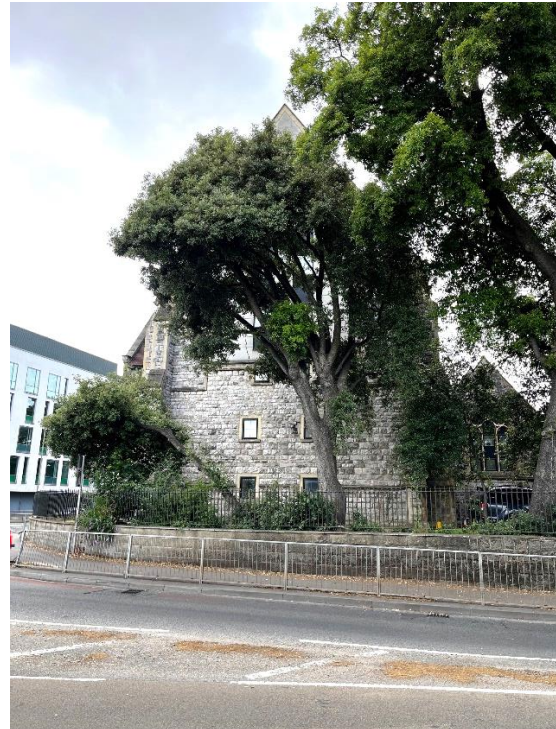
**T4176 Holm oak tree Looking West**
