## **Resistograph Tree Report**

**Vivid Housing Limited**

**12-64,**

**Prepared by  
Richard Daubeney Our Ref 0724-RD  
3rd of July 2024**

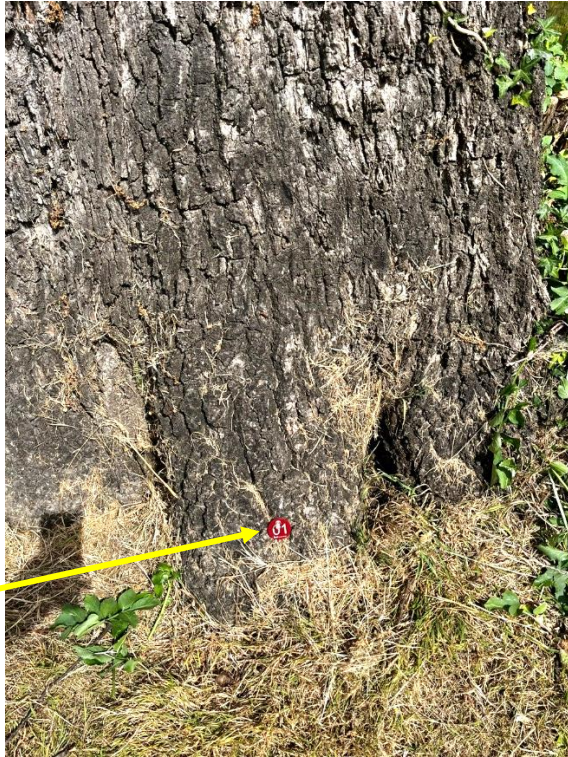
T4801 English oak looking East towards Drill location No.1.

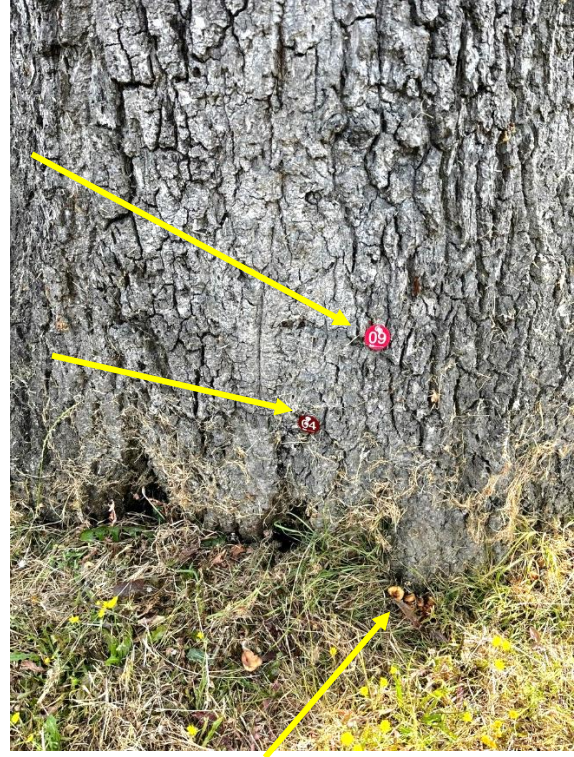
T4801 English oak tree looking to Southwest towards drill location No. 4 and 9 and fruiting body of *Gymnopus fuipes* at ground level against stem.
