## Section Inspection - 13/05/2024 - TANK 4 (A)X

| Town or Village: | Bishopstoke | Inspection Direction: | Upstream | Upstream Node: | TANK 4 (A) |
| Road: | Bow Lake Gardens | Inspected Length: | 8.30 m | Upstream Pipe Depth: | 0.000 m |

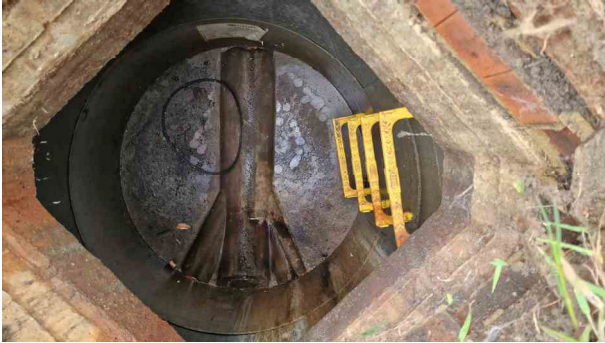
S23A\_\_TANK 4 (A)\_12.jpg, 00:00:00, 0.00 m  
Start node, manhole, reference: S23A

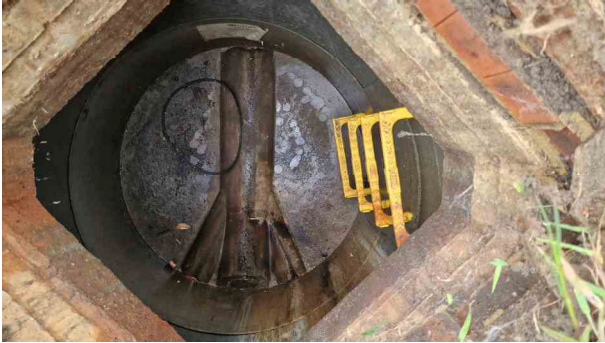
S23A\_\_TANK 4 (C)\_13.jpg, 00:00:00, 0.00 m  
 Start node, manhole, reference: S23A

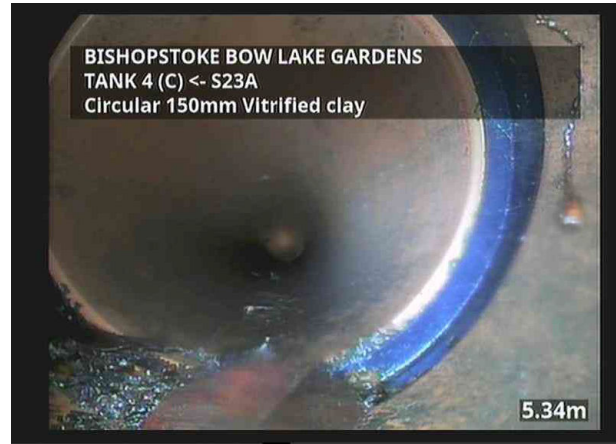
| Scale: | 1:65 | Position [m] | Code | Observation | MPEG | Photo | Grade |
|---|---|---|---|---|---|---|---|
| | | 5.30 | OJM | Open joint, medium | 00:00:38 | S23A_TA<br>NK 4<br>(C)_14.jpg | 1 |

S23A\_\_TANK 4 (C)\_14.jpg, 00:00:38, 5.30 m  
 Open joint, medium

Recommendations: PATCH REPAIR REQUIRED

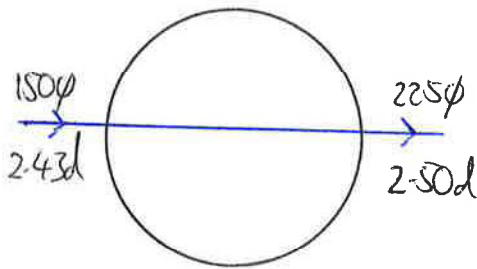
MH S12

Chamber size - 1200φ  
Chamber condition/remarks - Good

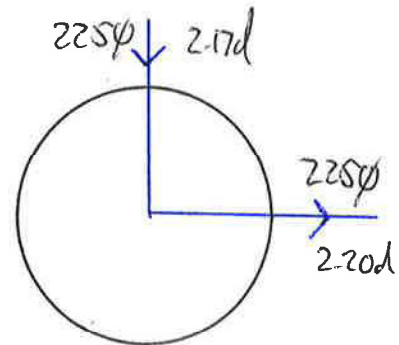
MH S10

Chamber size - 1200φ  
Chamber condition/remarks - Good

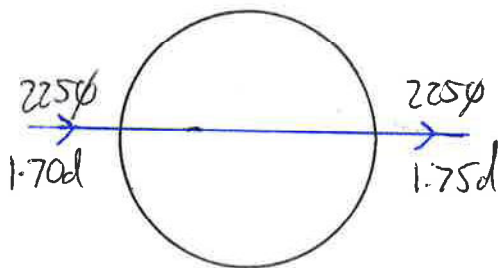
MH S18

Chamber size - 1200φ  
Chamber condition/remarks - Good

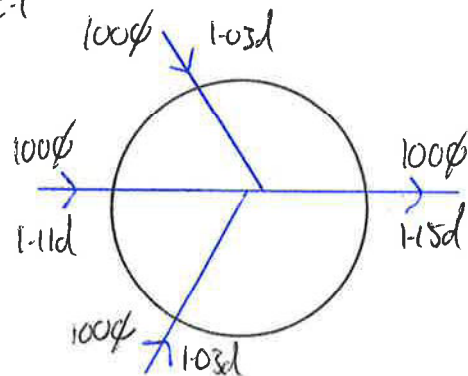
MH IC-1

Chamber size - 2500φ  
Chamber condition/remarks - Good

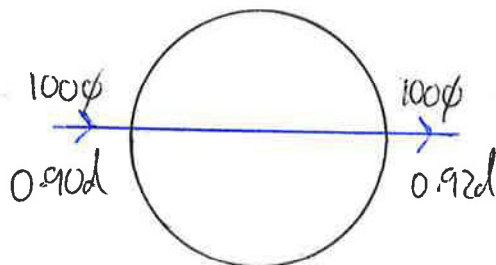
MH IC-2

Chamber size - 450φ  
Chamber condition/remarks - Good

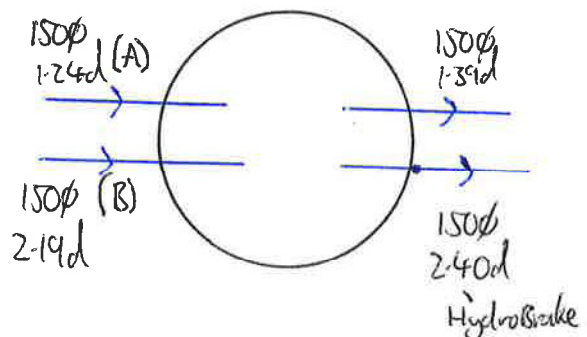
MH S24

Chamber size - 1200φ  
Chamber condition/remarks - Good

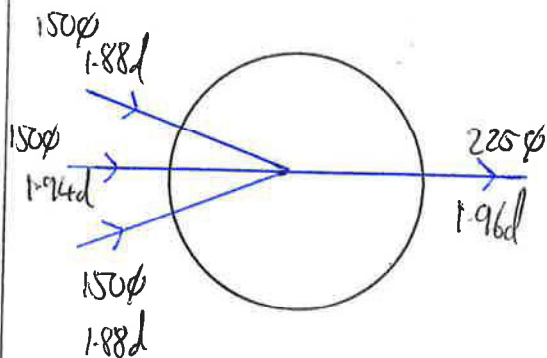
MH 523A

Chamber size - 1200φ  
Chamber condition/remarks - Good
