**Project Name:** 14595 BOW LAKE GARDENS

**Project Description:** CCTV SURVEY OF SURFACE WATER DRAINAGE TO ASCERTAIN IF THE ATTENUATION TANKS HAVE BEEN INSTALLED

**Project Date:** 13/05/2024

**Inspection Standard:** MSCC5 Sewers & Drainage GB (SRM5 Scoring)

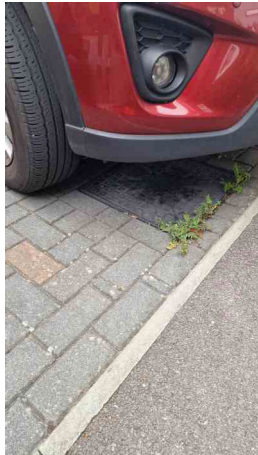
IC.3 IS UNDER A CAR SO UNABLE TO SURVEY DOWNSTREAM TO TANK.

IC.3 UNDER CAR UNABLE TO SURVEY, HOME OWNER NOT IN\_1

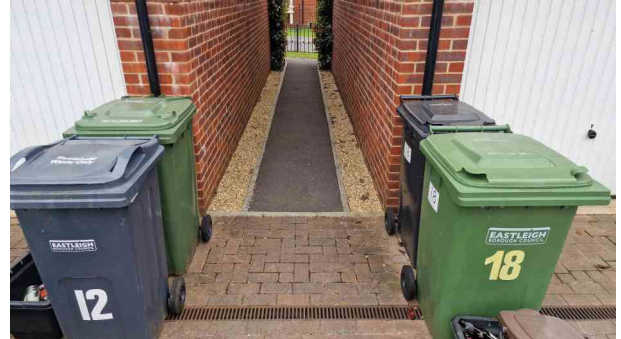
RE.1 DOES NOT EXIST AND RWPS NEARBY DONT HAVE CAMERA ACCESS.

Re.1 not visible\_081858\_1

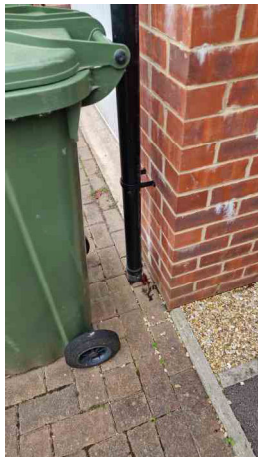
Rwp next to re.1 no camera access (1)\_1

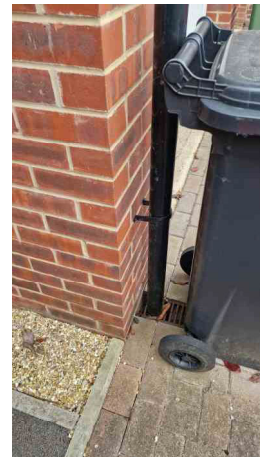
Rwp next to re.1 no camera access \_1

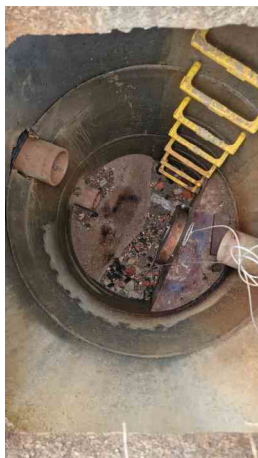
TANK 4 S24 SURVEYED INTO TANK 4 IN HIGHER PIPE, LOWER PIPE IS A HYDROBRAKE AND UNABLE TO SURVEY DUE TO CONFINED SPACE BEING REQUIRED.

S24 UNABLE TO SURVEY THROUGH HYDRO BRAKE CONFINED SPACE REQUIRED\_1

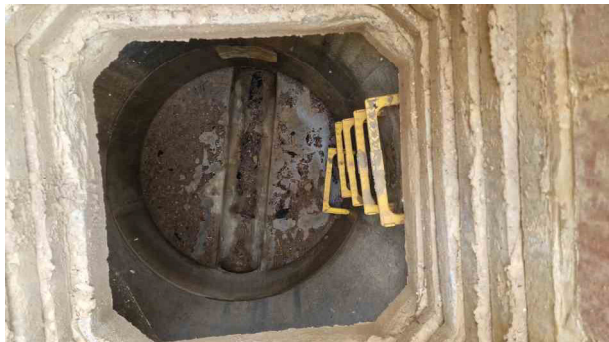
S12\_\_TANK 2\_1.jpg, 00:00:00, 0.00 m  
 Start node, manhole, reference: S12

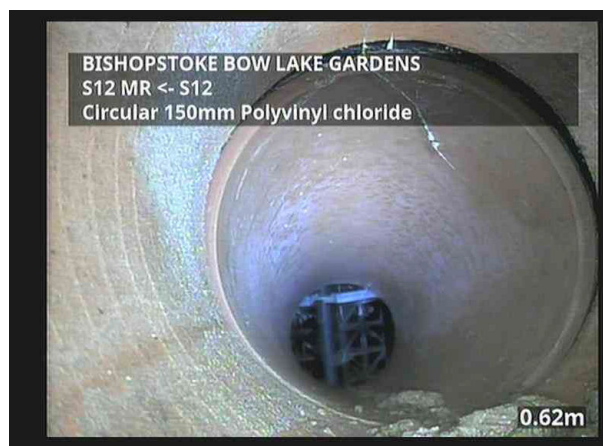
| Scale: | 1:50 | Position [m] | Code | Observation | MPEG | Photo | Grade |
|---|---|---|---|---|---|---|---|
| | | 0.62 | OJM | Open joint, medium | 00:00:20 | S12_TAN<br>K 2_2.jpg | 1 |

S12\_\_TANK 2\_2.jpg, 00:00:20, 0.62 m  
 Open joint, medium

Recommendations: REMEDIAL WORKS REQUIRED

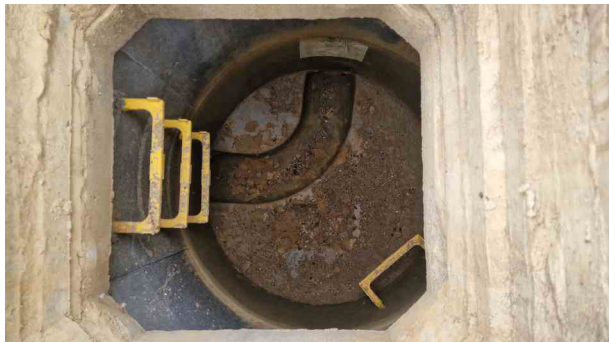
S10\_\_TANK 1\_3.jpg, 00:00:00, 0.00 m  
Start node, manhole, reference: S10

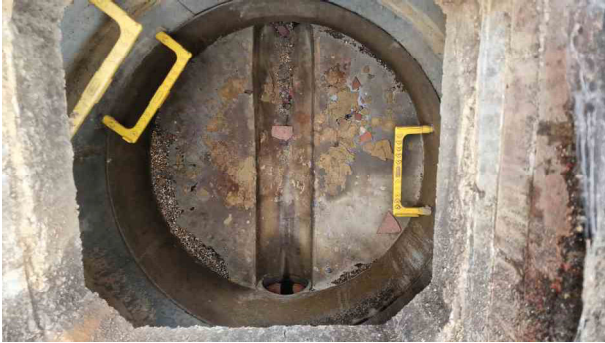
S18\_\_TANK 3\_4.jpg, 00:00:00, 0.00 m  
Start node, manhole, reference: S18

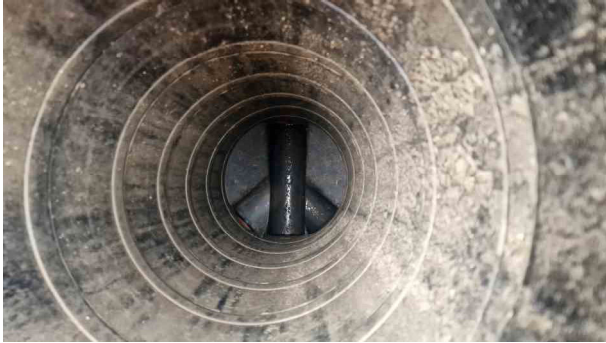
IC.1\_DS\_TANK 3\_5.jpg, 00:00:00, 0.00 m  
Start node, inspection chamber, reference: IC.1
