## **TECHNICAL ADDENDUM REPORT ON A SUBSIDENCE CLAIM**

**Crawford Reference: SU2203818**

**11 Ferndale  
Southampton  
Hampshire  
SO30 0PP**

### **SUBSIDENCE CLAIM**

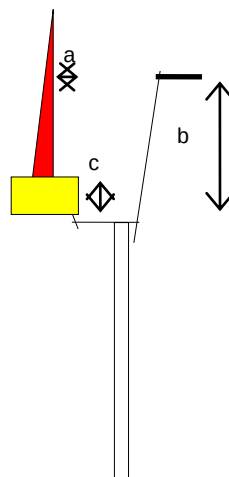
Foundation Details

| No. | Borehole Depth | Footing (a) | Underside (b) | Thickness (c) |
| TH1 | 3.00 m. | 350 mm. | 1100 mm. | 400 mm. |

- The foundations are at a depth of 1100mm which is below the level that normal seasonal movement would be expected to occur.
- The moisture content profile indicates a reduction in moisture content between a depth of 1.5m and 3.0m in borehole 1, which is indicative of desiccation caused by root induced moisture extraction.

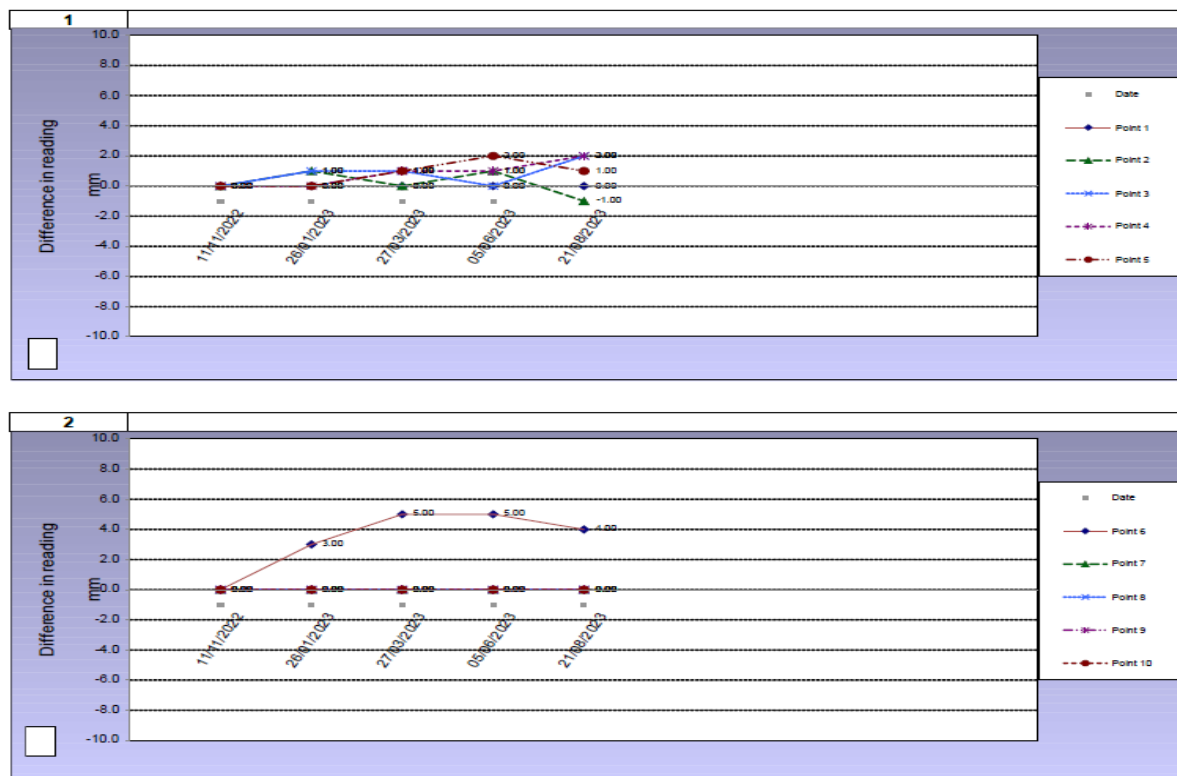
Level monitoring has been implemented to provide further evidence to support our conclusions. The initial Level monitoring reading was taken on 11<sup>th</sup> November 2022, with the last readings being taken on 21<sup>st</sup> august 2023. The readings have shown that the property is suffering from subsidence movement with recovery in the winter months and further subsidence movement occurring in the summer and autumn months. The monitoring has been extended to continue through the autumn and winter months, to continue to capture the rate of movement on the property, whilst the tree is in place.

- Level monitoring has confirmed subsidence movement with downward recording readings in the summer and recovery during the winter.
