**ADDENDUM ARBORICULTURAL REPORT**

**SUBSIDENCE CLAIM**

**Crawford Reference: 1784480  
Insurer Claim Reference: 12562946G**

**23a Crows Nest Lane, Botley, Southampton, SO32 2DD**

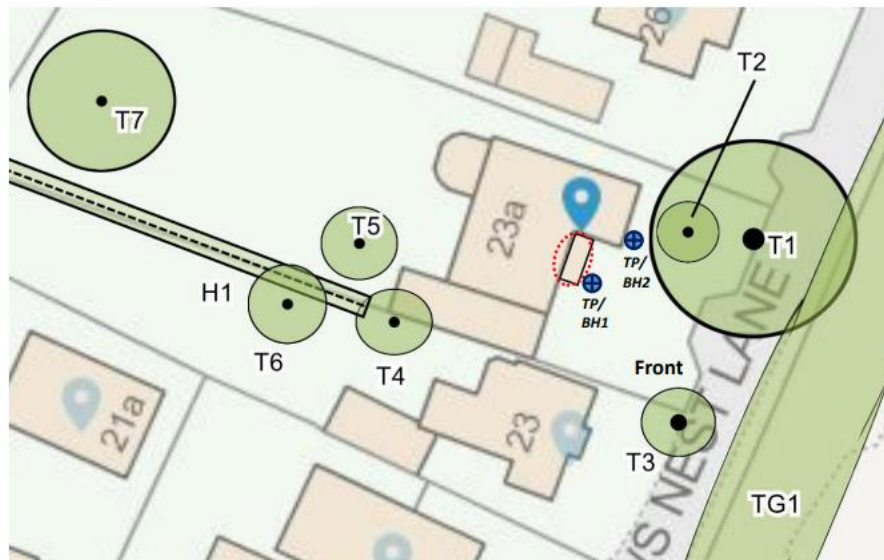
Site Plan

Approximate areas of damage

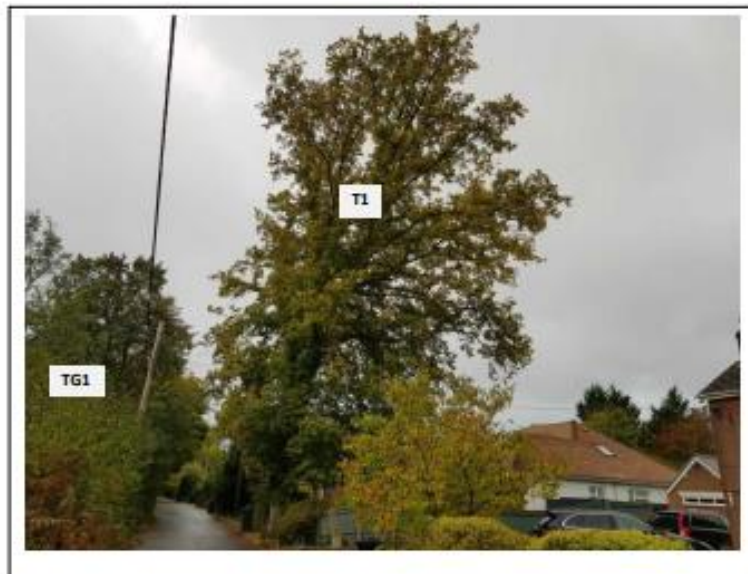
View of property from front right

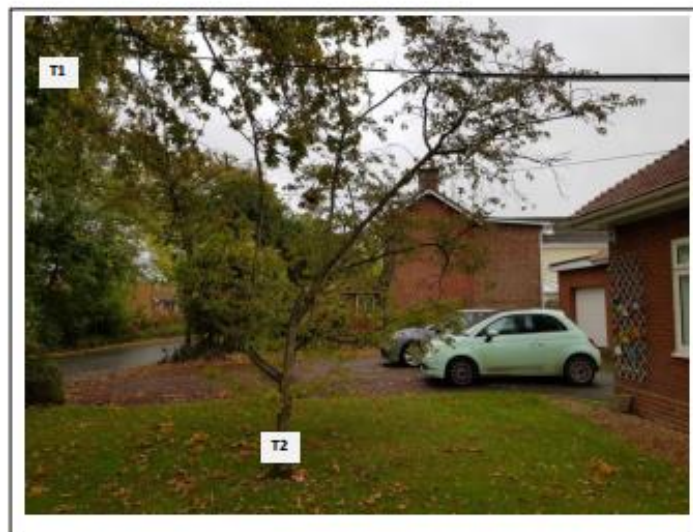
View of front garden looking left

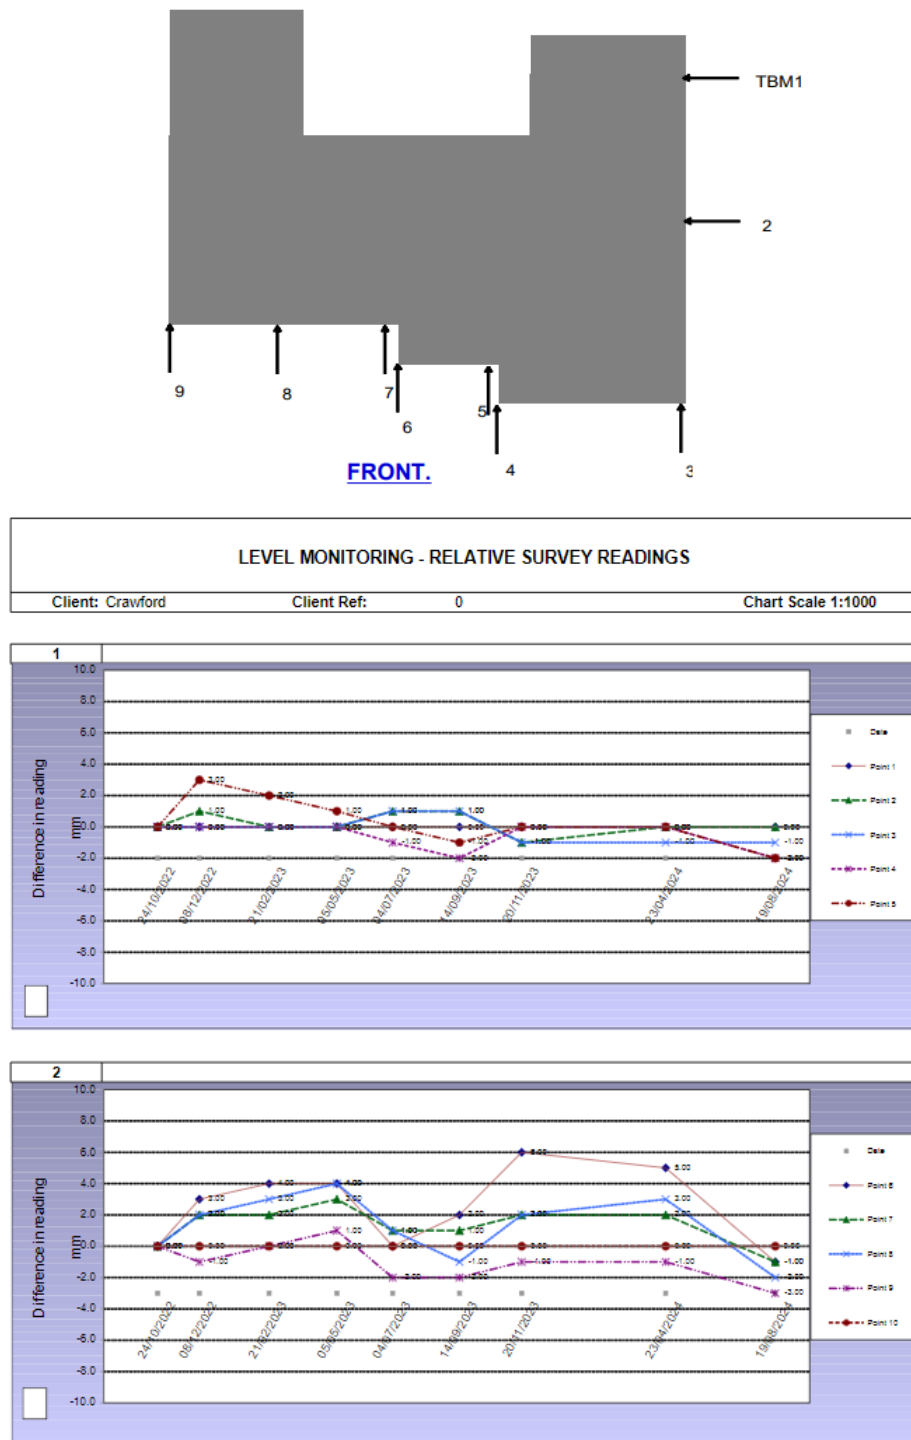
The level monitoring indicates a clear seasonal and cyclical pattern of movement consistent with root induced clay shrinkage with the greatest amplitude of movement being consistent with the locations of T1 & T2.

This seasonal pattern of movement occurred during summer 2023 and 2024 despite these summers having been considerably wetter than summer 2022 when the damage occurred.
