# Geotechnical Survey Report

| FSI Ref: | 25313 |
| Risk Address: | 23a Crows Nest Lane<br>Botley<br>Southampton<br>SO32 2DD |
| Claim Ref: | SU2203636 |

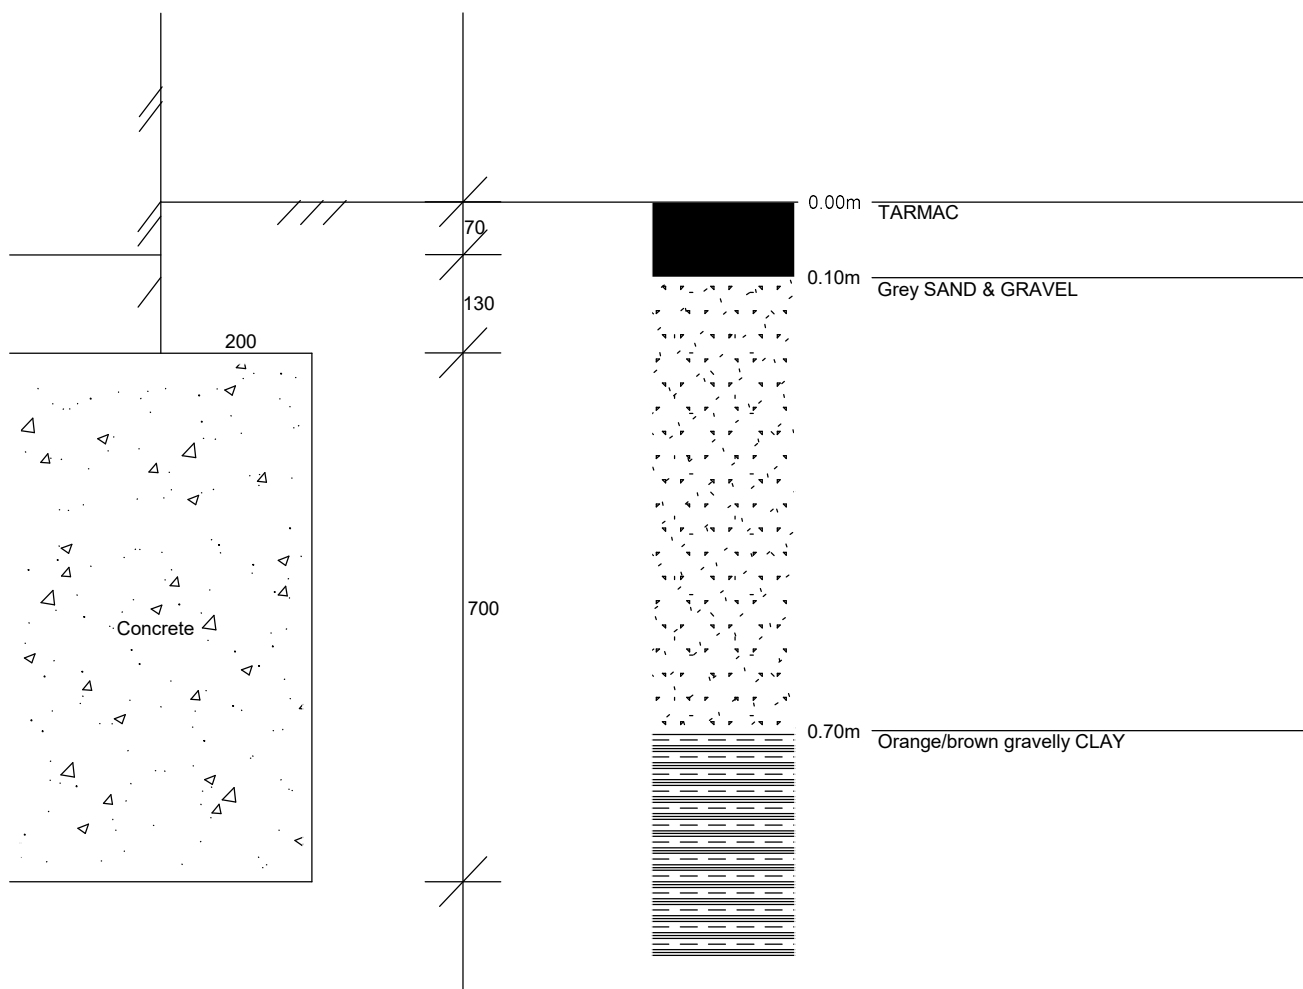
## TRIAL PIT 1

D1 @ F.L. (0.90m)

MP = 5-8-11-17/75mm

Founding strata: Orange/brown gravelly CLAY

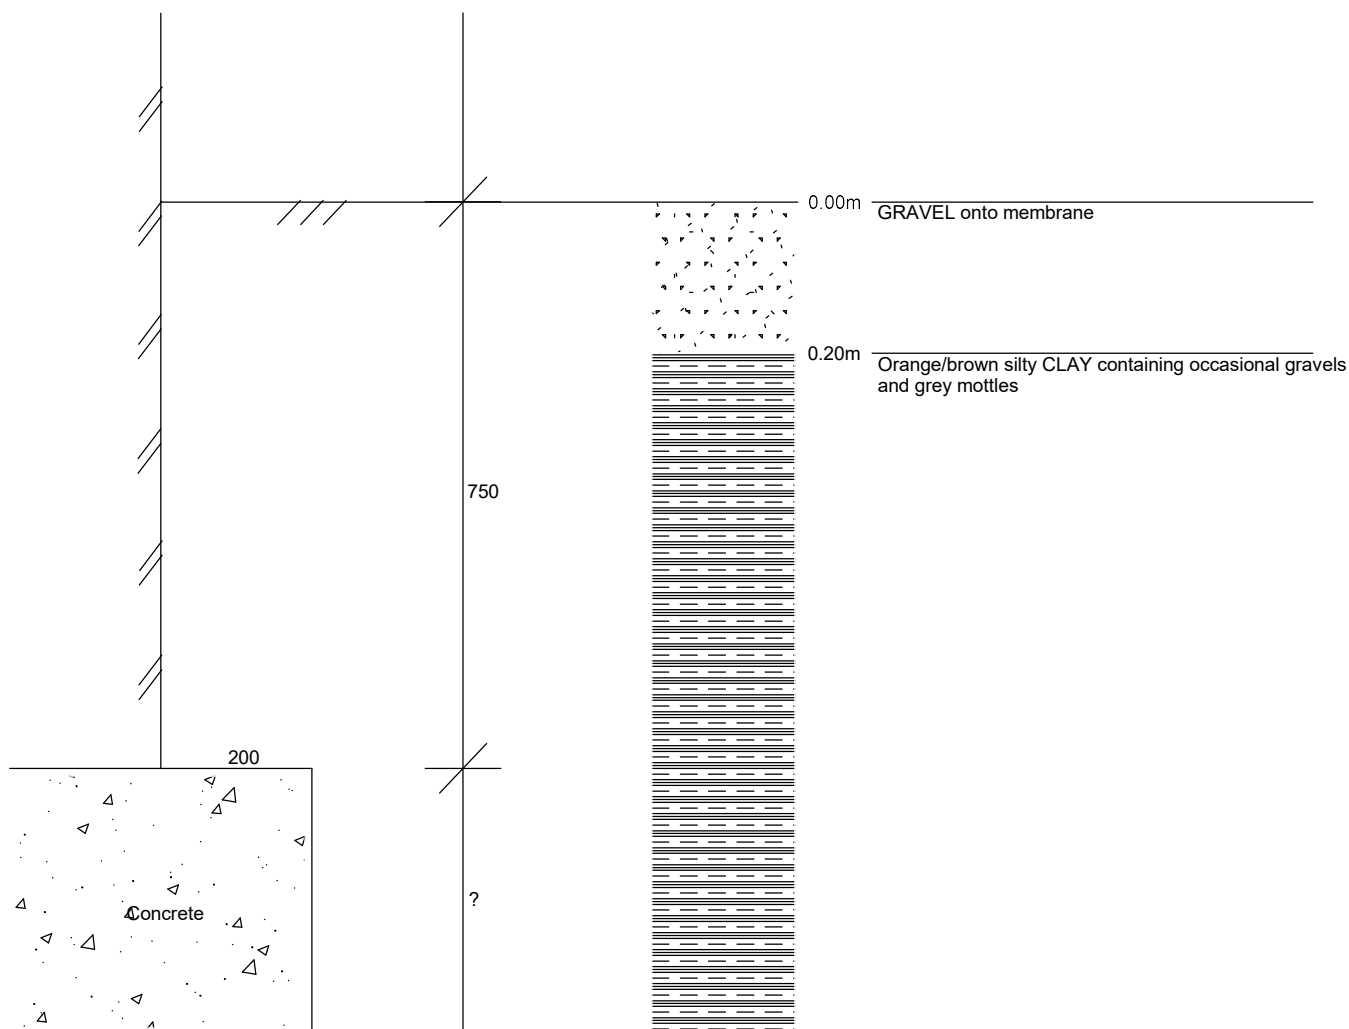
## TRIAL PIT 2

Foundation level greater than 1.50m

D1 @ 1.50m

MP = 18-32-48-42/75mm

Founding strata: Orange/brown silty CLAY containing occasional gravels and grey mottles

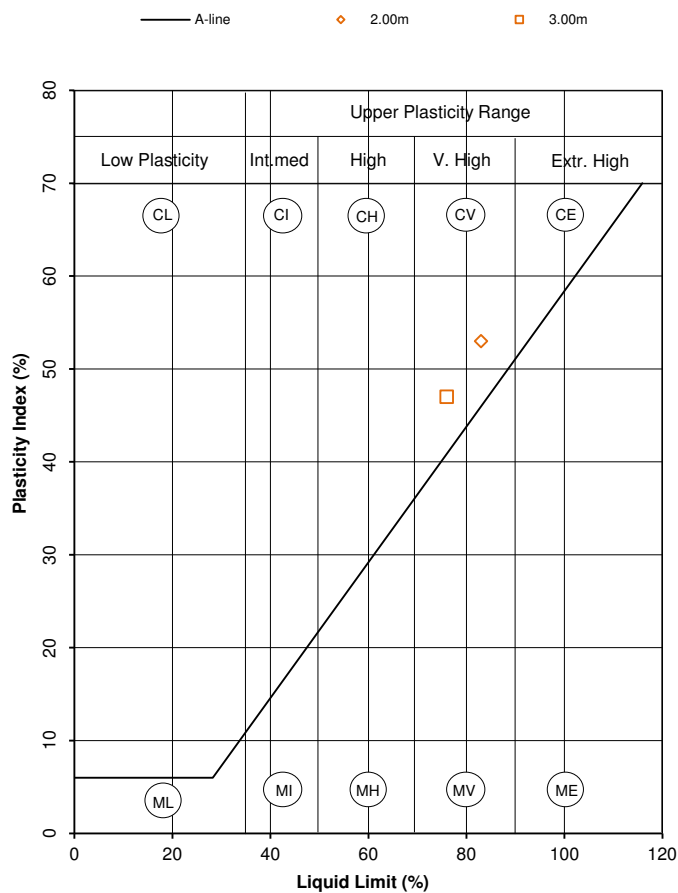
| Comments: | BH1 @ 0.90m - Unable to perform atterberg limits due to incohesive soil |
