## Section Pictures - 13/05/2024 - TANK 1X

## Section Inspection - 13/05/2024 - TANK 3X

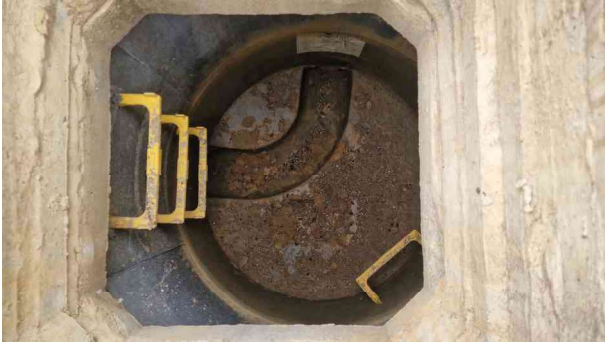
S10\_\_TANK 1\_3.jpg, 00:00:00, 0.00 m  
Start node, manhole, reference: S10

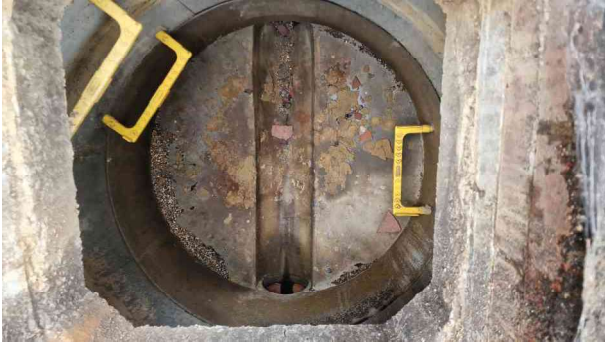
S18\_\_TANK 3\_4.jpg, 00:00:00, 0.00 m  
Start node, manhole, reference: S18

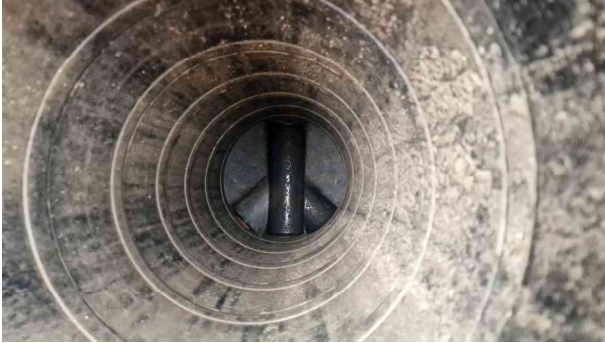
IC.1\_DS\_TANK 3\_5.jpg, 00:00:00, 0.00 m  
Start node, inspection chamber, reference: IC.1

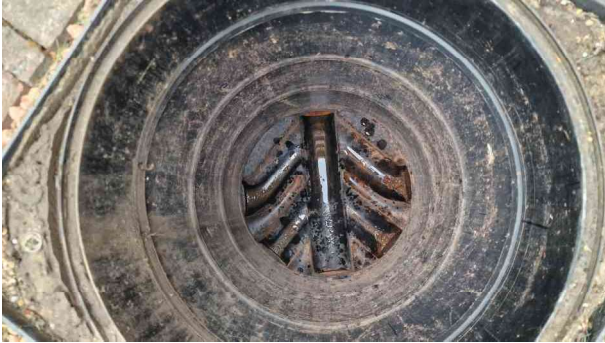
| Scale: 1:113 | Position [m] | Code | Observation | MPEG | Photo | Grade |
|---|---|---|---|---|---|---|
| | 11.80 | DES | Settled deposits, fine, 5% cross-sectional area loss | 00:01:42 | | 3 |
| | 12.50 | DES | Settled deposits, fine, 10% cross-sectional area loss | 00:01:50 | | 3 |
| | 13.00 | DES | Settled deposits, fine, 50% cross-sectional area loss | 00:01:59 | | 4 |

IC.2\_DS\_TANK 3\_6.jpg, 00:00:00, 0.00 m  
Start node, inspection chamber, reference: IC.2

Recommendations: HIGH PRESSURE WATER JETTING AND RESURVEY REQUIRED

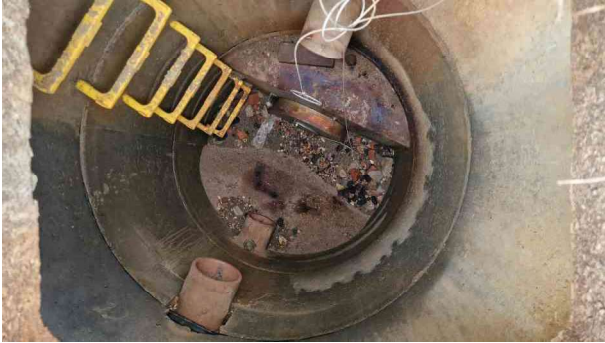
| Scale: | 1:50 | Position [m] | Code | Observation | MPEG | Photo | Grade |
|---|---|---|---|---|---|---|---|
| | | 0.40 | DES | Settled deposits, fine, 5% cross-sectional area loss | 00:00:10 | | 3 |

S24 (A)\_\_TANK 5 (A)\_7.jpg, 00:00:00, 0.00 m  
Start node, manhole, reference: S24 (A)

Recommendations: NO FURTHER WORKS REQUIRED
