Issue date: 05/09/2024

Monitoring visit 7 of 7

## Monitoring Plus Report

| Address | 62 Thistle Road<br>Hedge End<br>Southampton<br><br>SO30 0TT | Principal area of damage | to be advised | Installed | 17/05/2023 |

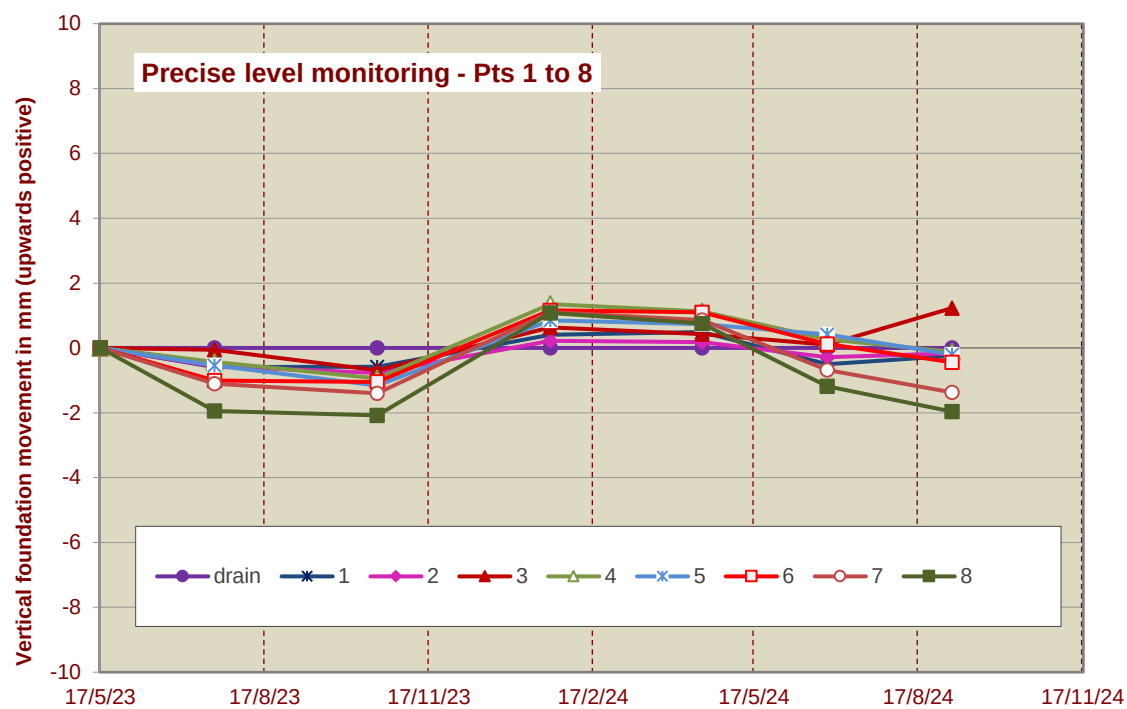
Precise level monitoring related to drain

| Max moveme 3.2 mm | no feedback for this visit | | | | |
| Focal area Pts 3, 4, 5, 6, 7, 8, | | | | | |
