## Engineers Report

**Risk Address** 62 Thistle Road  
Hedge End  
Southampton  
SO30 0TT

**360 Reference** LIV-SN-22-004886  
**Claim Reference** 100-50-192954  
**Policy Holder** Mr. Antony Marsh

**Date Notified** 22/08/2022  
**Date Instructed** 22/08/2022  
**Report Date** 26/09/2022

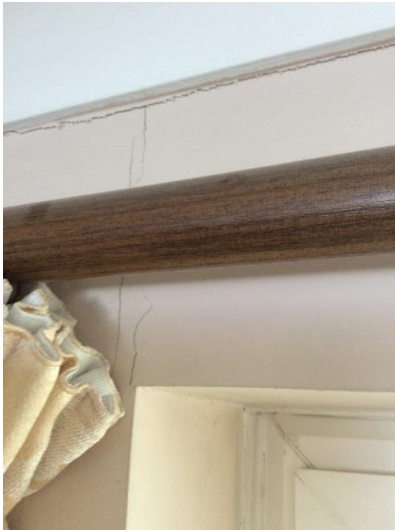
Picture 1: Very slight vertical cracking internally on left hand side above patio doors

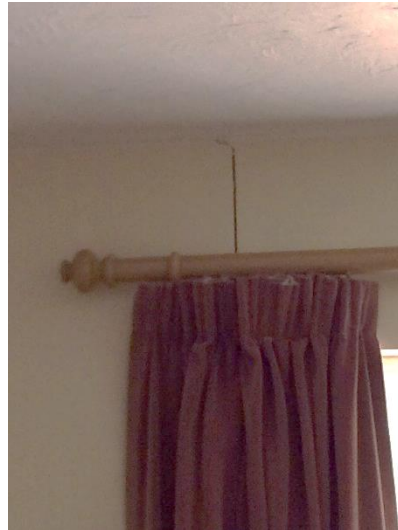
Picture 2: Vertical tapered crack extends to ceiling level in first floor bedroom above patio doors and reflective of cracking observed externally

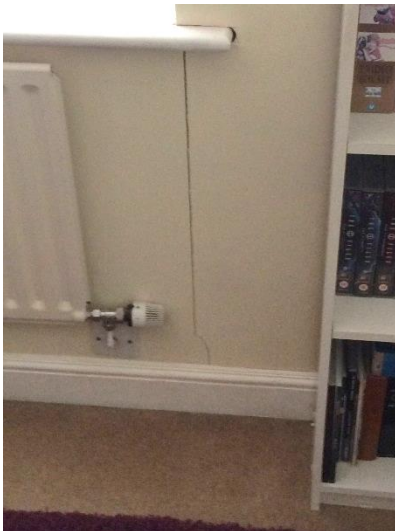
Picture 3: Vertical tapered crack in first floor bedroom on rear left-hand side reflective of that seen externally above patio doors

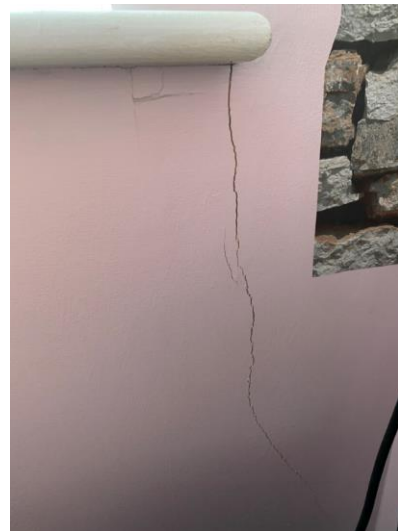
Picture 4: Vertical tapered cracking in first floor middle bedroom above the front door on left side of window

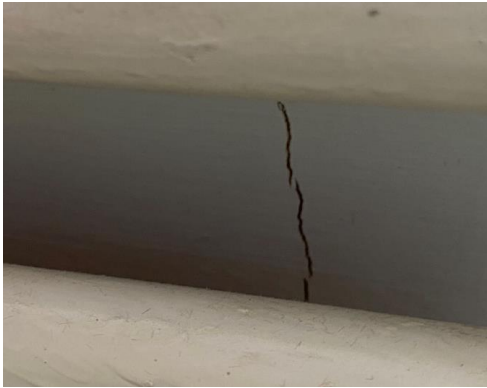
Picture 5: Vertical cracks noted around radiator beneath window in first floor bedroom on front right-hand side

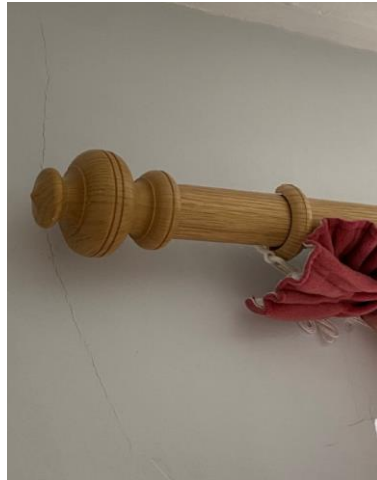
Picture 6: Cracks up to ceiling level near window in first floor bedroom on front right-hand side

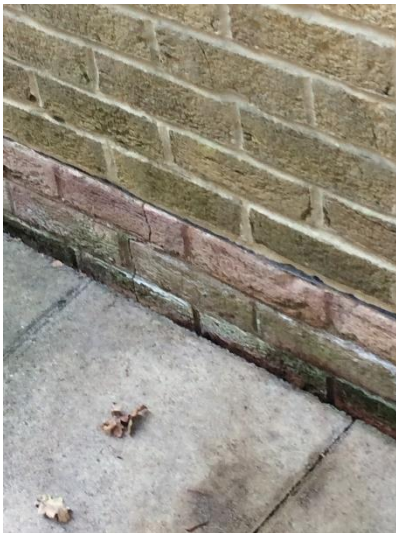
Picture 7: Close up showing where paving slabs appear to have dropped

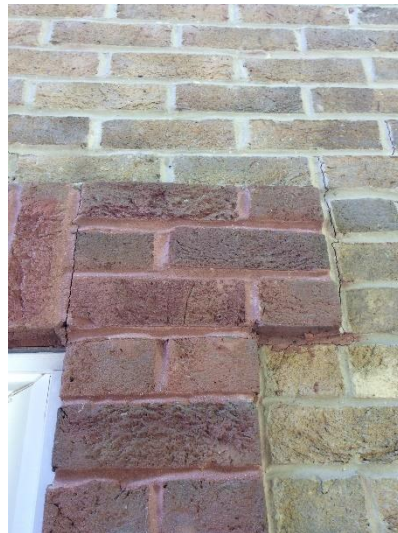
Picture 8: Cracking on left hand side of rear patio doors

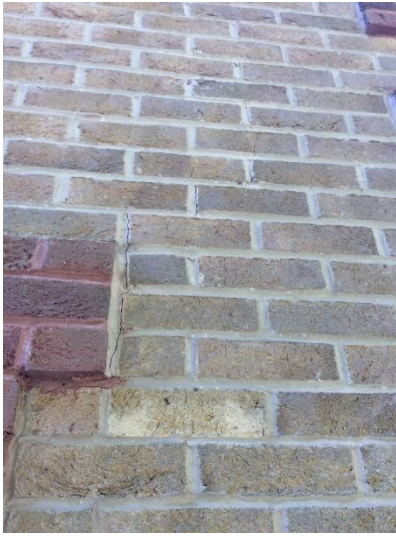
Picture 9: Diagonal crack extends up from left hand corner of rear left patio doors towards rear left corner

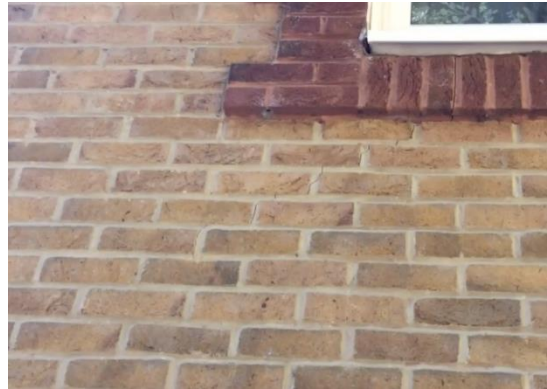
Picture 10: Diagonal crack above patio doors on rear left hand side going up to first floor bedroom window (with respective vertical internal cracking seen in picture 3)

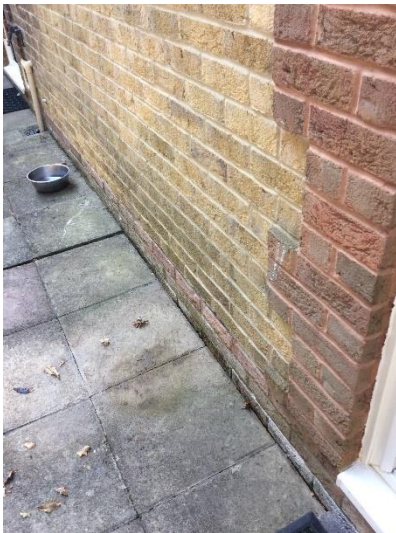
Picture 11: Patio paving slabs appear to have dropped towards rear left corner

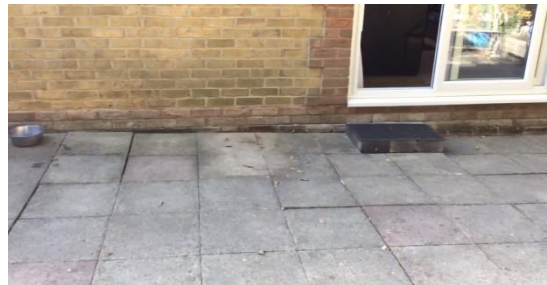
Picture 12: Patio paving slabs appear to have dropped towards rear left-hand corner (view 2)

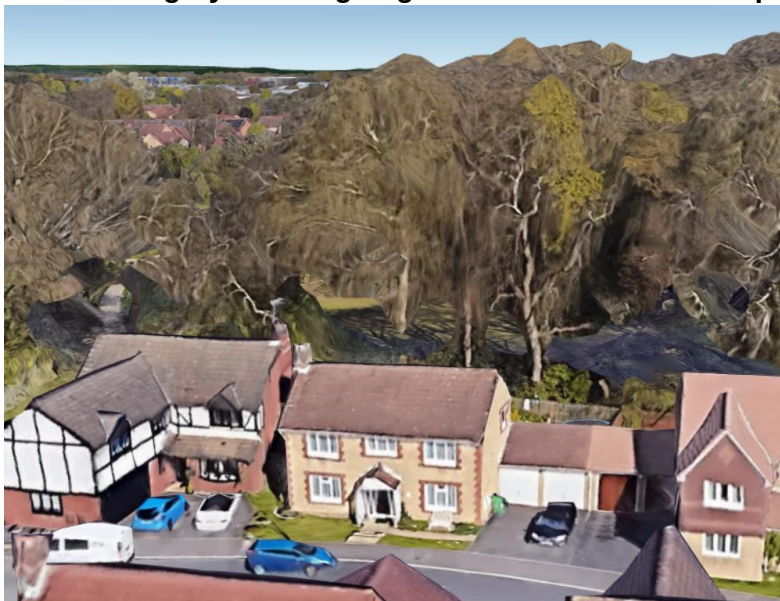
#### **Google Earth imagery showing large trees at the rear of the property**

There is a conservation area containing numerous large deciduous trees approximately 12m from the rear. These are very large and thus very old trees. It is therefore likely that their roots were already beneath the property when it was built.

Large mature trees like this are usually less of a concern as their root growth and influence in desiccating the surrounding soils has had a long time to occur before the house was built. However, given the recent historically significant drought experienced in August, it is possible that these trees have exerted a greater water demand on the ground than has previously been experienced in the history of the property, causing further shrinkage and possibly subsidence.

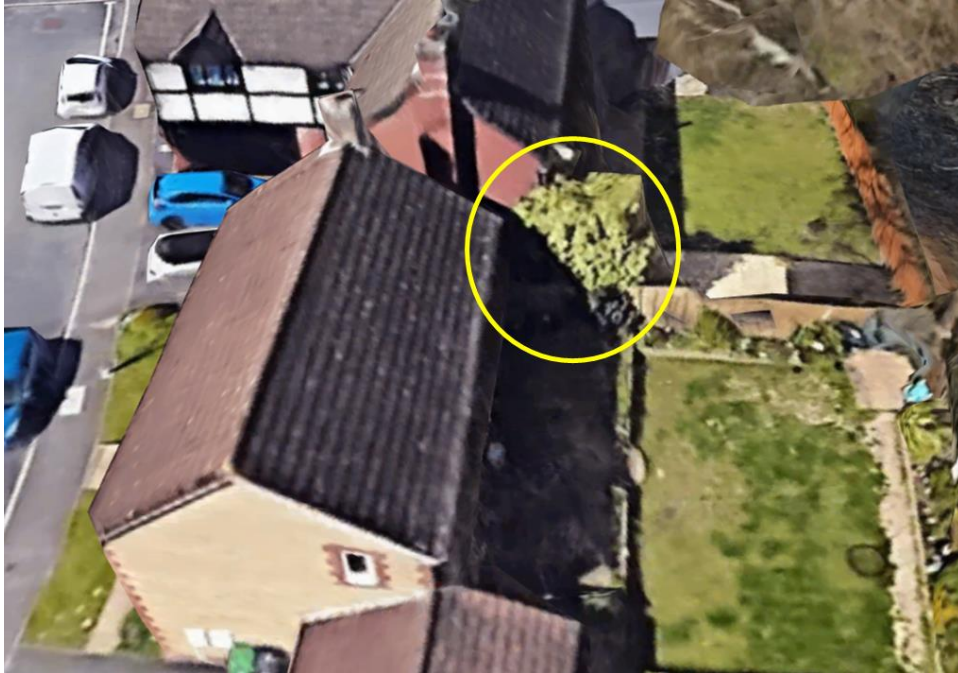
**More juvenile tree/shrub present within close proximity to the area of suspected subsidence**

Notably, there is an approximately 5m tall tree/hedge growing approximately 3m from the rear left hand corner of the property, belonging to the neighbour, as has been highlighted below. This is more likely to be causing root induced shrinkage of the underlying soils if they are susceptible.

The geology report suggests the area to be underlain with medium volume change potential clay, which is susceptible to root induced subsidence.

A trial hole shall be instructed on the rear left hand corner to see what roots if any may be present beneath the foundations. This investigation shall also seek to confirm the depth of the foundations and the types of soil present. The investigation shall include root identification to help in discussions with the neighbour if their tree is found to be involved in the apparent movement.

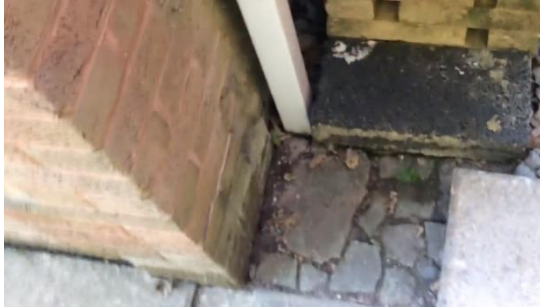
There is notably a rainwater downpipe on the rear left-hand corner of the property, where the movement appears to be occurring. This downpipe covers a large area of roof and thus may be more likely to cause problems.

The timing of the event suggests the damage to be more likely due to clay shrinkage, however this will be surveyed as part of an investigation to ensure it is in sound condition and hasn't encouraged roots beneath the area or caused washout of material.

Picture 4: Rainwater down pipe located on rear left-hand corner, which appears to have dropped

To determine the extent of any influence from leaking drains, a survey of the surrounding drainage runs will be carried out. Any damage to the drains which fall within your responsibility can be addressed, allowing stability to be restored to the structure.
