**CCTV REPORT FOR: 62 THISTLE ROAD  
HEDGE END  
SOUTHAMPTON  
SO30 0TT**

**Insured:** Mr. Antony Marsh  
**Reference:** LIV-SN-22-004886

**Site Visit:** 26-Nov-22  
**Report Date:** 17-Feb-23

Date: 26-Nov-22

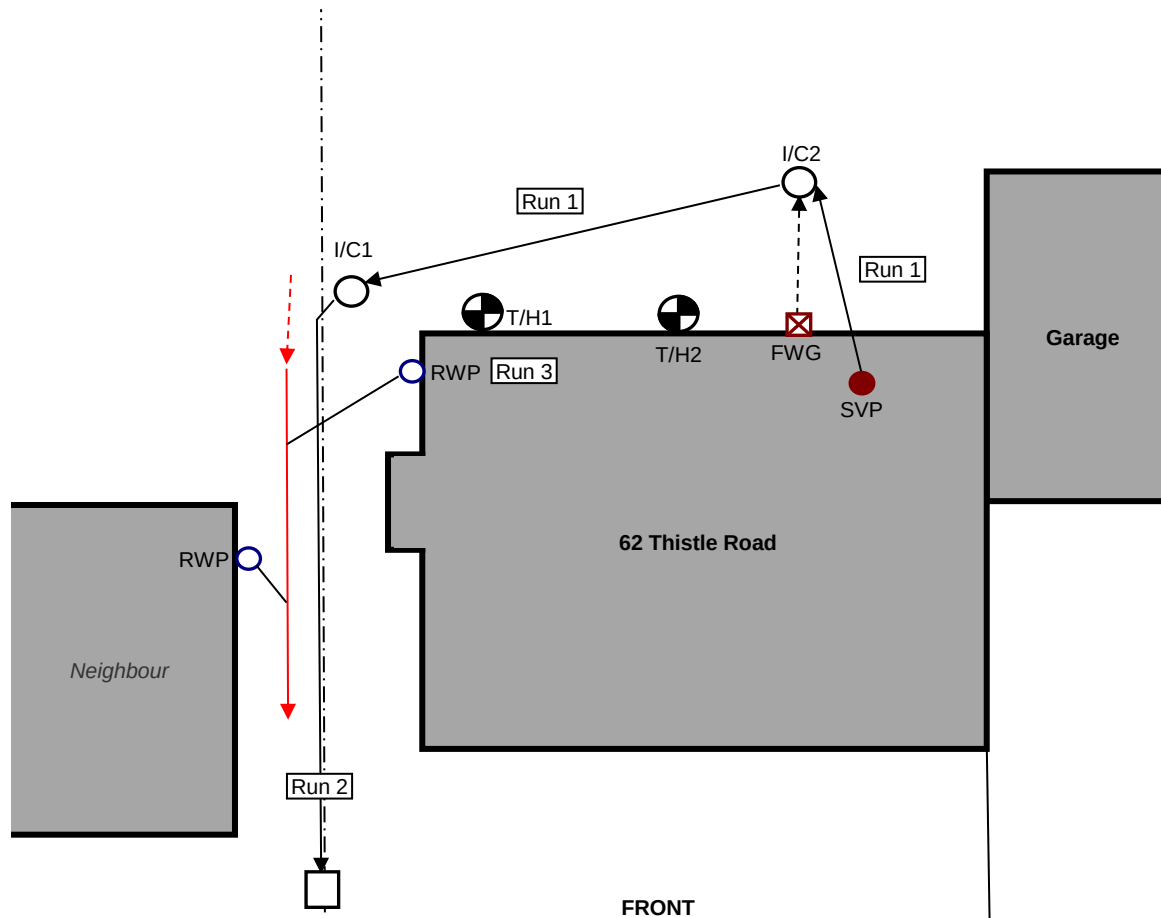
= Area of damage

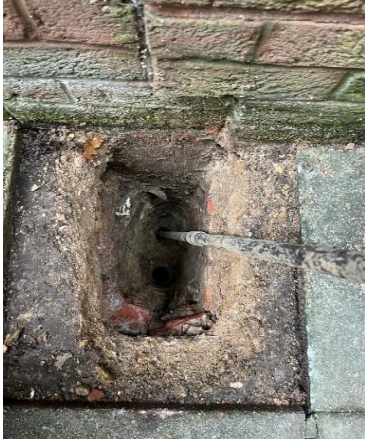
TH1

| TP/BH1, 2.0-3.0m | |
| 13 no. | Examined root: QUERCUS (Oak). |

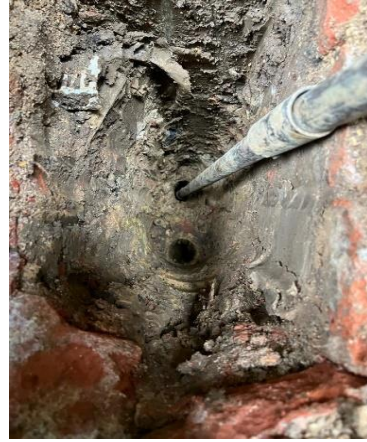
TH2

| TP/BH1, 2.0-3.0m | |
|---|---|
| TP/BH2, 2.0-3.0m | |
| 4 no. | Examined root: QUERCUS (Oak). |
| 5 no. | All pieces of BARK only - not enough material for identification. |

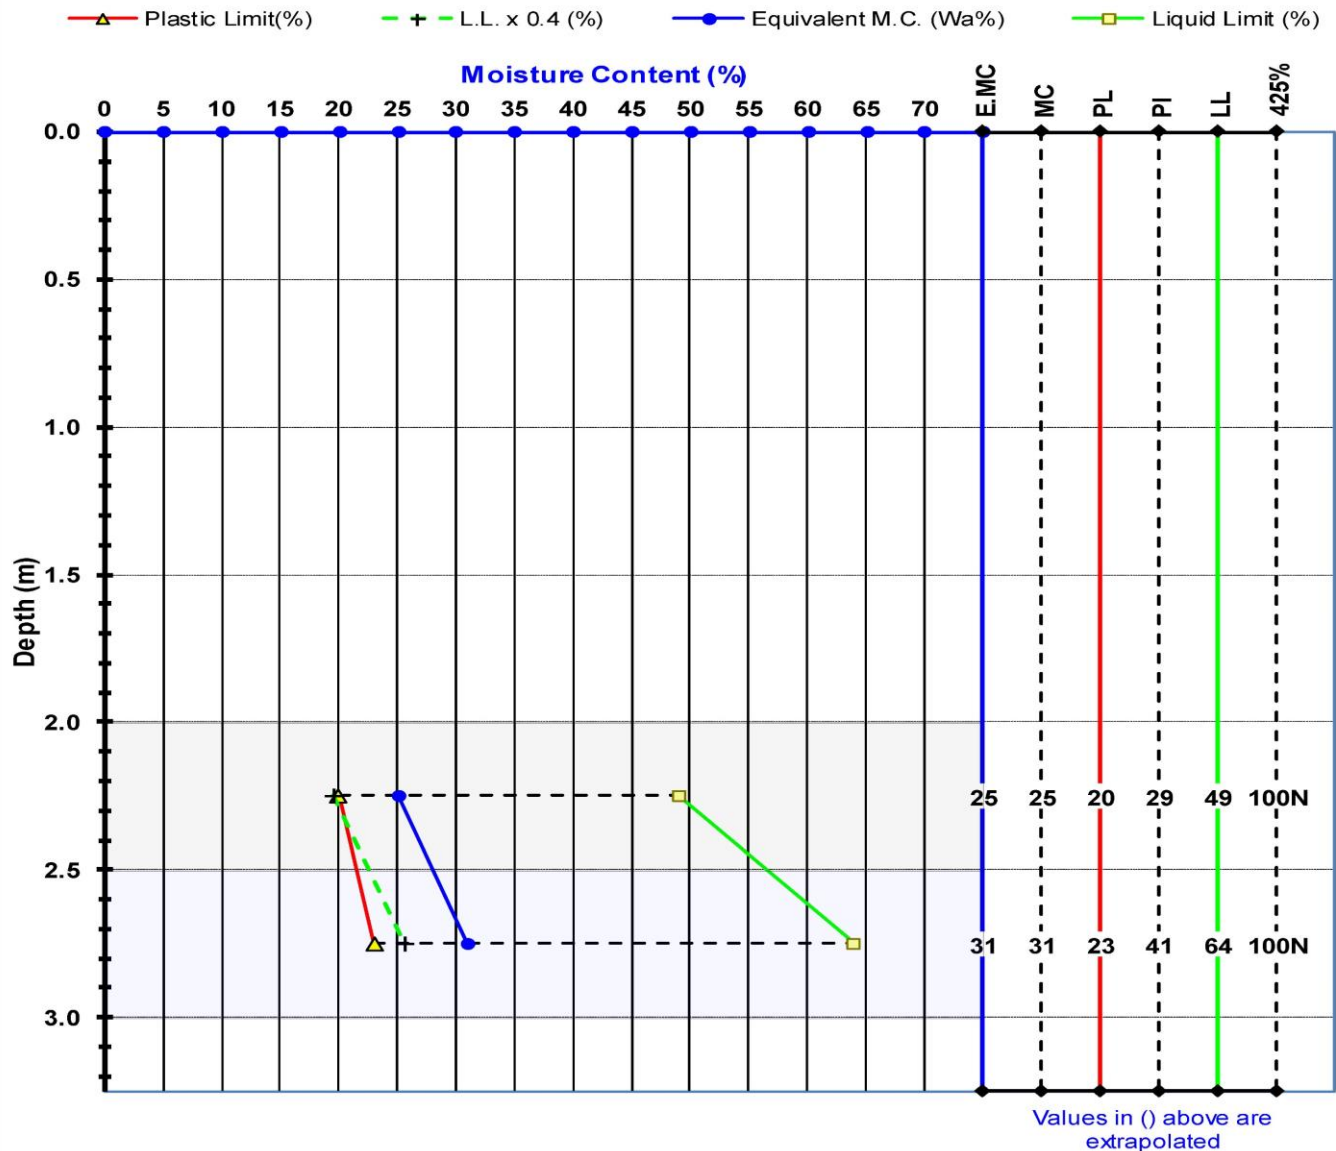
| Depth<br>T (m) | Depth<br>B (m) | 1 - Rear LHC of house | Plasticity<br>(BS 5930) | Volume Change | |
| 2 | 2.5 | Soft/firm brown slightly sandy CLAY with rare medium gravel & roots | Intmd. CI | 29% | Medium |
| 2.5 | 3 | Soft/firm brown slightly sandy CLAY with rare medium gravel & roots | High CH | 41% | High |

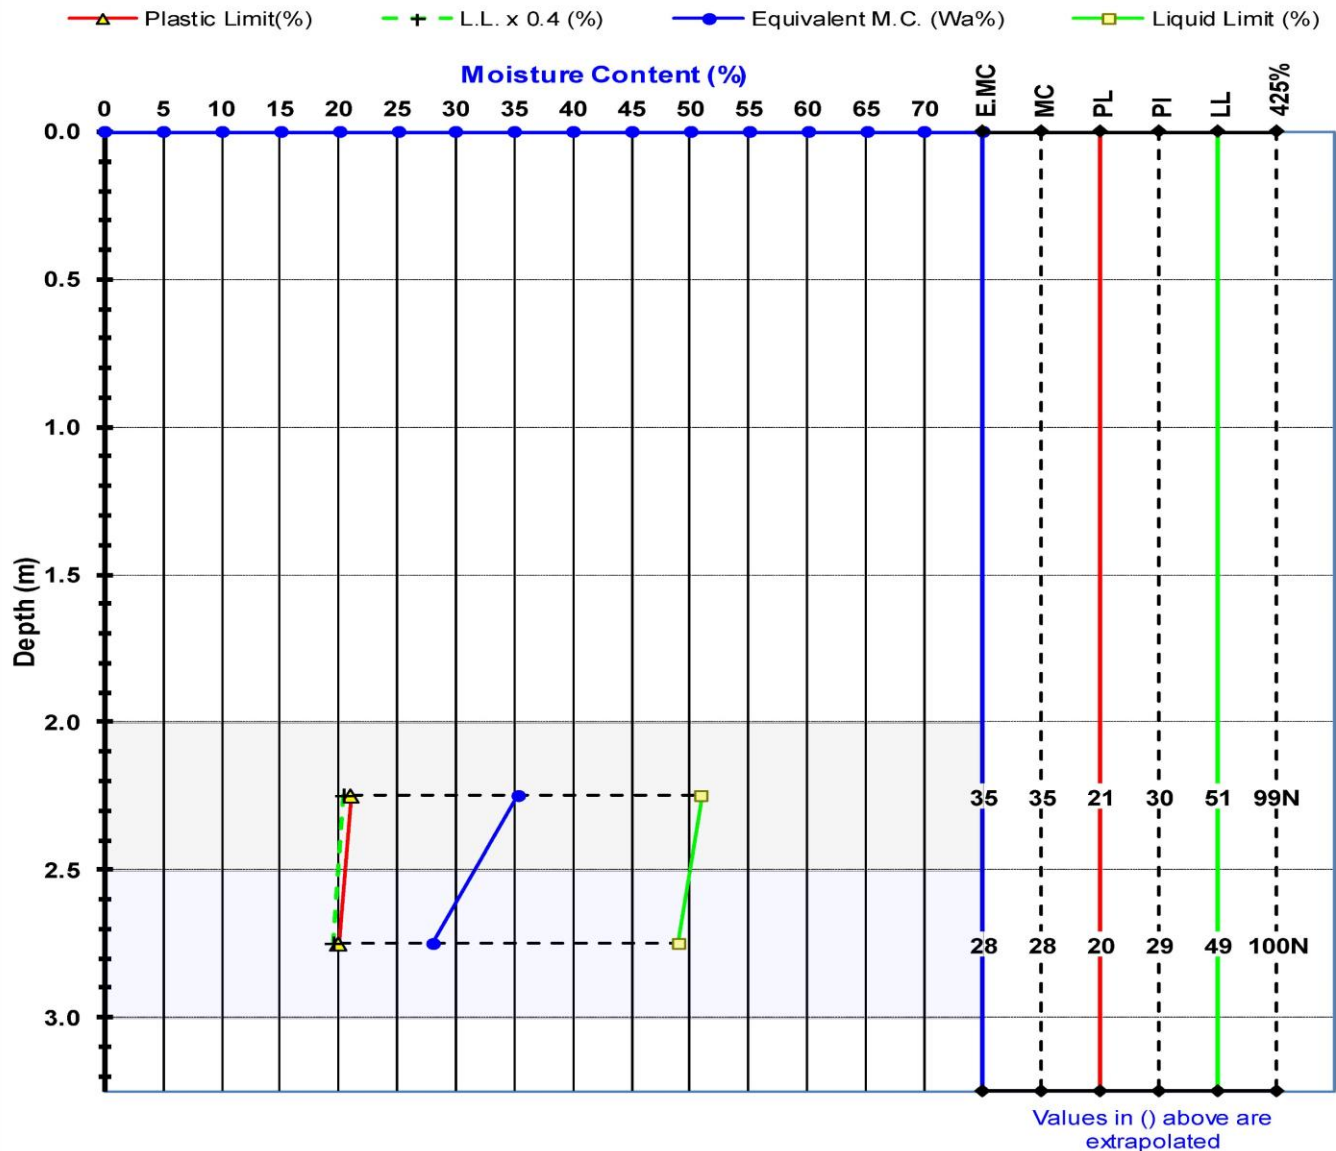
| Depth<br>T (m) | Depth<br>B (m) | 2 - Rear wall centre | Plasticity<br>(BS 5930) | Volume Change | |
| 2 | 2.5 | Soft/firm brown CLAY with rare medium gravel | High CH | 30% | Medium |
| 2.5 | 3 | Soft/firm brown slightly sandy CLAY with rare medium gravel | Intmd. CI | 29% | Medium |
