0309046/CW/LC  
26 September 2024

## **EASTLEIGH – SUPPLEMENTARY GROUND INVESTIGATION**

Colliers PBC (Colliers) has been commissioned by Athora UK RE Log Property 24 Limited, to undertake an intrusive investigation on the newly redeveloped units at Unit 1 – 5 Woodside Road, Eastleigh, SO50 4DP. The works were completed to support the discharge of conditions 4-7 under Planning Application Reference: F/21/91183. These works were undertaken in connection with the previous works undertaken at the site and the requirements listed by the Local Authority for investigation within areas previously inaccessible at the time of investigation focused around identified potential sources. It is understood that the site, once development is completed, is to be leased by tenants for commercial use as newly developed units

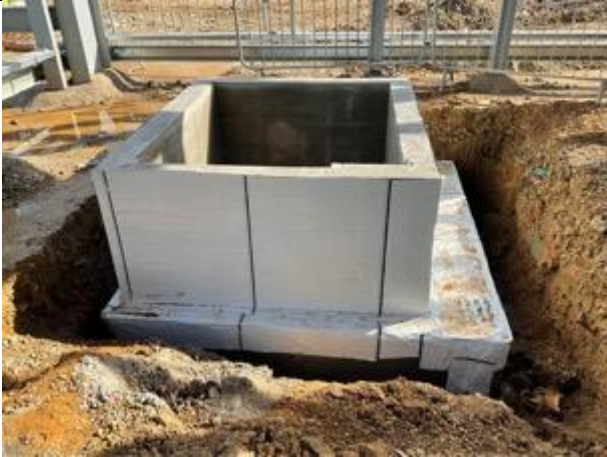
Unit 3/4. Overview of Lit pit wrap installation.

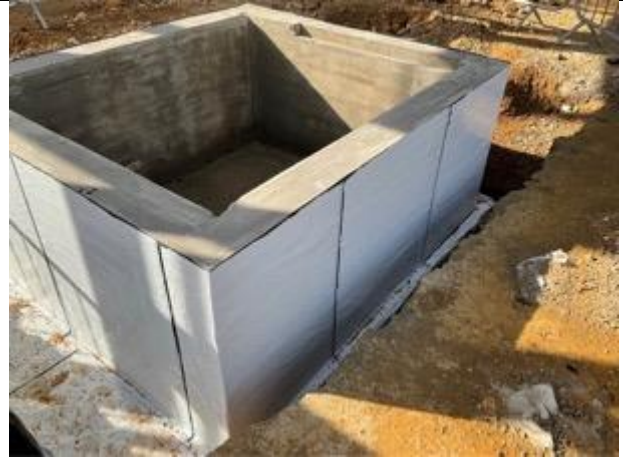
Unit 3/4. Overview of the installation of Juta GP SAM to lift pit.

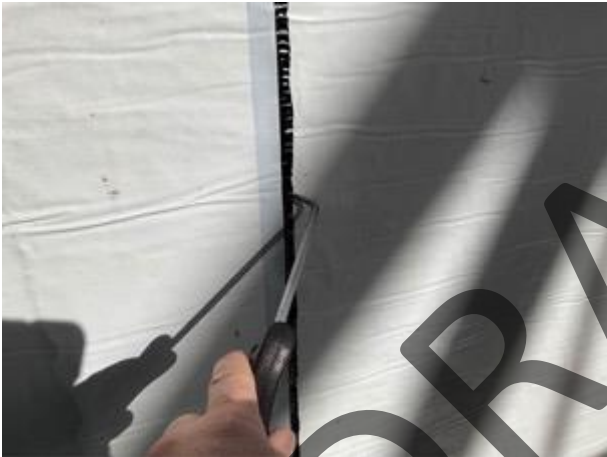
Unit 3/4. Pick test conducted membrane lap joint.

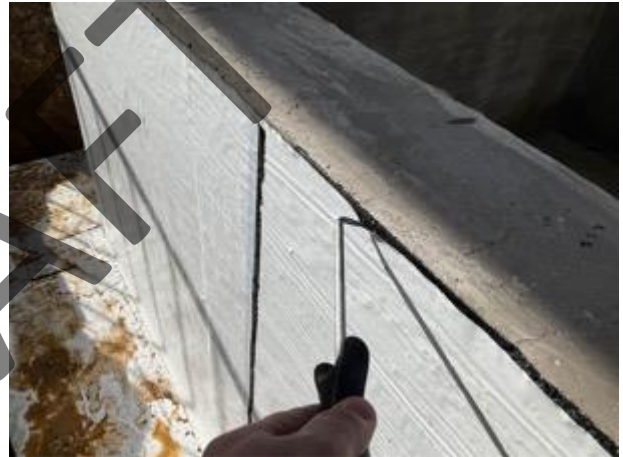
Unit 3/4. Pick test upon termination of Juta GP SAM.

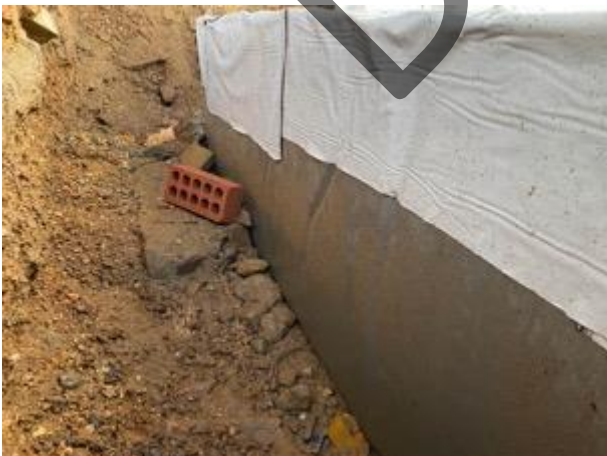
Unit 3/4. Juta GP SAM successfully terminated upon previously installed Juta TitanBond base.

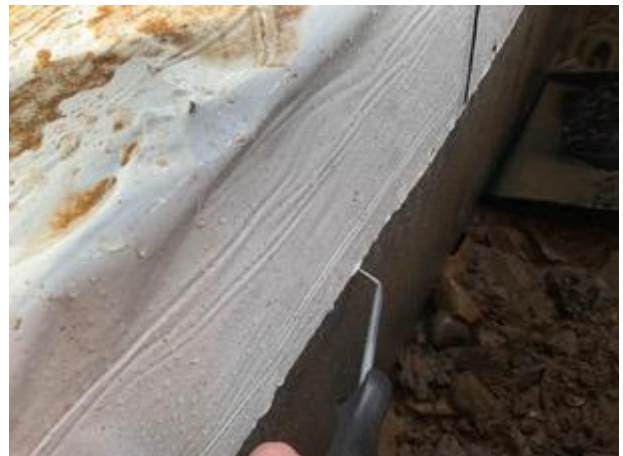
Unit 3/4. Pick test upon termination between membranes.

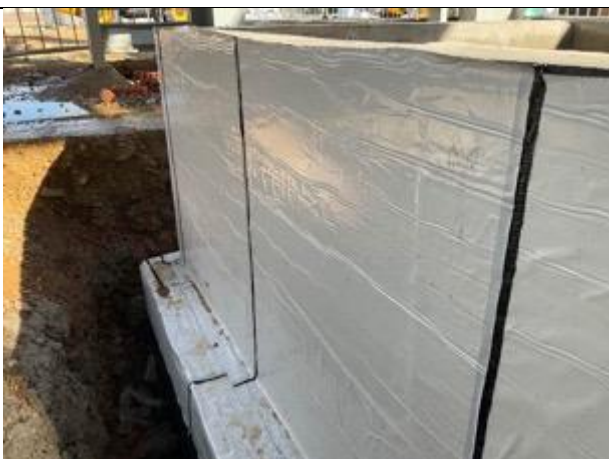
Unit 3/4. Juta GP SAM sealed continuously to lift pit wrap.

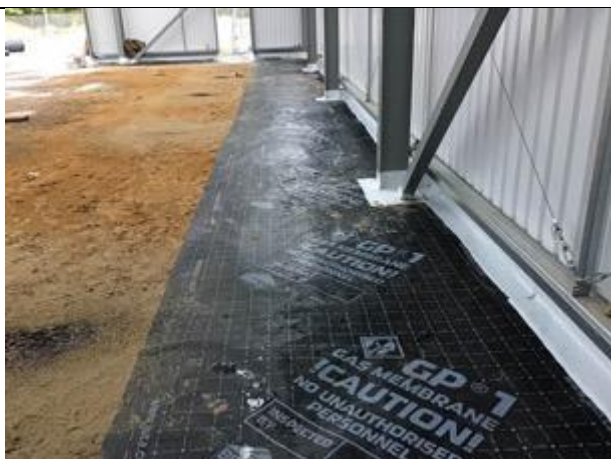
Overview of installed membrane to the perimeter of using 5.

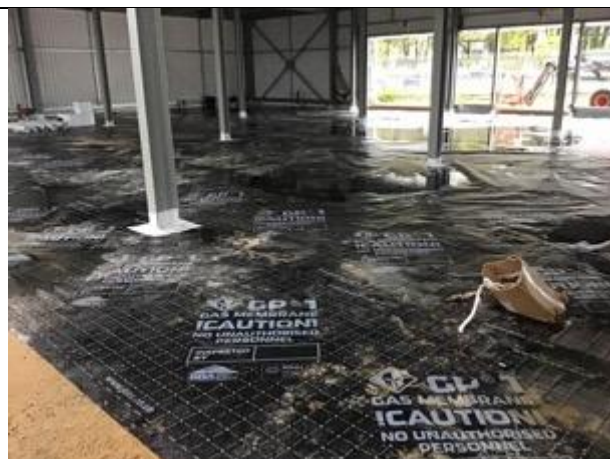
Overview of installed membrane under the mezzanine floor area.

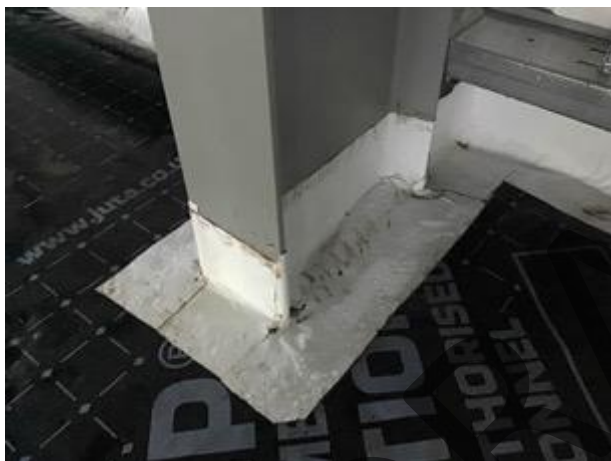
Typical stanchion seal using SAGM.

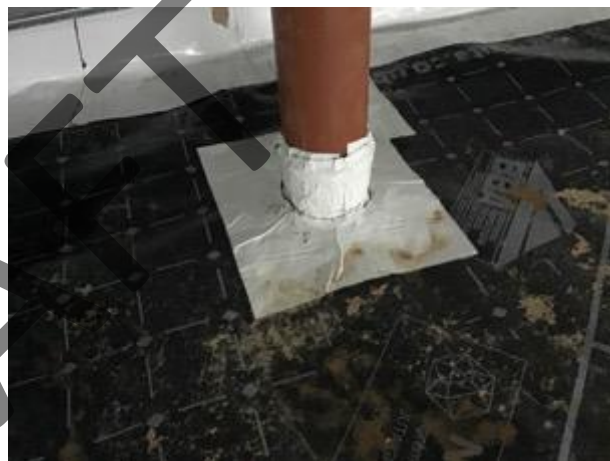
Typical pipe penetration seal using SAGM.

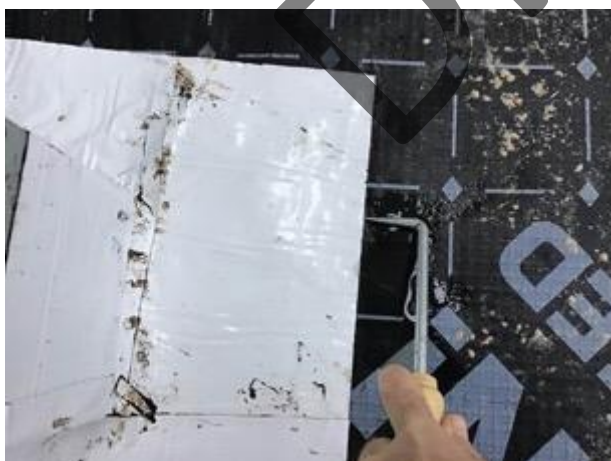
Pick testing all SAGM detailing.

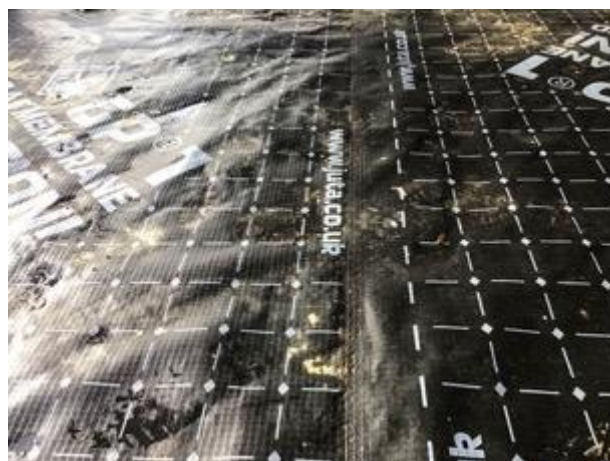
Hand welded membrane lap.

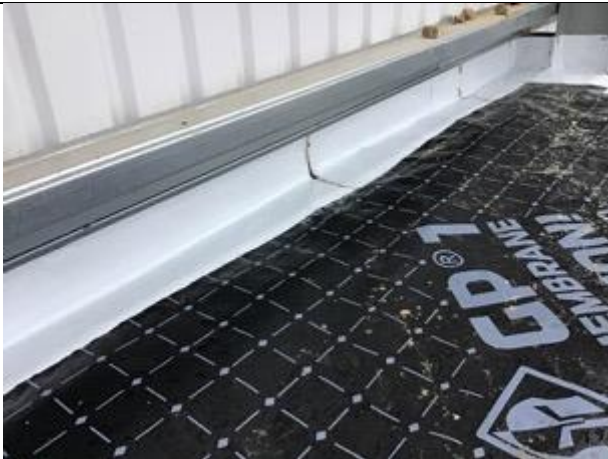
Retro fit detail using SAGM to the perimeter steel channel.

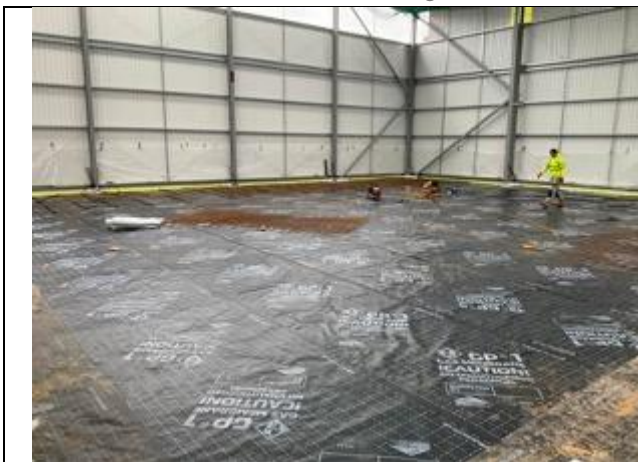
Overview of the full footprint installation of Juta GP1 Gas Barrier.

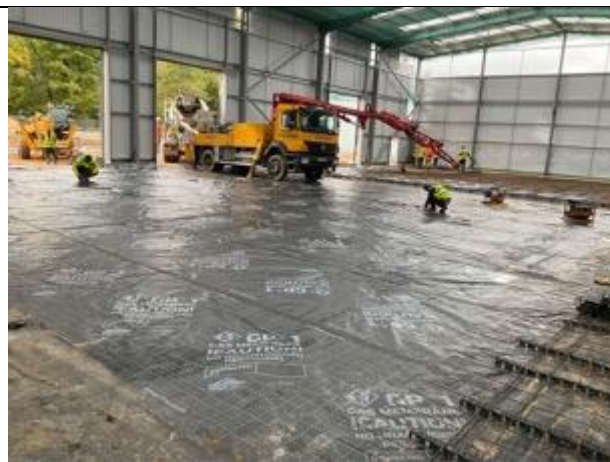
Overview of the installation of Juta GP1 Gas Barrier.

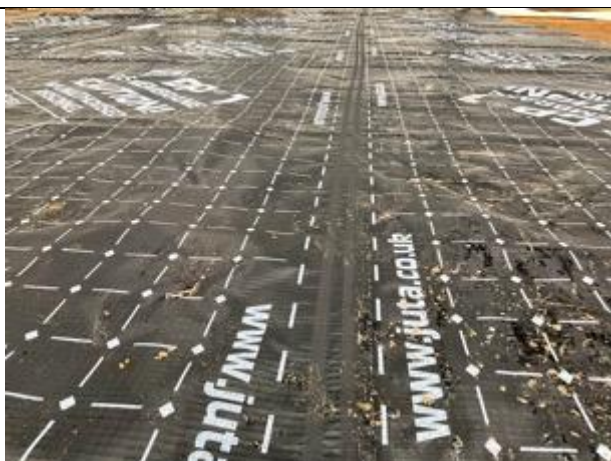
Auto welded membrane lap joint.

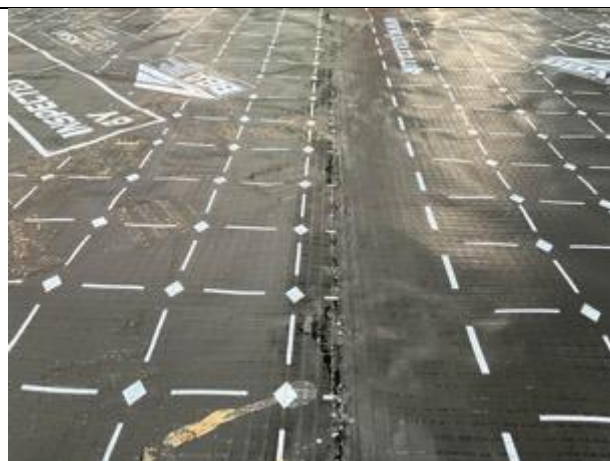
Hand welded membrane lap joint.

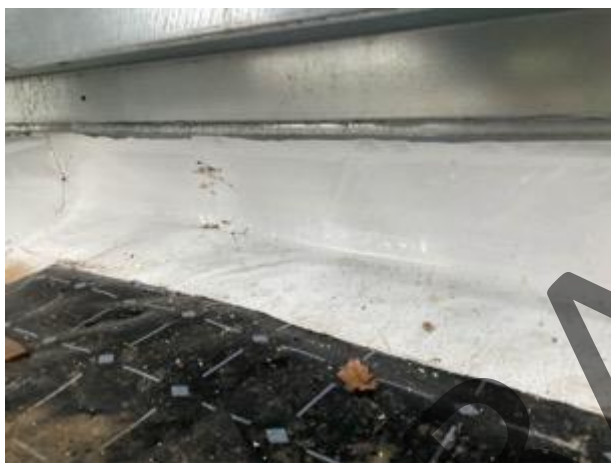
Termination detailing to the perimeter screed rail using SAGM.

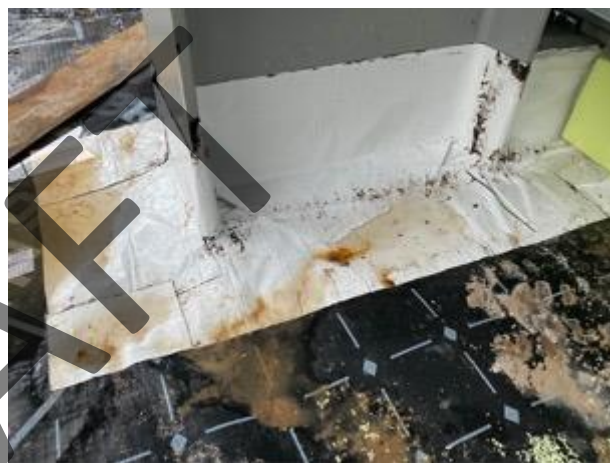
Typical steel stanchion sealed using SAGM

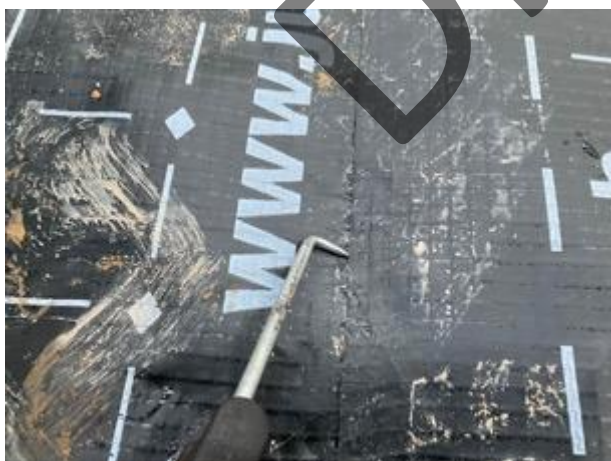
Pick test conducted upon a hand welded membrane lap joint.

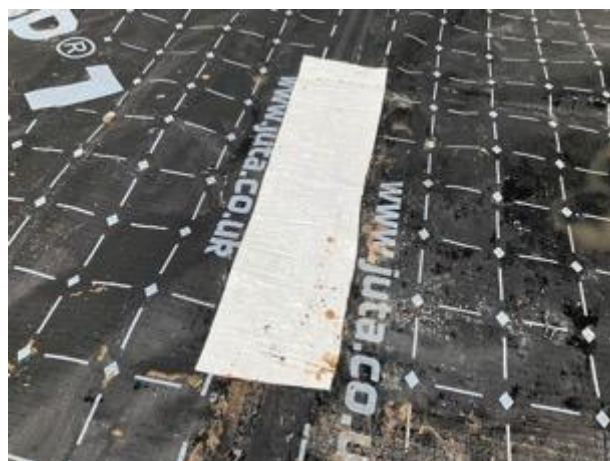
Patch repair using SAGM.

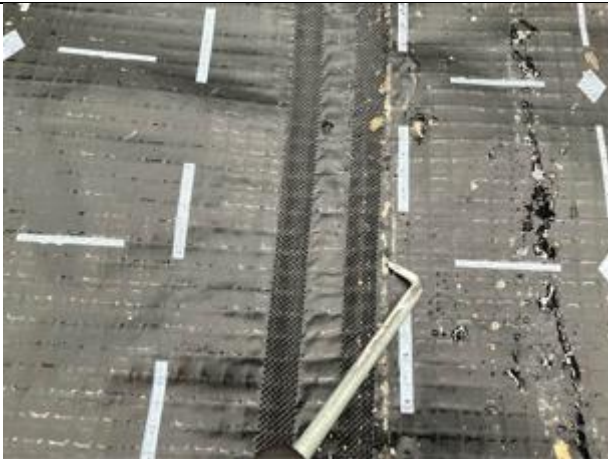
Pick test upon a auto welded membrane lap joint.

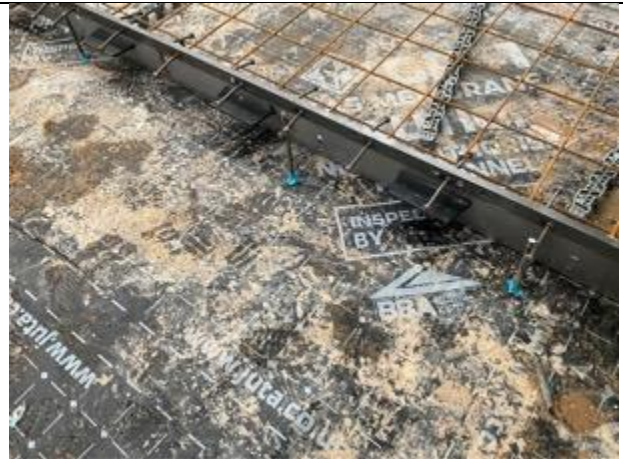
Armoured joint pin's left in and a continuous band of double sided butyl tape wrapped around.
