## JR1-2396 Vistry Gateway Development

**Title:** Tree protection fencing audit

Boorley Park Local Centre (Conditions 6) - DC/23/95019

**Month of inspection:** September 2024

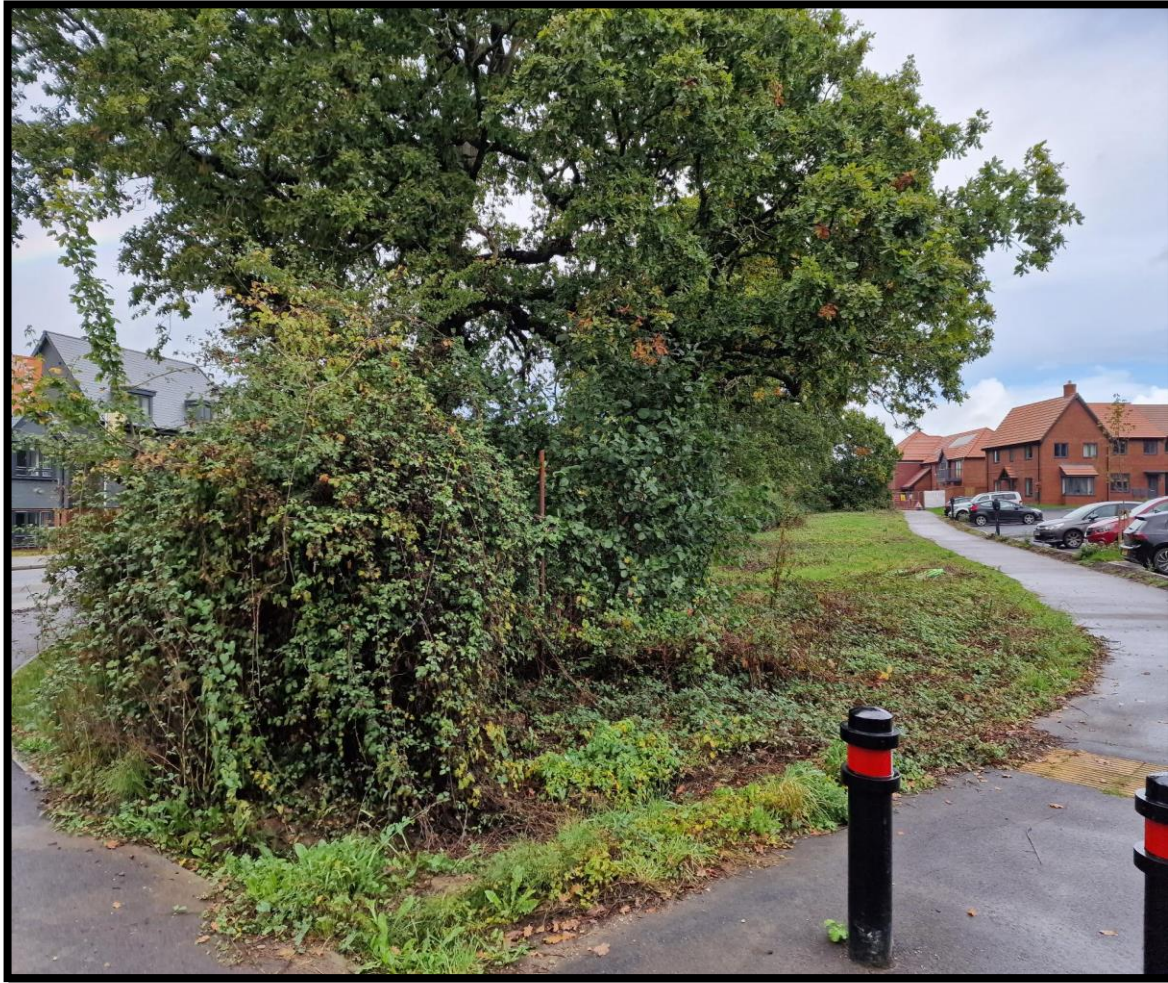
Image 1

| 1 | Were all the proposed action(s) from the previous audit addressed | ✓ | | | As agreed with EBC, Arborcall have removed approx. 52 nr fence panels (images 1-6). Fencing adjacent to live site remains insitu. |
