## ARBORICULTURAL REPORT

**Client:** GH Property Management Ltd

**Site:** 241 Simpkins Court, Chandlers Ford SO53 1AL.

**Date:** 27<sup>th</sup> August 2024

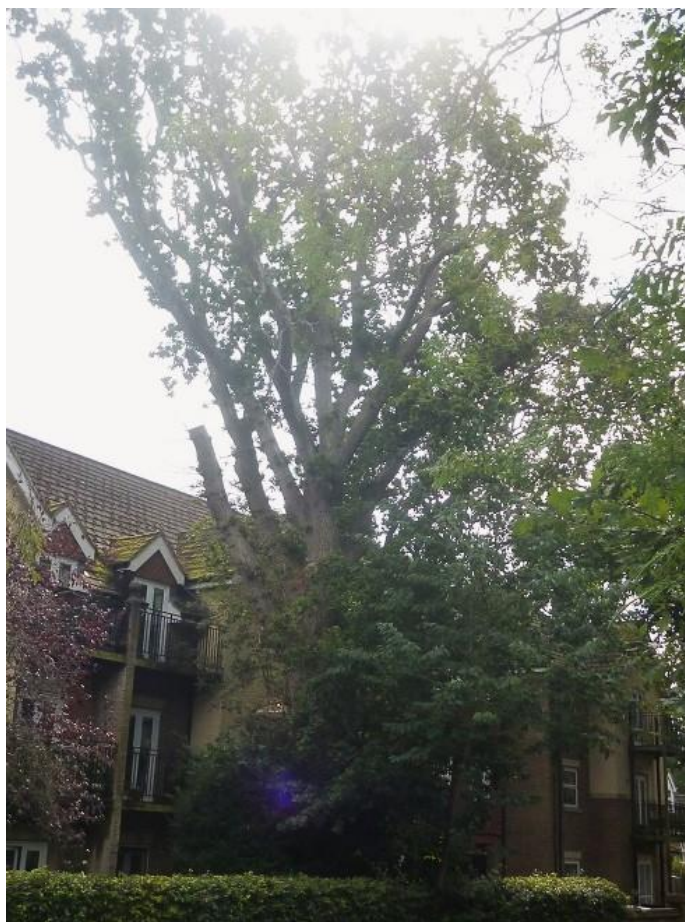
- 1.1 I have been instructed by GH Property Management Ltd to undertake this arboricultural report in relation to inspecting 1 (one) Oak tree (*Quercus robur*) at 241 Simpkins Court and report on my findings with any recommendations for the future management of the tree.
- 1.2 Figure 1 below (page 2) shows Oak tree to the site frontage.
- 1.3 This tree I am advised is covered by a Tree Preservation Order (TPO).
- 1.4 The tree inspection took place on 27<sup>th</sup> August when the weather was cloudy with sunny spells.

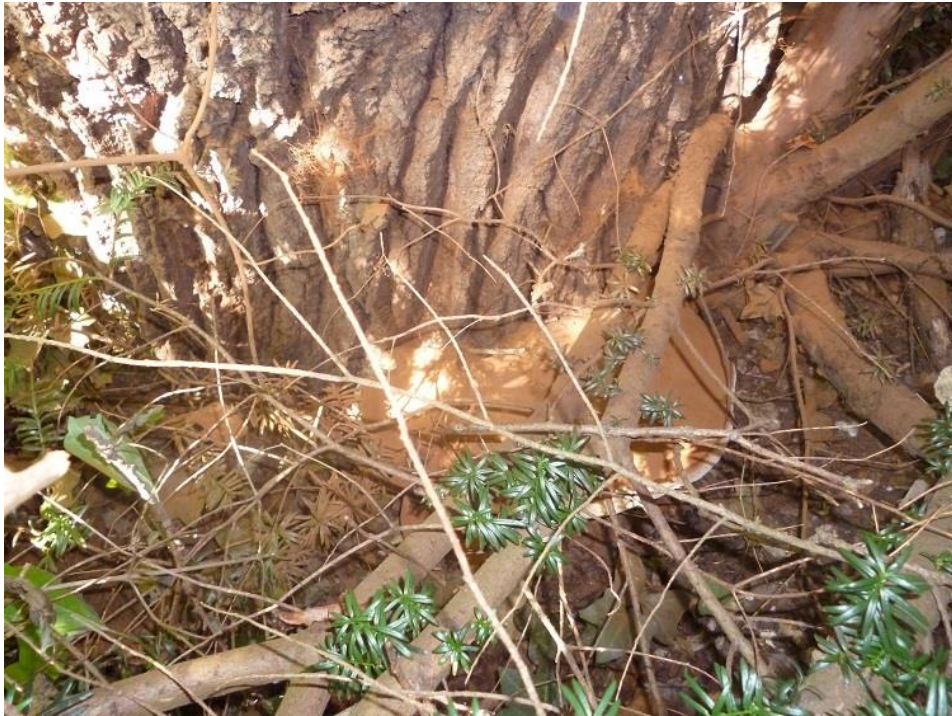
- N: 7m
  - S: 9m
  - E: 7m
  - W: 5m
- 2.2 At the base of the tree a large fungal fruiting body of the species Artist's Bracket Fungus (*Ganoderma applanatum*) was present on the east side of the tree. This decay fungus produces rot of the butt and in to the roots. The stem of the tree was tapped with a rubber headed mallet to determine the extent of any decay from ground level to approximately 1.3m above ground level. When tapped with the hammer good solid sounding were heard on the west side. However, the south, east and north sides when tapped sounded a dull thud which would indicate either cavities or extensive decayed wood from ground level to 1.3m above ground level.

2.3 Figure 2: Image of fungal fruiting base of tree

- 3.1 Artist's bracket fungus is a decay pathogen of the lower stem and in to the roots. The dull soundings when tapped with the rubber headed mallet indicates that the stem from ground level to a height of approximately 1.3m above ground level is composed of decayed wood and or cavities. This has compromised the structural integrity of the stem. The root system cannot be measured for decay, although it is highly likely that decay is present but to what extent is not possible to comment on. The declining crown and major dead wood can be contributed to the decayed stem and active pathogen involved.

- 3.2 The decay is likely to increase in time and increase the risk of failure of part or whole tree failure.
- 3.3 Considering the location of the tree and the close proximity of the residential building and public highway it is highly recommended that the tree be taken down to ground level in a controlled manner by a fully qualified contractor in accordance with BS3998:2010 in the interests of good arboricultural practice. The stump should also be ground out and the resulting debris removed and burnt to prevent further contamination to other trees. The resulting hole will be filled with good quality top soil and turfed.  
This work should be undertaken within 12 months of the date of this report.

- 3.4 It is also recommended that a replacement is planted to continue the green aspect of the immediate area. Suitable species that are tolerant of *Ganoderma* are the Maidenhair Tree (*Ginkgo biloba*) and Paperbark Maple

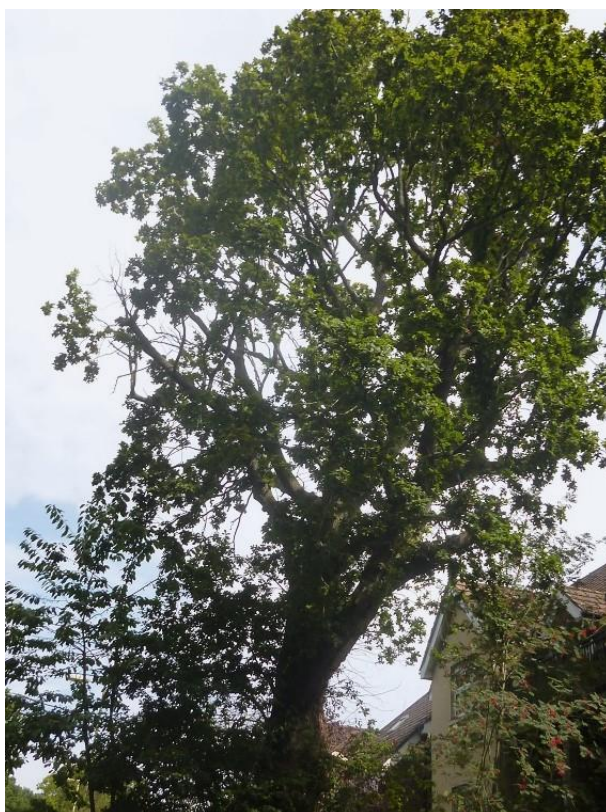
- 2.4 An old pruning wound was present on the east side at 5m above ground level occluding with a wildlife hole. This cavity was not inspected as the general tree inspection was confined to ground level. Long stubs on the north side indicated previous crown reduction work with dead epicormic growth. The east side of the crown has also been crown reduced back from the building.
- 2.5 The crown showed low density growth with major dead wood on the north and west sides over the highway. Epicormic growth was present throughout the crown.
- 2.6 Figure 3: Image from the south aspect shown below on page 3.
