Our Ref:MH/Kingsway75/Cond/7435

**ASH TREE AT 75 KINGSWAY, CHANDLERS FORD, EASTLEIGH, SO53 1FH**

**Brief:** The ash tree on the rear boundary of 75 Chandlers Ford, Eastleigh, SO53 1FH has recently shed some significant limbs. Inspect the tree, consider its condition and make management recommendations if considered necessary.

**Date of inspection:** 16.10.24.

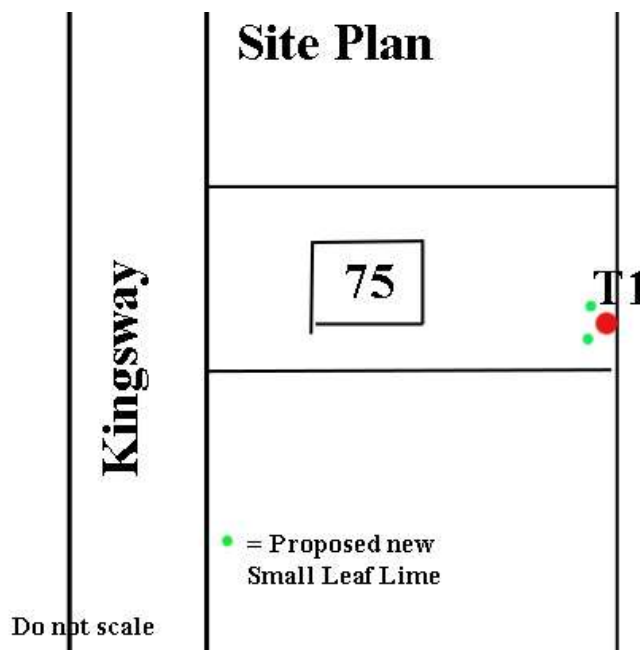
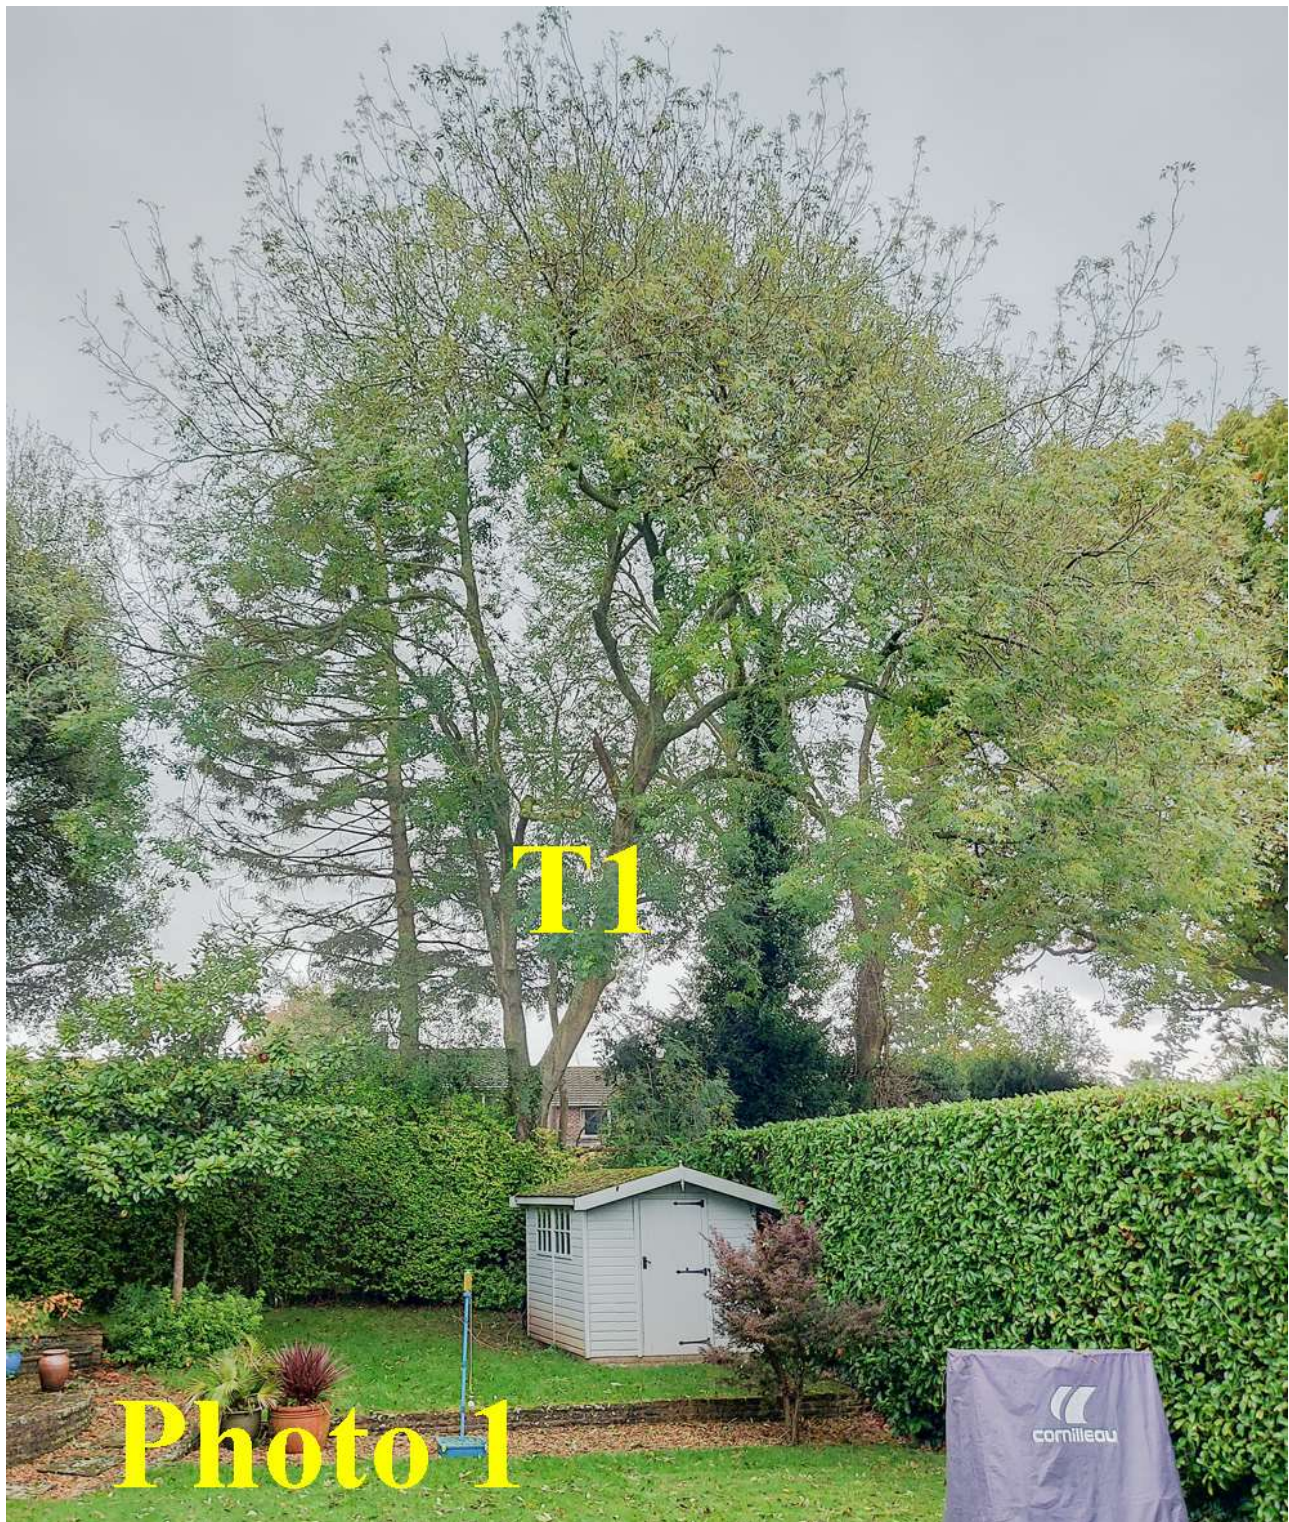
The ash tree (T1) is standing close to the rear boundary of 75 Kingsway (Photo 1) below

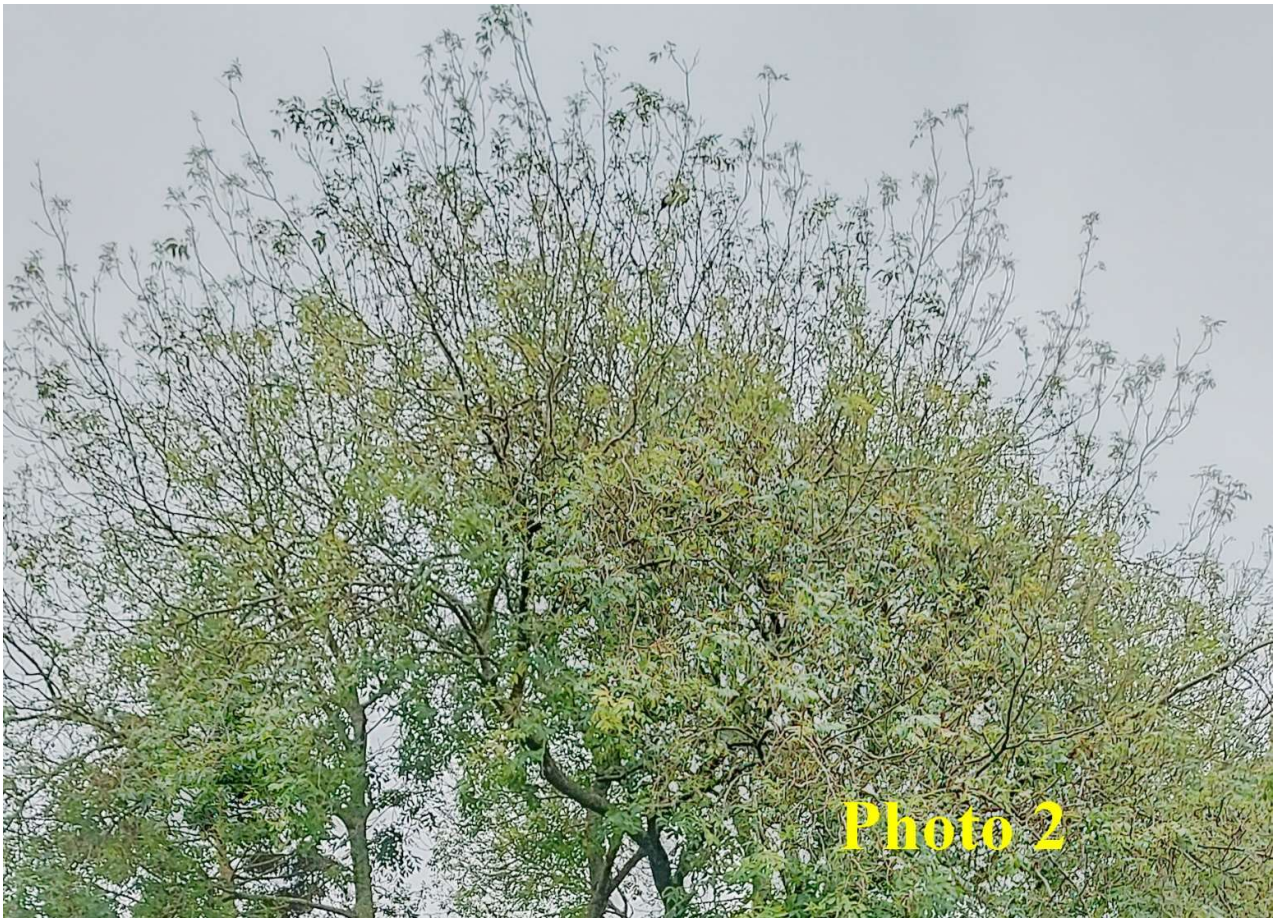
There is a significant amount of dieback in the outer canopy (Photo 2).

The thinning of the canopy and leaves turning dark brown and falling early (Photo 3) are classic symptoms of Ash Dieback. It can also be seen that the tip die-back has stimulated the production of some epicormic growth in the lower crown.

Whilst the presence of Ash Dieback may be serious for the tree in the longer term, it has not reached the point of deterioration that would indicate that it should be felled under Forestry Commission or DEFRA guidance. Neither does the presence of Ash Dieback explain the recent limb failures.

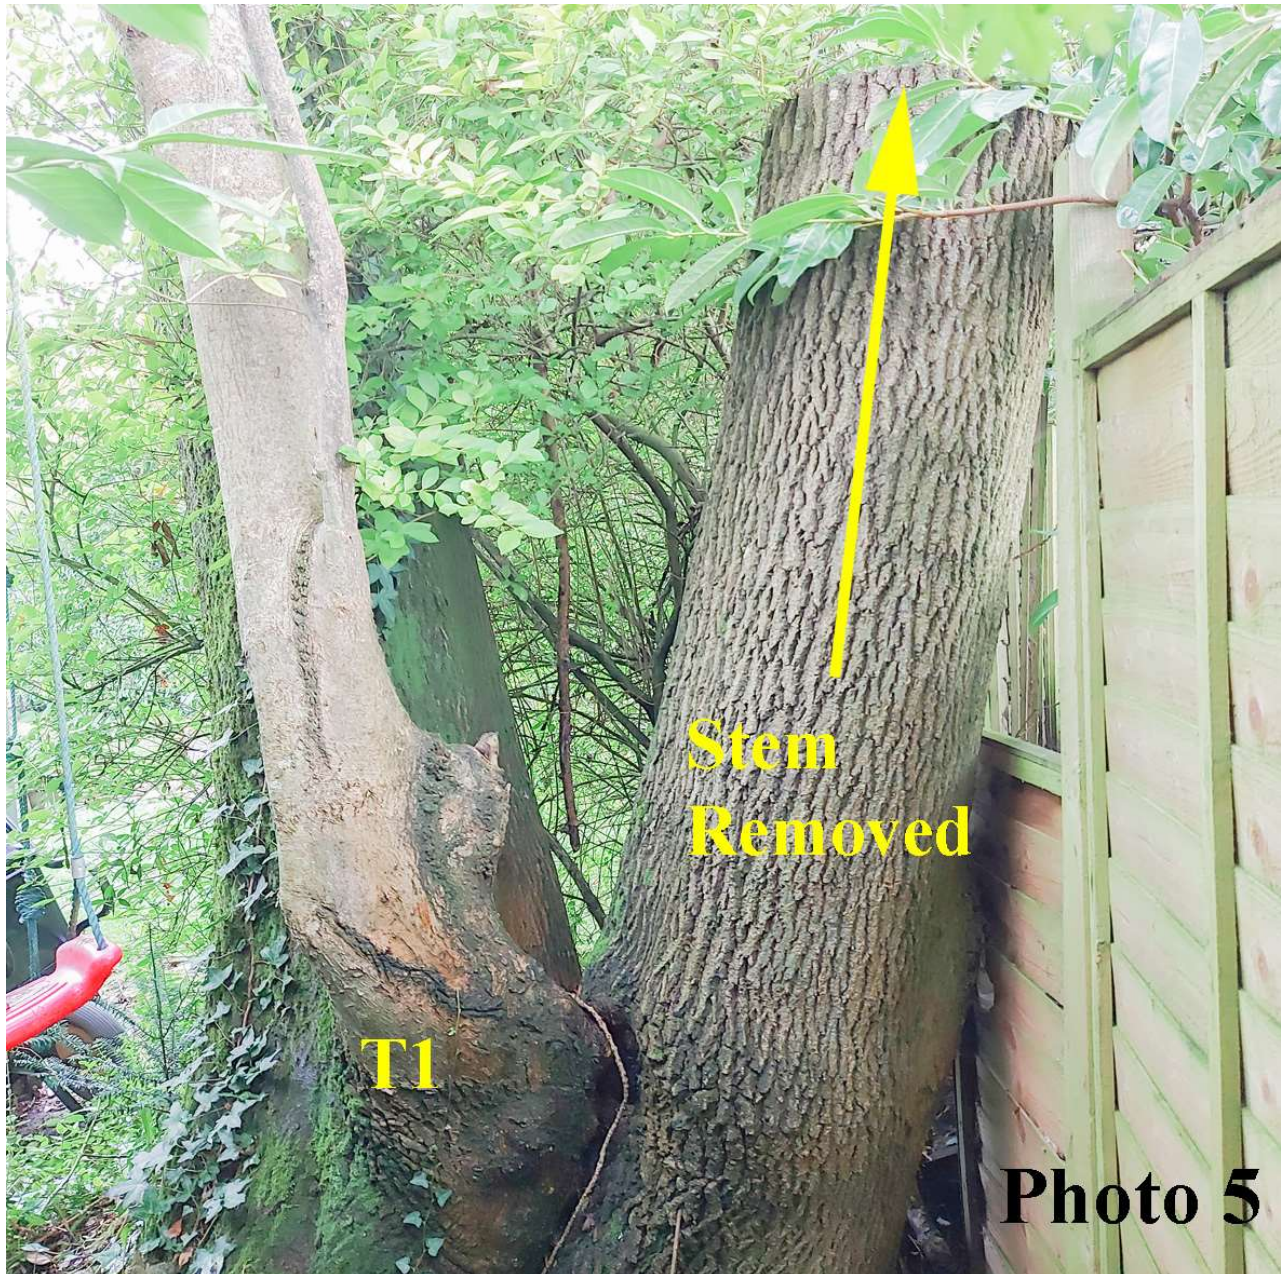
Part of this historic back stem still exists on site (Photo 5), although it appears to us that it was removed before 2019.

The removal of this back stem with no apparent formal consent on record suggests it may have occurred before the TPO was put on.

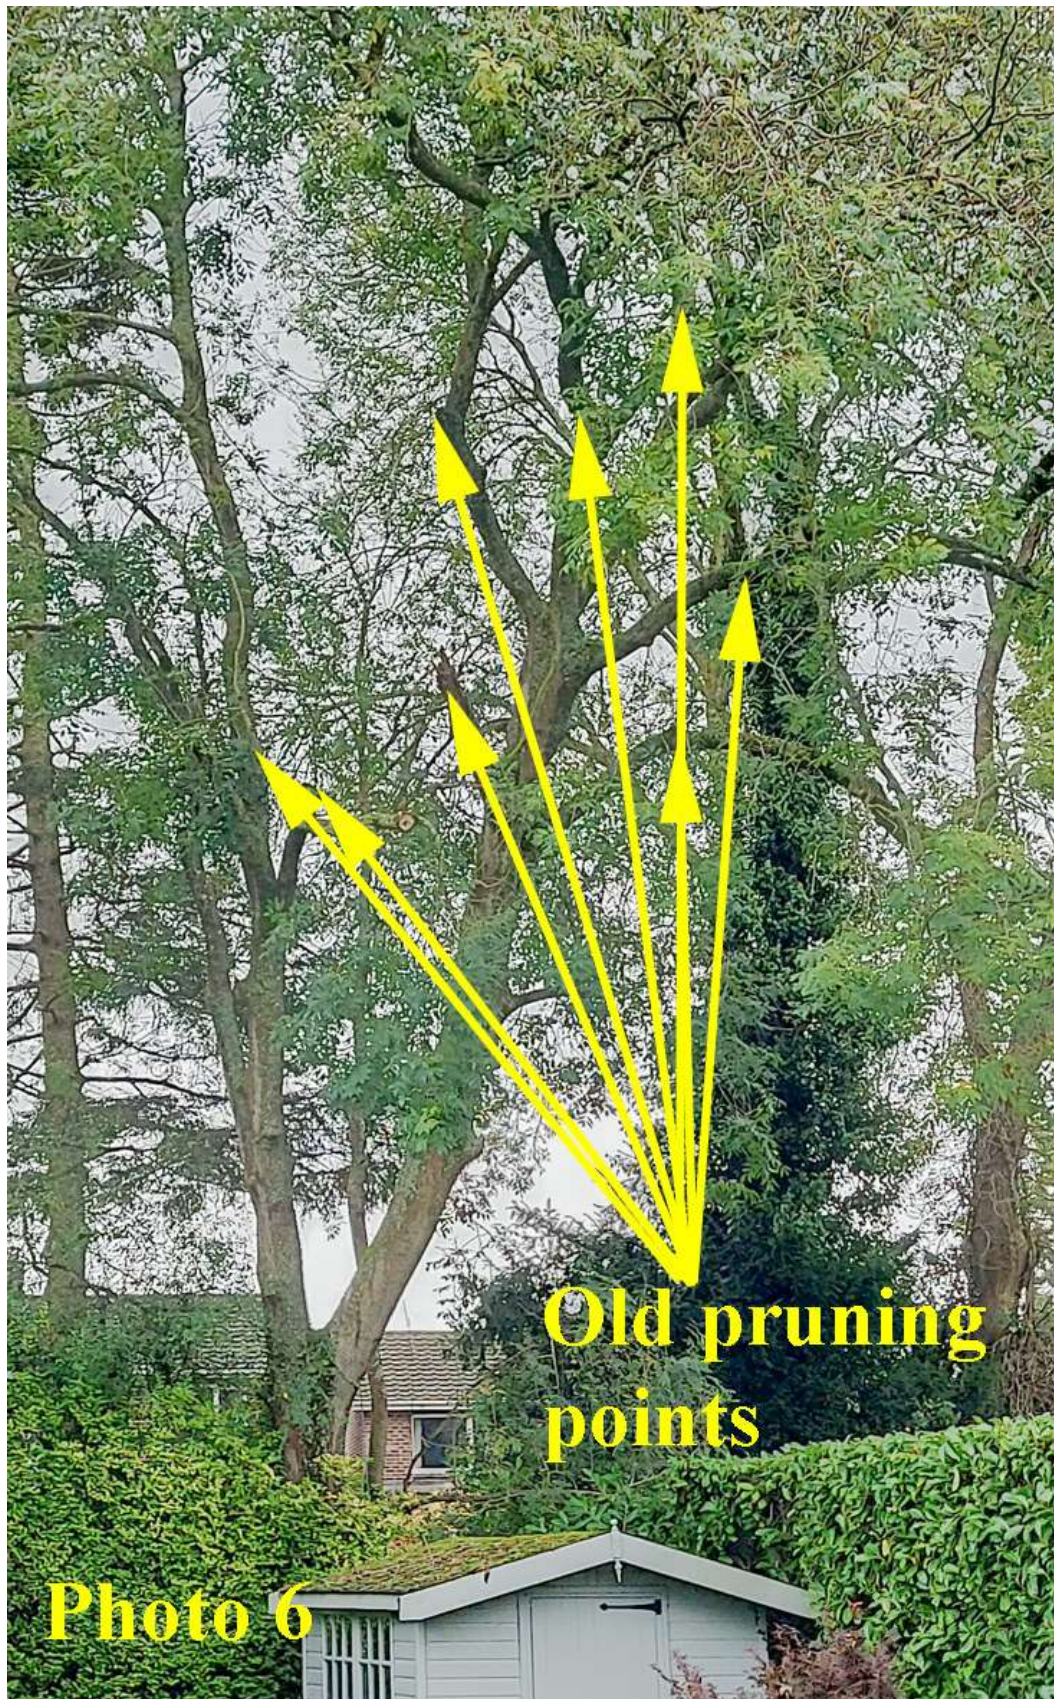
Close inspection of the canopy of T1 revealed no indications of the presence of *Innanotus hispidus*, which would have readily explained the branch failures. However, a careful look revealed some anomalies which may relate to some very poor, pre TPO pruning. Throughout the canopy of the ash are a series of ‘knees’ that represent the kind of branch direction change that would be consistent with new growth stimulated by heavy branch removal (Photo 6 below).

These old pruning points are exactly where one would expect to find them if the tree had been, sometime in its past, brutally pruned by an unqualified and uncaring operative. Possibly working off a ladder.

One of these old pruning points is precisely where the most recent large limb which fell into the garden of No 75 had been attached.

The problem caused by such dreadful pruning is now coming to fruition. Once one or two of the regrowth branches have failed at the old pruning points it is unreasonable to think that more of them will not. The owner of a tree is required to take all reasonable precaution to prevent an accident or loss to third party's resultant of his tree. Given the warnings that failing branches have given, and the reason identified for said failure, it seems to us that a prudent citizen has no reasonable course of action to pursue other than to apply to the Local Planning Authority for consent to fell the tree.

**Recommendation:** Apply to Eastleigh Borough Council for consent to fell the ash T1 on the grounds that historic poor pruning has rendered the tree structurally unreliable and therefore unreasonable to retain. Replace it with two Small Leaf Limes. Planting stock to be half standards.
