64 Thistle Road  
Hedge End  
SOUTHAMPTON  
Hampshire  
SO30 0TT

#### **CONCERNING SUSPECTED SUBSIDENCE**

#### **ADDENDUM ENGINEERING APPRAISAL REPORT**

Date: 19/11/2024

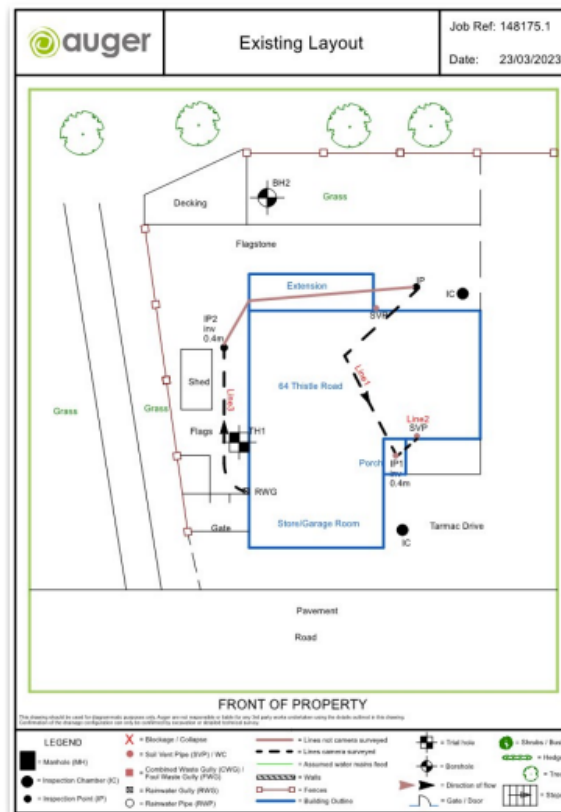
An initial site investigation was carried out by Auger in March 2023 to confirm the cause of damage. The investigation comprised of one trial hole and one remote borehole. The trial hole was located to the mid-left flank and the borehole within the grassed area of the rear garden (see site plan below).

The results of the site investigation confirm that the property is built off very stiff gravelly silty CLAY.

The trial hole was excavated to the target depth of 3000 mm below ground level (BGL). This exposed the foundation and confirmed this to be comprised of brickwork to 800 mm BGL, underlain by a 800 mm thick concrete strip to a total depth of 1600 mm BGL.

The foundation was seated onto a moist, very stiff brown fine-to-medium gravelly silty CLAY.

In-situ shear vane testing confirmed values of 95 kPa at the foundation underside, with increasing stiffness with depth, recording values of 121 kPa at the base of the borehole.

No roots were noted at the underside of the foundation.

Roots were encountered at 1600, 2100 and 2600 mm BGL.

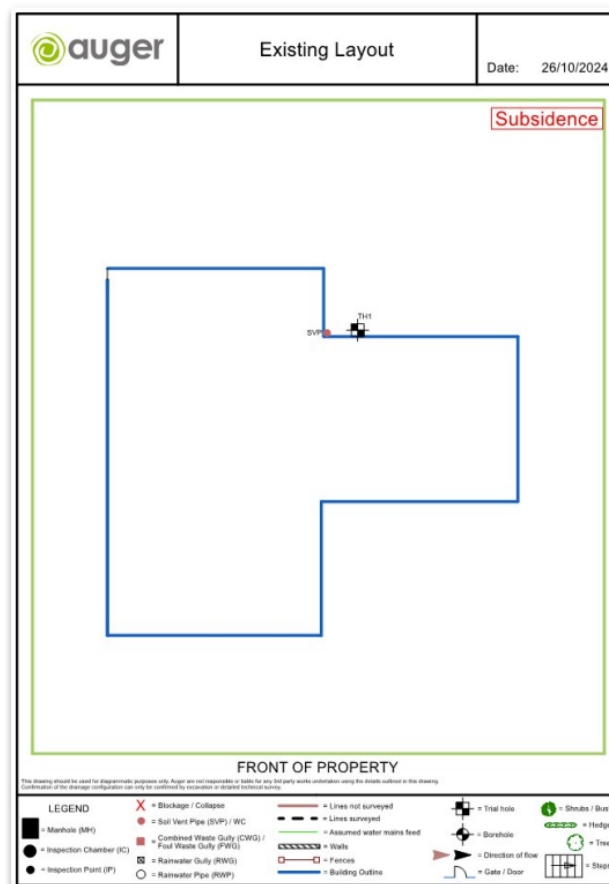
A period of foundation monitoring was undertaken and, following confirmation of vegetation influence at the rear of the property, a further ground investigation comprising a single trial hole was undertaken by Auger in October 2024 relative to the areas of most pronounced movement (see site plan below).

The results of the site investigation confirm that the soil below the rear foundation is very stiff gravelly silty CLAY.

The trial hole was excavated to the target depth of 3000 mm below ground level (BGL). This exposed the foundation which comprised of brickwork to 1250 mm BGL, underlain by a 850 mm thick concrete strip to a total depth of 2100 mm BGL.

The foundation was seated onto a moist, very stiff fine-to-medium gravelly silty CLAY.

In-situ shear vane testing confirmed values of 80 kPa at the foundation underside, with increasing stiffness with depth, recording values of 100 kPa at the base of the borehole.

Roots were observed at the underside of the foundation and at 2600 mm BGL.

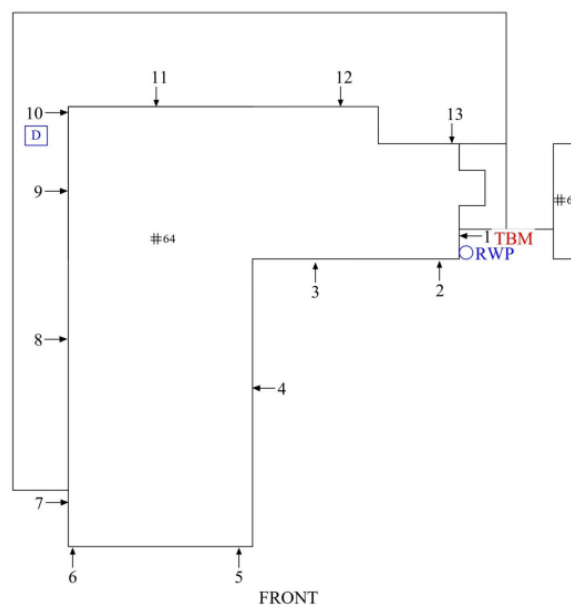
Level monitoring commenced in March 2023 and readings have been obtained on an approximate bi-monthly basis since. Monitoring stations were affixed around the perimeter and taken relative to a temporary benchmark – see plan below:

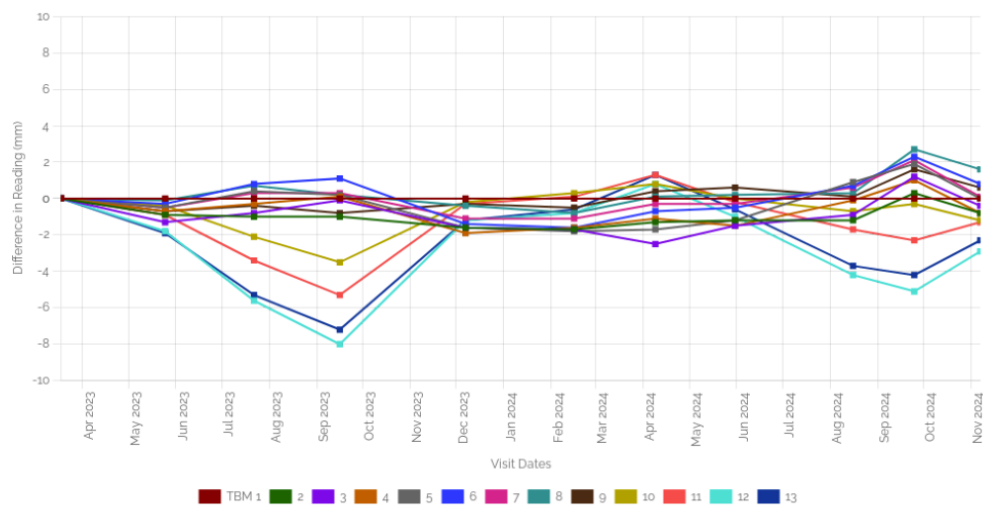
Results to November 2024 have recorded pronounced cyclical movements at stations 12 and 13 (circa 8 mm) with lesser recorded at stations 10 and 11 (circa 5 mm) during 2023 and a recurrence of cyclical movement (albeit reduced) at stations 11, 12 and 13.

Whilst there was a reduction in the magnitude of cyclical movement recorded within the level monitoring relative to 2023 and following removal of the policyholder Elaeagnus, we still consider the oaks as the dominant and effective cause due to a similar noted reductions at stations 10 and 11 which are remote from, and stand outside any possible root influence of the Elaeagnus.
