Inspection Report - Cockpit Barn, Knowle Lane, Fair Oak

**Task:** To inspect and report on the suitability of the barn for conversion to residential use.

**Inspection:** The property was inspected by Mr Elvin Gomery BEng on 12 August 2021.

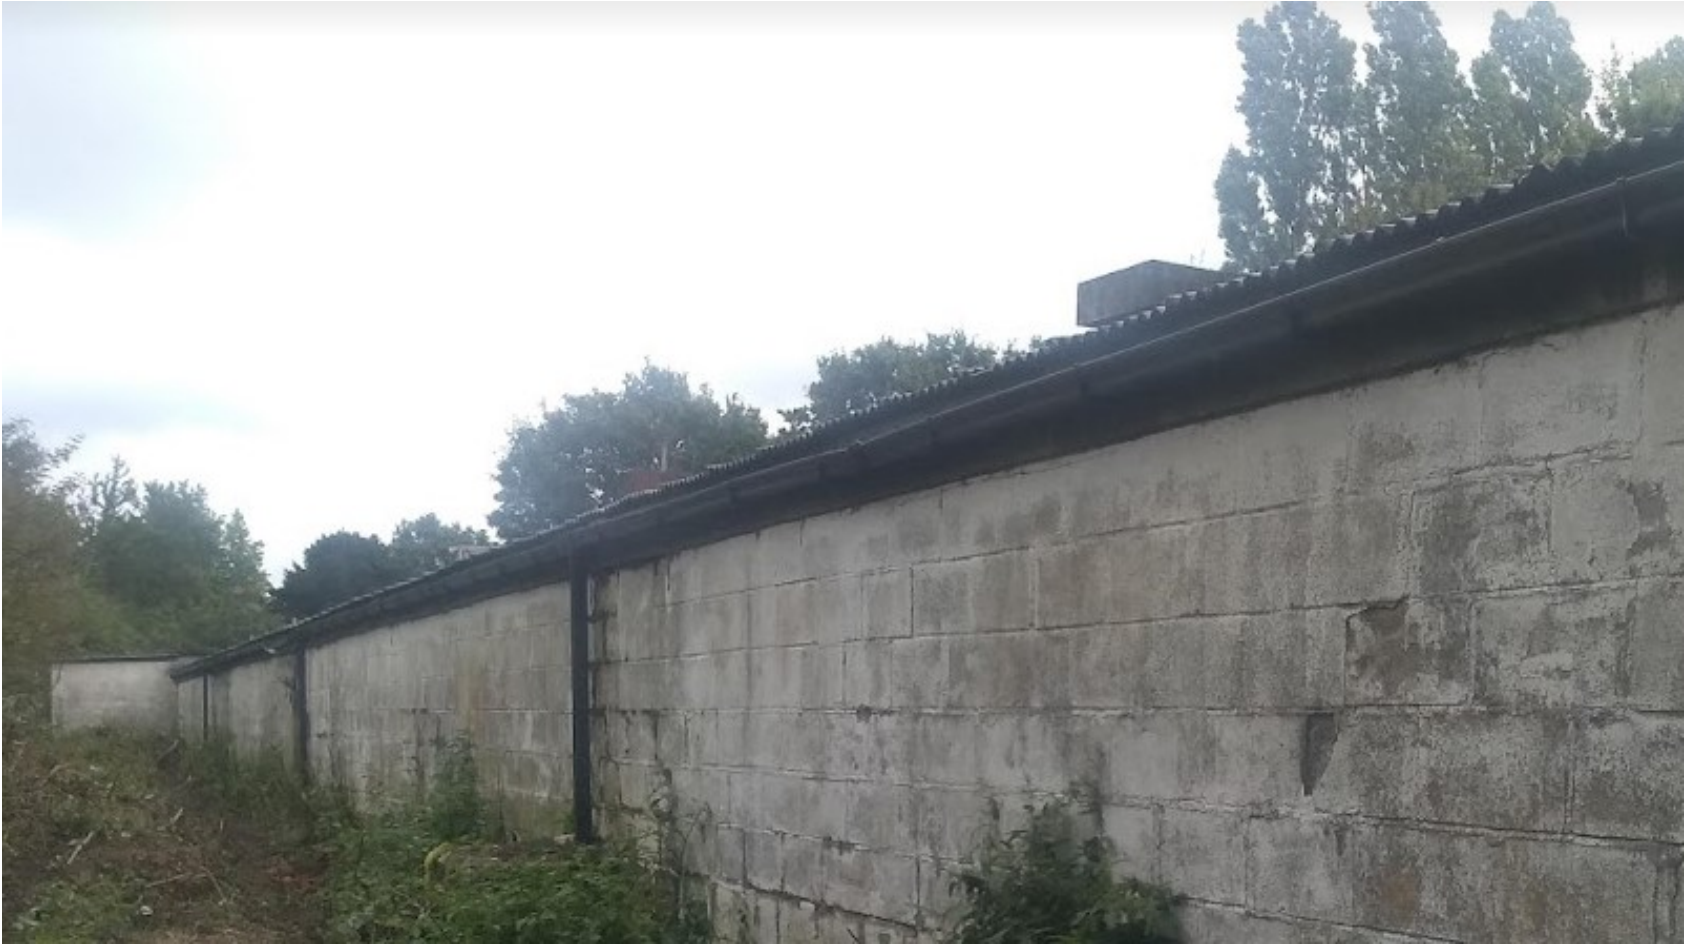
**External Walls:** Walls are generally in sound condition with no significant out of plumbness. There are some minor cracks which will need repair as part of the renovation works.

External blockwork walls

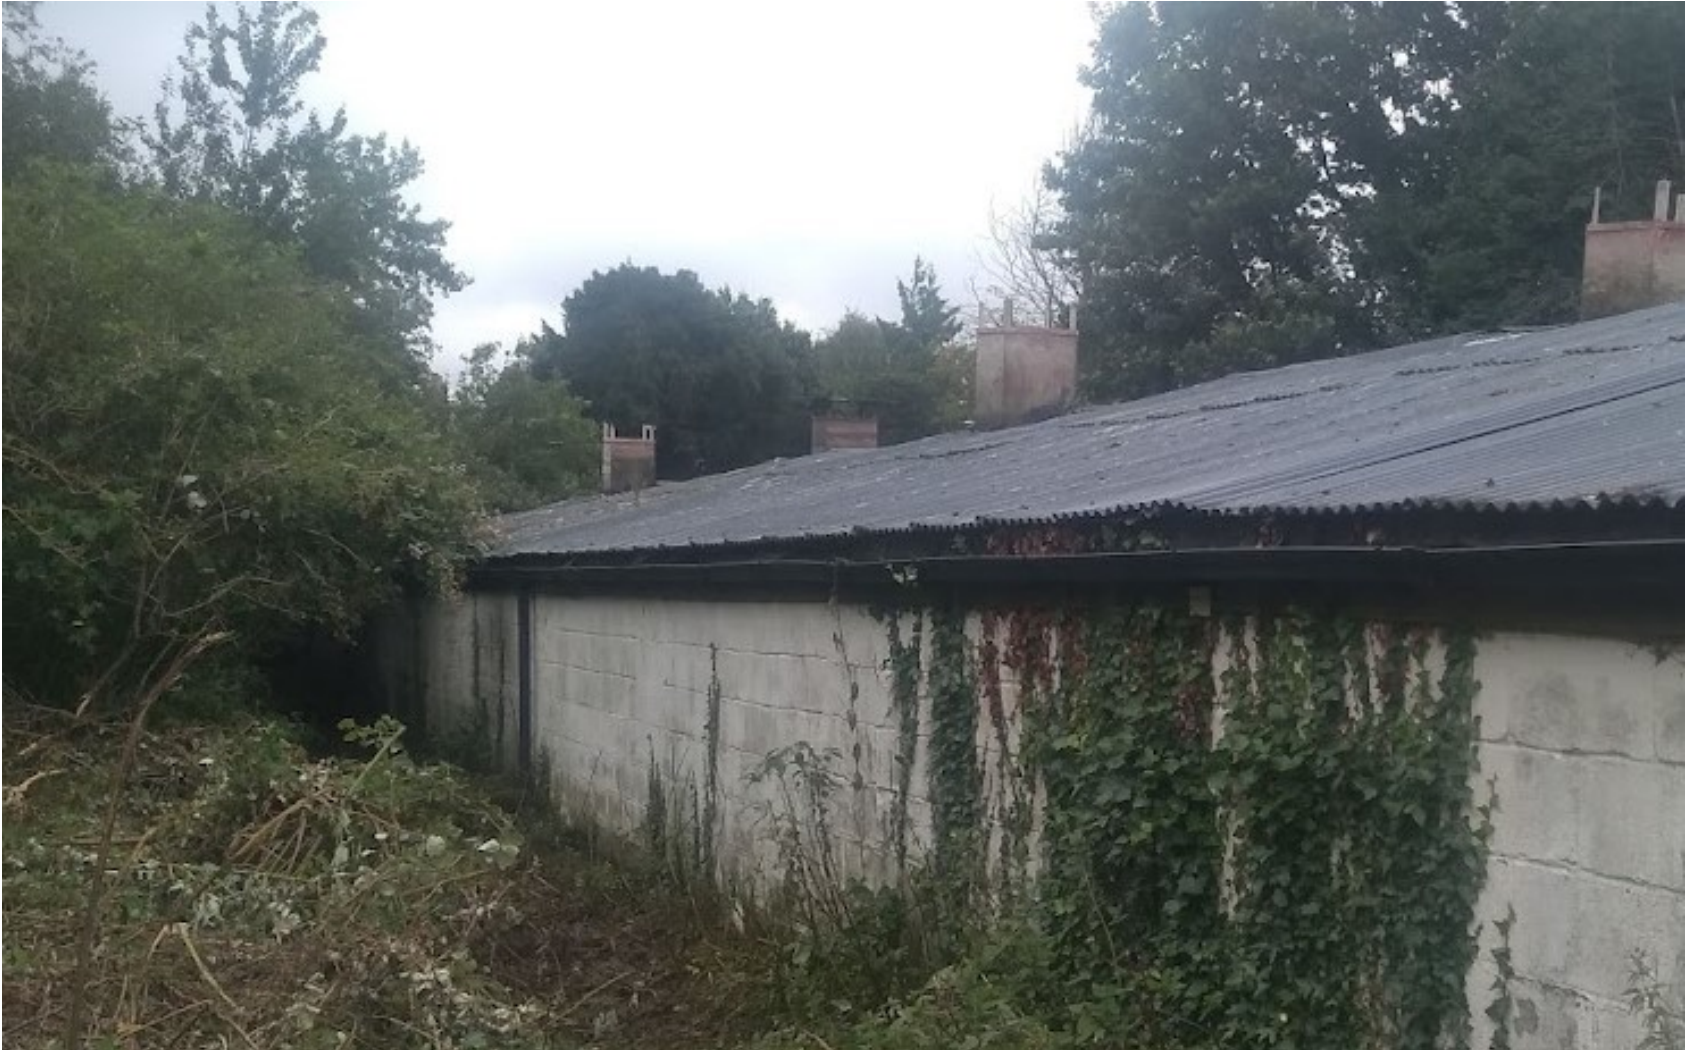
**Roof:** The roof was inspected from ground level. The roof is gently pitched and covered with profiled steel sheeting. The roof structure does sag in some areas but appears generally sound. The roof coverings need repair in some areas

External blockwork walls with metal sheet roofing

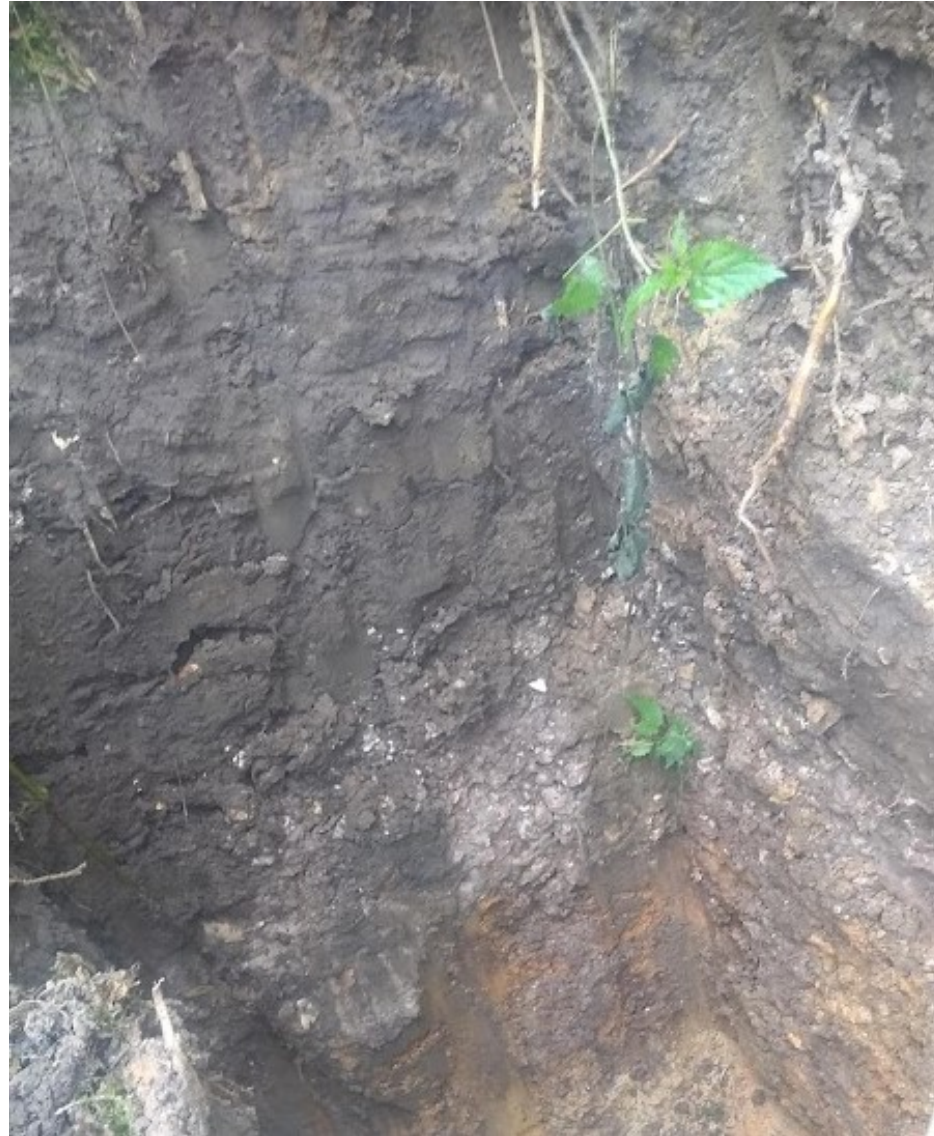
**Foundations:** Two trial holes were excavated on site to determine the existing foundation build up. It was found that the foundations are concrete and extend approximately 0.5m below existing ground level and the concrete foundations are approximately 200mm thick. No significant structural issues were noted to the foundations

Concrete foundations revealed in tril hole

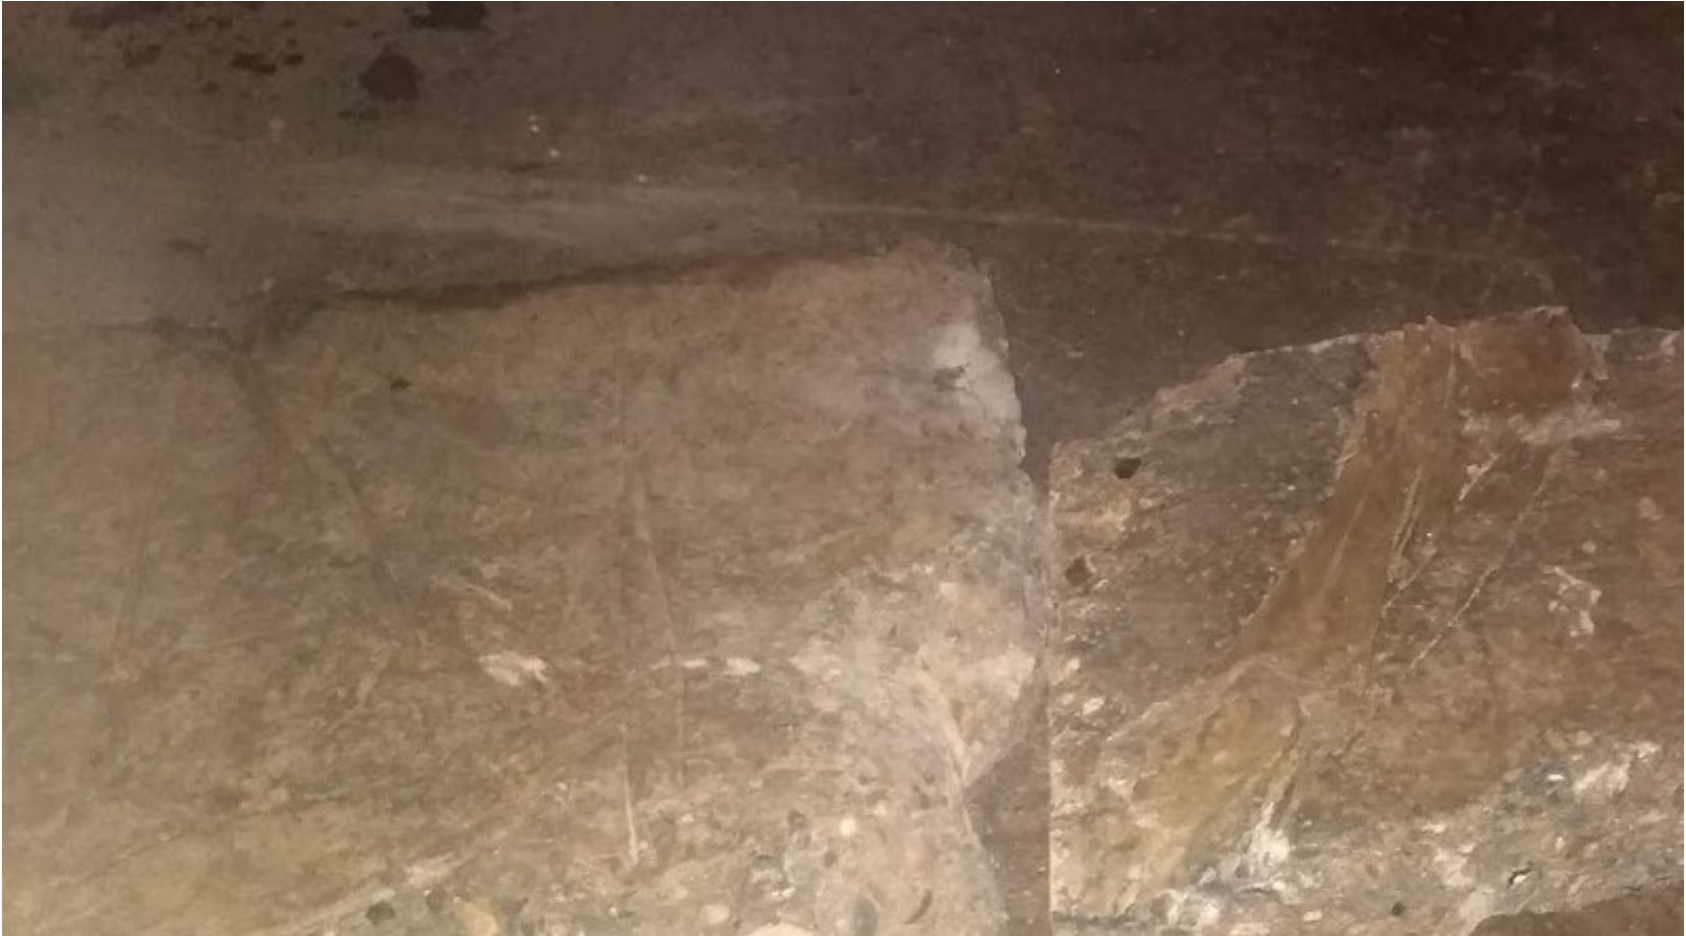
**Ground Floor:** Trial holes were excavated through the ground floor slab to determine its construction. The ground floor is of solid, concrete construction and found to be ground-bearing and appears to be in a satisfactory condition. The floor is level, and there are no signs of settlement at the floor / wall junctions. The slab is a minimum of 100 mm thick concrete on granular fill over chalk soil.

Concrete ground floor slab revealed in trial hole

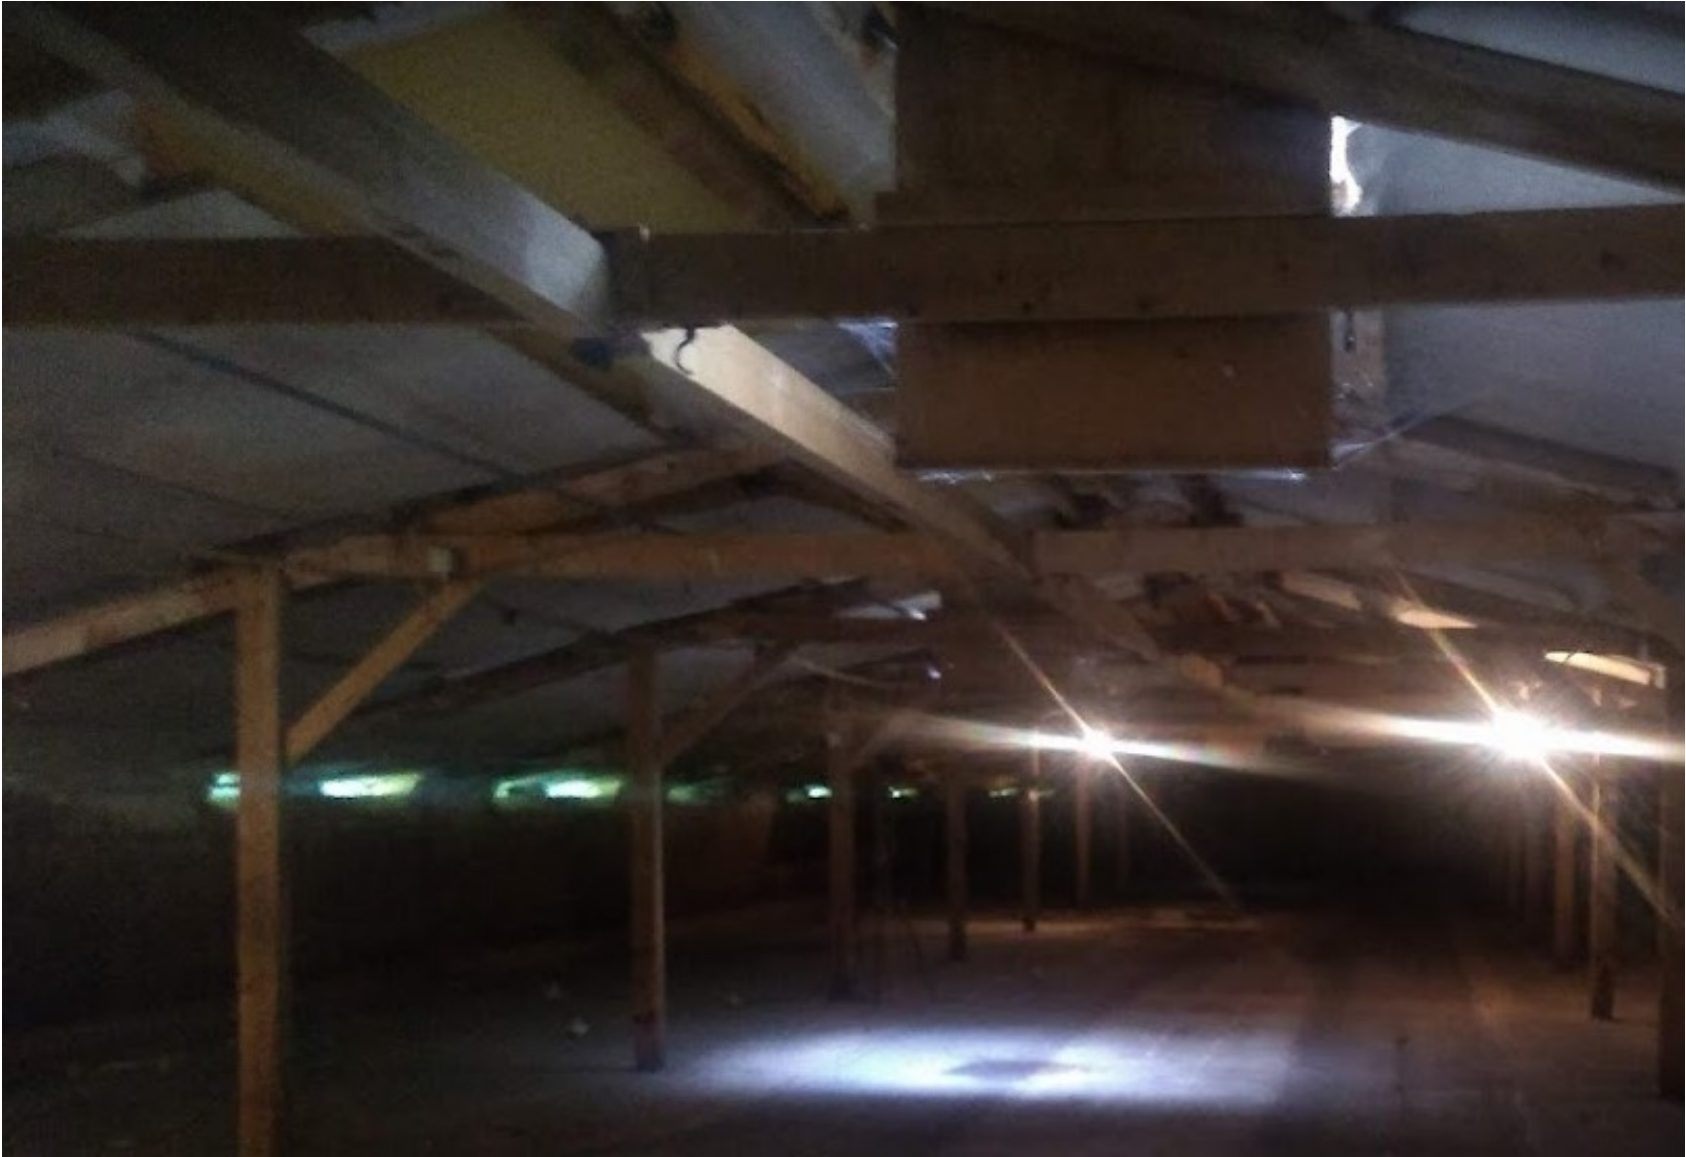
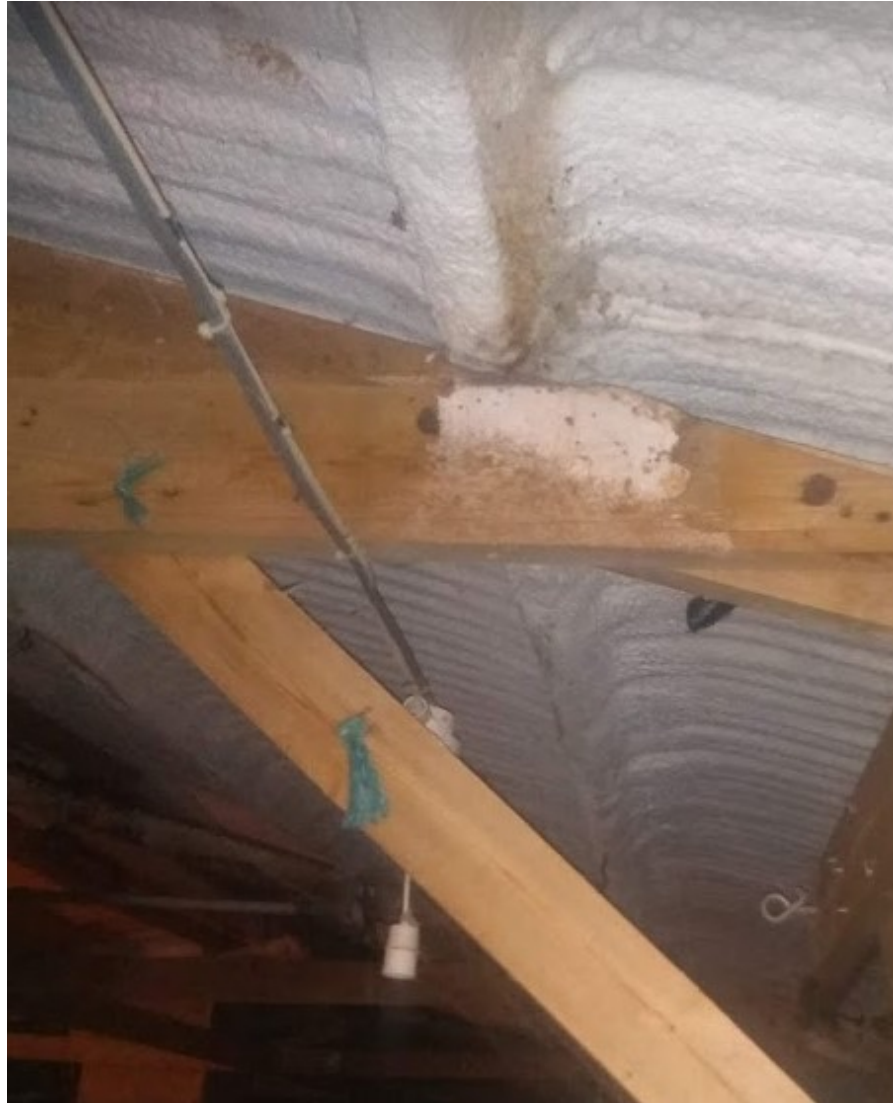
**Roof Structure:** The roof structure is supported on timber purlins which appeared in sound condition. These purlins are in turn supported on timber trusses spanning between the external walls and internal timber posts. The majority of the timber work appeared sound, however some posts were noted to have rotted at the ground slab supporting level and some rafters beginning to rot were supported on the external walls. These timber members were beginning to rot and will need to be repaired as part of any renovation works.

Internal roof timber roof support frames

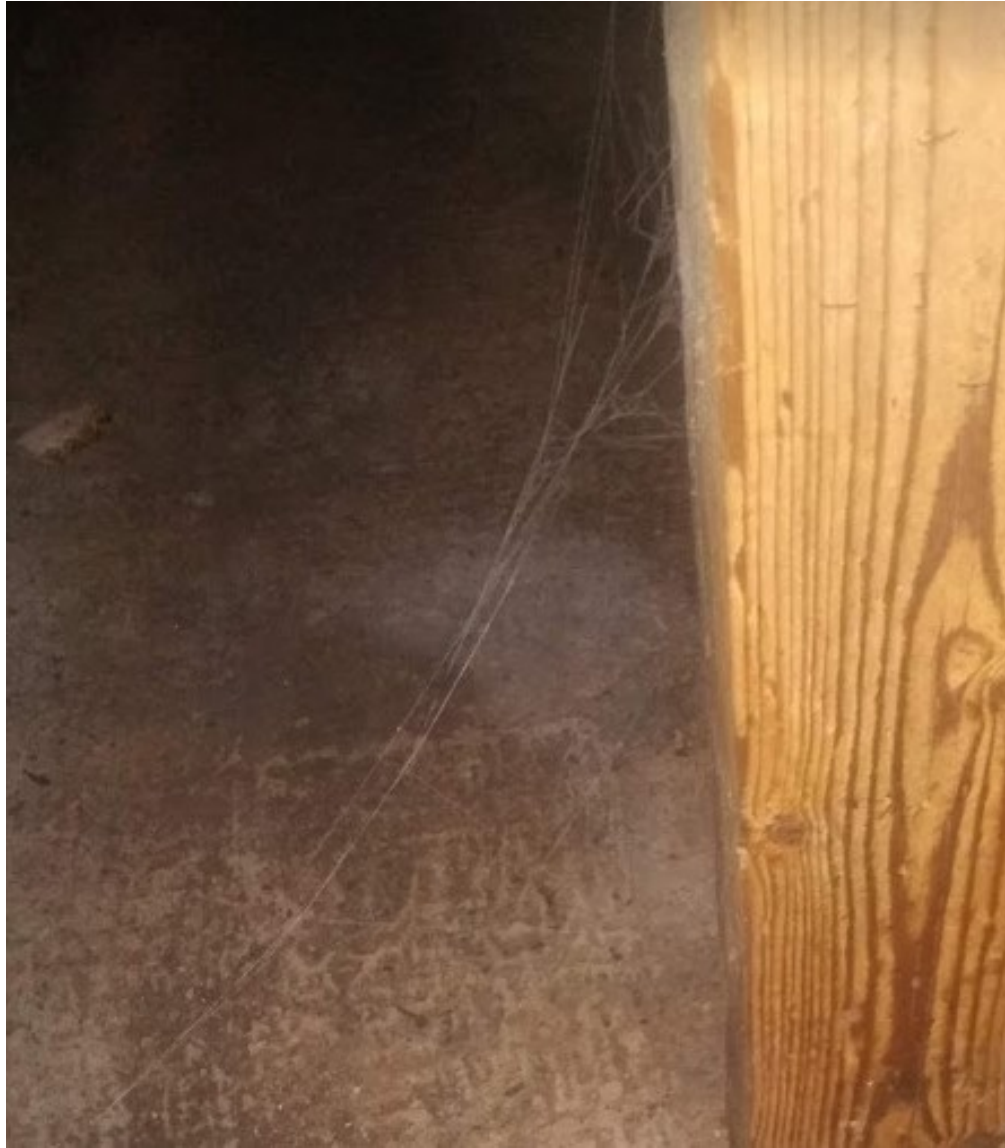
Structural timber support posts supported on ground floor slab
