# Tree Condition Survey Report (VTA)

**Site:** Bright Horizons – Hedge End, Pomeroy Crescent,  
Hedge End, Southampton, SO30 2LF

**Client:** Bright Horizons

| <i>GC Document Reference</i> | J240701 | | |

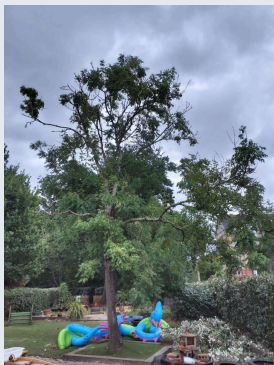
Common ash Tree ID #1

| Tree Survey Schedule | | | | | | | | | | | | | | | | | |
|---|---|---|---|---|---|---|---|---|---|---|---|---|---|---|---|---|---|
| 1 | | Common ash | Fraxinus excelsior | 5-10m | 300 | Semi-mature | Fair | Fair | Ash Dieback present. Reactive growth throughout crown. Lacerations on stems and limbs. Dieback throughout crown. | None Significant | Forked, Pruning Wounds- Occluding, Reactive Growth | Branch Rip Wound, Dieback - Whole Crown, Major Dead Wood Over 50mm Diameter, Pruning Wound | Fungus - Hymenoscyphus fraxineus | Building, Playground | High | Good | Client |

| Tree / Group ID | Common Name | Work Task | Work Priority | Description |
|---|---|---|---|---|
| 1 | Common ash | Remove Dead Wood | Within 1 - 3 Months | Remove all deadwood from crown. |

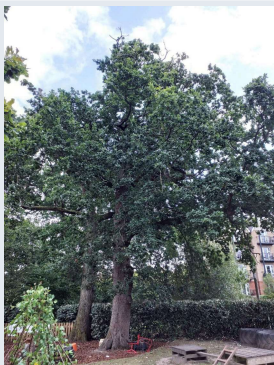
Pedunculate oak Tree ID #3

| Tree Survey Schedule | | | | | | | | | | | | | | | | | |
|---|---|---|---|---|---|---|---|---|---|---|---|---|---|---|---|---|---|
| 3 | | Pedunculate oak | Quercus robur | 11-15m | 800 | Over-mature | Fair | Fair | Cavity in base with signs of internal decay and dysfunction, acoustically tested with arboricultural mallet with no significant change in resonance. Some evidence of retrenchment. | None Significant | Acoustically tested with rubber mallet - no significant decay noted, Cavity at Base | Branch Rip Wound, Major Dead Wood Over 50mm Diameter, Pruning Wound | None Observed | Playground | High | Good | Client |

| Tree / Group ID | Common Name | Work Task | Work Priority | Description |
|---|---|---|---|---|
| 3 | Pedunculate oak | Remove Dead Wood | Within 1 - 3 Months | Remove deadwood |

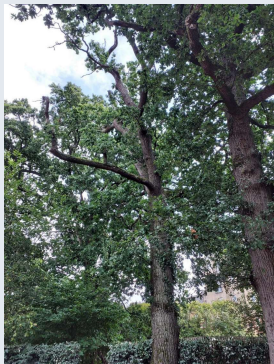
Pedunculate oak Tree ID #4

| Tree Survey Schedule | | | | | | | | | | | | | | | | | |
|---|---|---|---|---|---|---|---|---|---|---|---|---|---|---|---|---|---|
| 4 | | Pedunculate oak | Quercus robur | 11-15m | 750 | Over-mature | Poor | Fair | Evidence of retrenchment and signs of age class. Significant deadwood throughout crown. | None Significant | Forked, Ivy - Insignificant | Branch Rip Wound, Dieback - Stag Headed, Major Dead Wood Over 50mm Diameter, Pruning Wound | None Observed | Playground | High | Good | Client |

| Tree / Group ID | Common Name | Work Task | Work Priority | Description |
|---|---|---|---|---|
| 4 | Pedunculate oak | Remove Dead Wood | Within 1 - 3 Months | Remove deadwood throughout crown |

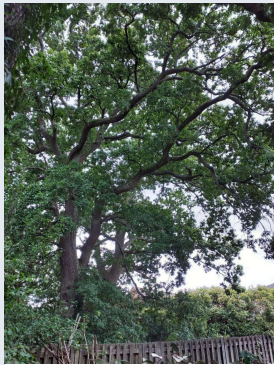
Pedunculate oak Tree ID #8

| Tree Survey Schedule | | | | | | | | | | | | | | | | | |
|---|---|---|---|---|---|---|---|---|---|---|---|---|---|---|---|---|---|
| 8 | | Pedunculate oak | Quercus robur | 16-20m | 800 | Mature | Fair | Good | Third party ownership no access to base. | | Forked | Major Dead Wood Over 50mm Diameter | None Observed | Building, Footpath, Playground | High | No access to base/stem | Third party |

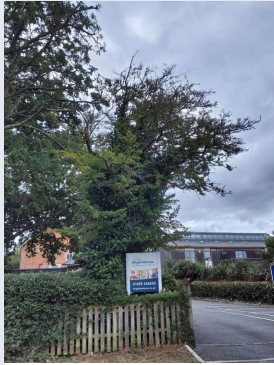
Common hawthorn Tree ID #12

| Tree Survey Schedule | | | | | | | | | | | | | | | | | |
|---|---|---|---|---|---|---|---|---|---|---|---|---|---|---|---|---|---|
| 12 | | Common hawthorn | Crataegus monogyna | 5-10m | 250 | Mature | Fair | Fair | No access to base due to dense vegetation | | Forked, Ivy - Significant (limits assessment) | Dieback - Branch Tip, Ivy - Significant, Minor Dead Wood Under 50mm Diameter | None Observed | Car park, Footpath, Road | High | No access to base/stem | Client |

| Tree / Group ID | Common Name | Work Task | Work Priority | Description |
|---|---|---|---|---|
| 12 | Common hawthorn | Sever and Remove Ivy to 1.5m Above Ground Level | Within 6 - 12 Months | Sever and remove ivy to 1.5m above ground level |

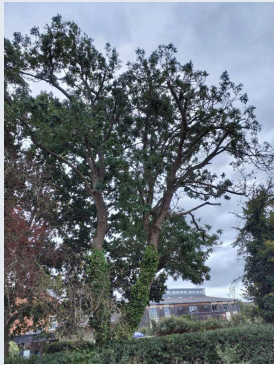
Common ash Tree ID #13

| Tree Survey Schedule | | | | | | | | | | | | | | | | | |
|---|---|---|---|---|---|---|---|---|---|---|---|---|---|---|---|---|---|
| 13 | | Common ash | Fraxinus excelsior | 11-15m | 450 | Mature | Poor | Fair | Ash Dieback present. Reactive growth throughout crown. Lacerations on stems and limbs. Dieback throughout crown. | None Significant | Forked, Ivy - Insignificant, Pruning Wounds- Occluding, Reactive Growth | Branch Rip Wound, Dieback - Whole Crown, Major Dead Wood Over 50mm Diameter | Fungus - Hymenoscyphus fraxineus | Building, Car park, Road | High | Good | Client |

| Tree / Group ID | Common Name | Work Task | Work Priority | Description |
|---|---|---|---|---|
| 13 | Common ash | Remove Dead Wood | Within 1 - 3 Months | Remove deadwood throughout crown and sever ivy at base to 1.5m above ground level. |

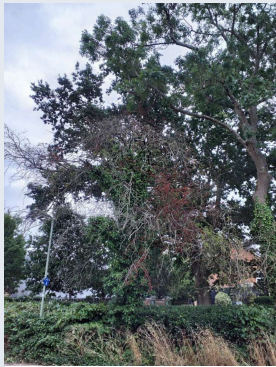
Common hawthorn Tree ID #14

| Tree Survey Schedule | | | | | | | | | | | | | | | | | |
|---|---|---|---|---|---|---|---|---|---|---|---|---|---|---|---|---|---|
| 14 | | Common hawthorn | Crataegus monogyna | 5-10m | 400 | Mature | Poor | Fair | Tree is physiologically poor with minimal life remaining. | None Significant | Forked, Ivy - Significant (limits assessment) | Dieback - Whole Crown, Ivy - Significant, Low Vigour, Major Dead Wood Over 50mm Diameter, Poor Vitality | None Observed | Car park, Footpath, Road | High | Good | Client |

| Tree / Group ID | Common Name | Work Task | Work Priority | Description |
|---|---|---|---|---|
| 14 | Common hawthorn | Dismantle to ground level | Within 3 - 6 Months | Remove to ground level, tree is physiologically poor with only minimal life remaining. |
