| Arboricultural advice note. 25/11/24.<br>Netley Police Training HQ new security fence. | |
| Client | Jeff Japes. Building Surveyor. Universal Services, HCC Corporate Estate & Partners. |
| Scope | To offer guidance to inform the best arboricultural outcomes and that will support a forthcoming planning application for the proposal. |

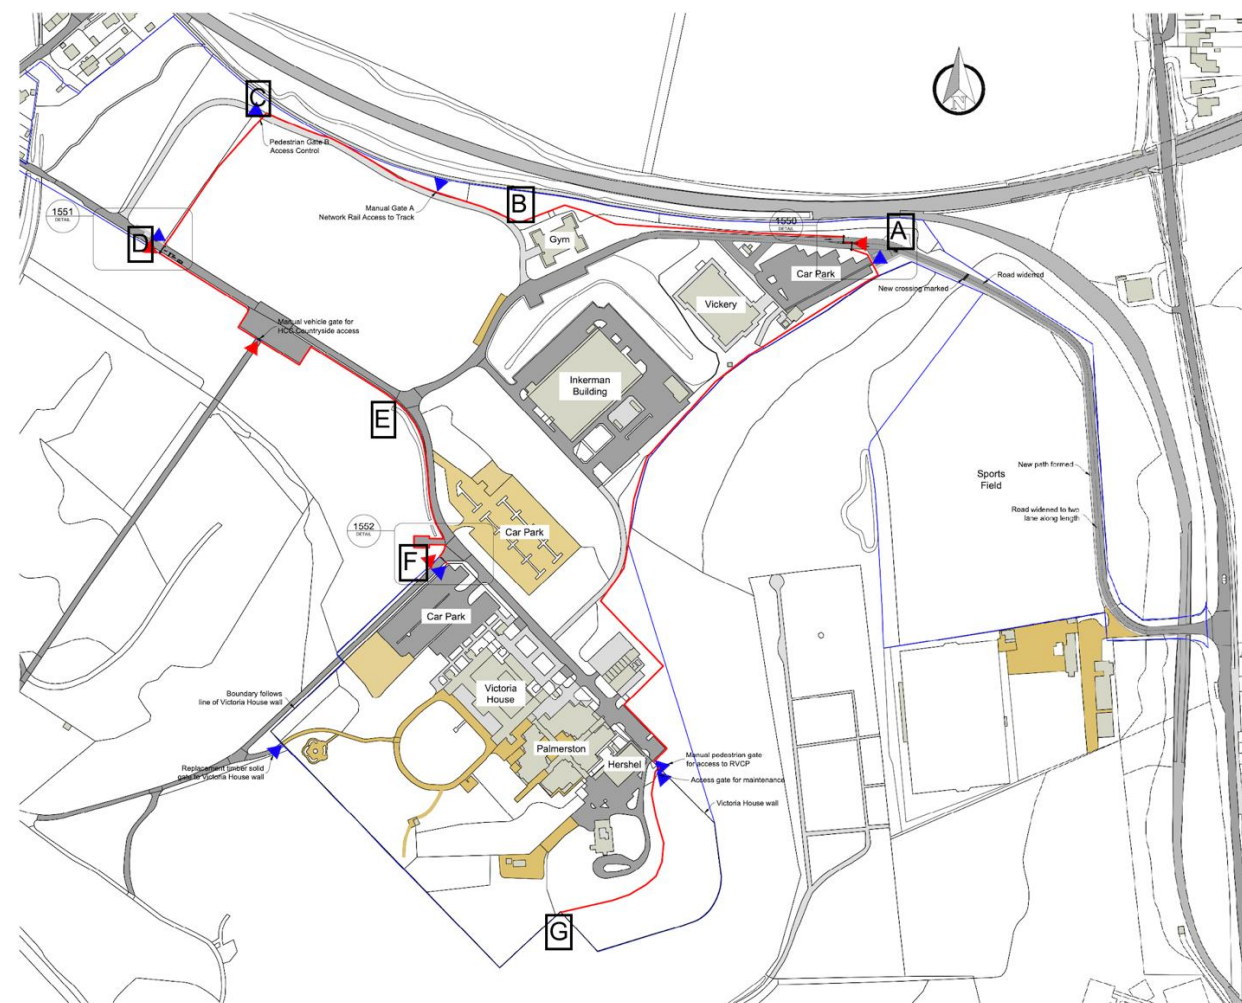
### Areas and connecting points around the perimeter of the security fence.

Several maturing hybrid poplars stand on the north side of the road, close to the "Hamble rail trail" footpath and the railway line. These are problematic trees to manage and maintain in this location and are displaying early symptoms of decline common to the tree type.

| Section A-B | <p>South of the railway line and Hamble rail trail.</p> <p>Along the red line of the proposed fence alignment. A large poplar stands close to the western corner of the gym building, and a smaller willow stands several metres west of the poplar. The poplar has outgrown this location and shows evidence of large-diameter branch failure. The willow has decay at the base. Both trees have been previously recommended for removal in the June 2024 tree condition report.</p> <p><u>Recommend:</u></p> <p>As previously recommended, remove the large poplar and treat or grind the stump to prevent regrowth. Coppice the willow.</p> <p>With arboricultural supervision, clear the undergrowth to enable the proposed fence alignment, and some crown lifting of lower branches and shrubs is likely necessary.</p> <p>No trees of Category A or B are currently proposed to be removed. Some small-diameter Category C trees of poor form, and small diameter shrubby understorey vegetation, will be favoured for removal in all instances. Mitigation planting for any Category A or B trees lost to the development, on a 2:1 basis, will be offered elsewhere on the site.</p> |

| Section B-C | <p>Between B and C is the proposed rail-side access gate, adjacent to the existing informal access point from the client side.</p> <p><u>Recommend:</u></p> <p>Remove the poor-quality small diameter trees, and undergrowth along the route.</p> <p>With arboricultural supervision, clear the undergrowth to enable the proposed fence alignment, and some crown lifting of lower branches and shrubs is likely necessary.</p> <p>No trees of Category A or B are currently proposed to be removed. Some small-diameter Category C trees of poor form, and small diameter shrubby understorey vegetation, will be favoured for removal in all instances. Mitigation planting for any Category A or B trees lost to the development, on a 2:1 basis, will be offered elsewhere on the site.</p> |

| Section C-D | <p>Open recreational field with trim trail apparatus.</p> <p>No real arboricultural issues.</p> <p><u>Recommend:</u></p> <p>"Fence in" the trim trail apparatus, retaining it within the Netley complex.</p> |

| Section D-E | <p>Along the tarmac driveway. HCC Royal Victoria Country Park is immediately adjacent to the south. Establish precise land ownership and agree accessibility.</p> <p>The route follows the existing post and rail fencing. Remove poor-quality trees and undergrowth along the route, likely to be vegetation growing or arising from the HCC Country Park.</p> <p>A very large mature hybrid black poplar stands on the western edge of the car parking area. Establish the ownership and manage this tree accordingly.</p> <p>A windblown oak tree has fallen across the western section of the car park. Establish ownership of the tree/land on which it stands and manage the tree accordingly.</p> <p><u>Recommend:</u></p> <p>With arboricultural supervision, clear the undergrowth to enable the proposed fence alignment, and some crown lifting of lower branches and shrubs is likely necessary.</p> <p>The tree owner should carry out a detailed visual inspection of the black poplar; if this proves the tree to be reasonable to retain, then crown clean the tree to remove dead, dying, rubbing and crossing branches as necessary. If the detailed visual inspection finds the poplar to be unsuitable for retention, the tree owner should arrange to coppice the tree or prune it sufficiently to reduce its likely impact onto the subject site.</p> <p>The tree owner should remove/clear the windblown oak tree as necessary.</p> <p>Both parties to establish and agree on a reasonable width for maintenance of both sides of the fence line, to enable e.g., at least 1m of vegetation clearance to enable ongoing maintenance of the fence line and boundary features.</p> <p>No trees of Category A or B are currently proposed to be removed. Some small-diameter Category C trees of poor form, and small diameter shrubby understorey vegetation, will be favoured for removal in all instances. Mitigation planting for any Category A or B trees lost to the development, on a 2:1 basis, will be offered elsewhere on the site.</p> |

| Section E-F | <p>Along the tarmac driveway. The HCC Royal Victoria Country Park is immediately adjacent to the south. Establish precise land ownership and accessibility.</p> <p>The route follows the existing post and rail fencing where present, and then follows the existing well maintained Ionicera hedge which extends to a point adjacent to the western arm of the mini roundabout.</p> <p>The land falls away steeply towards the wet woodland to the southwest, adjacent to the mini-roundabout and car park.</p> <p>Installing the weldmesh fence here will necessitate clearance of the existing vegetation, including holly and holm oak scrub, which will in turn open up the views into the client's site.</p> <p><u>Recommend:</u></p> <p>With arboricultural supervision, clear the undergrowth and Ionicera hedge to enable the proposed fence alignment, and some crown lifting of lower branches and shrubs is likely necessary. Establish who owns the Ionicera hedge and depending upon ownership; seek to provide suitable mitigation for the loss of the Ionicera hedge elsewhere on the site or the HCC Country Park.</p> <p>Establish and agree on a reasonable width for maintenance of both sides of the fence line, to enable e.g., at least 1m of vegetation clearance.</p> <p>No trees of Category A or B are currently proposed to be removed. Some small-diameter Category C trees of poor form, and small diameter shrubby understorey vegetation, will be favoured for removal in all instances. Mitigation planting for any Category A or B trees lost to the development, on a 2:1 basis, will be offered elsewhere on the site.</p> |

| Section G | <p>Section G to the existing brick wall on the south of the site, near the dog training area.</p> <p>Quite dense undergrowth of mature laurel trees here. Also, some mature and well-established ornamental rhododendrons and very large mature trees, approaching 30m in height, including Wellingtonia, black pine, Monterey pine and beech. The land falls away steeply to the southeast and down towards the existing brick wall boundary with the HCC Country Park.</p> <p>A reasonable 2+m width of vegetation will need to be cleared to enable the alignment of the fence, whilst avoiding harm to the better quality and specimen trees and large shrubs.</p> <p><u>Recommend:</u></p> <p>With arboricultural supervision, set out the alignment of the fence to avoid all retained trees that are larger than 300cm dbh. Cut/clear the laurel as necessary to enable the fence installation, and ideally remove the laurel arisings from the site (due to the toxicity of the laurel arisings to other plants etc.).</p> <p>No trees of Category A or B are currently proposed to be removed. Some small-diameter Category C trees of poor form, and small diameter shrubby understorey vegetation, will be favoured for removal in all instances. Mitigation planting for any Category A or B trees lost to the development, on a 2:1 basis, will be offered elsewhere on the site.</p> |

| Section G-A | <p>HCC Country Park is immediately adjacent to the east and then south.</p> <p>Establish precise land ownership and accessibility. The land falls away to the east, and numerous desire lines to/from the country park are evident along this section.</p> <p>Some important large and mature trees stand immediately on the HCC Country Park site boundary, e.g., the mature English oak that encroaches over the "portacabin" building at point G, and the mature English oak that stands adjacent to the Inkerman building footpath.</p> <p><u>Recommend:</u></p> <p>With arboricultural supervision, remove poor-quality trees and undergrowth along the route. Carefully assess and identify the vegetation that is likely to be on HCC Country Park land and liaise with HCC Country Park team as necessary to enable tree pruning or shrub removal as necessary to install the fence.</p> <p>Establish and agree on a reasonable width for maintenance of both sides of the fence line, to enable e.g., at least 1m of vegetation clearance.</p> <p>Follow the existing chain link fencing where present and be sure to "fence out" any of the HCC Country Park trees.</p> <p>No trees of Category A or B are currently proposed to be removed. Some small-diameter Category C trees of poor form, and small diameter shrubby understorey vegetation, will be favoured for removal in all instances. Mitigation planting for any Category A or B trees lost to the development, on a 2:1 basis, will be offered elsewhere on the site.</p> |

Coppice the poplars and allow them to regrow as multi-stemmed coppice stools. This will make future maintenance via re-coppicing more straightforward and with less impact towards the nearby Hamble Rail Trail and railway line.

This will enable a widening of the road, with likely less impact on the nearby retained trees.

With arboricultural supervision, clear the undergrowth to enable the proposed fence alignment, and some crown lifting of lower branches and shrubs is likely necessary.

No trees of Category A or B are currently proposed to be removed. Some small-diameter Category C trees of poor form, and small diameter shrubby understorey vegetation, will be favoured for removal in all instances. Mitigation planting for any Category A or B trees lost to the development, on a 2:1 basis, will be offered elsewhere on the site.
