6 Keble Close  
Chandler's Ford  
EASTLEIGH  
Hampshire  
SO53 3AN

## **INSURANCE CLAIM**

## **CONCERNING SUBSIDENCE DAMAGE**

## **ENGINEERING APPRAISAL REPORT**

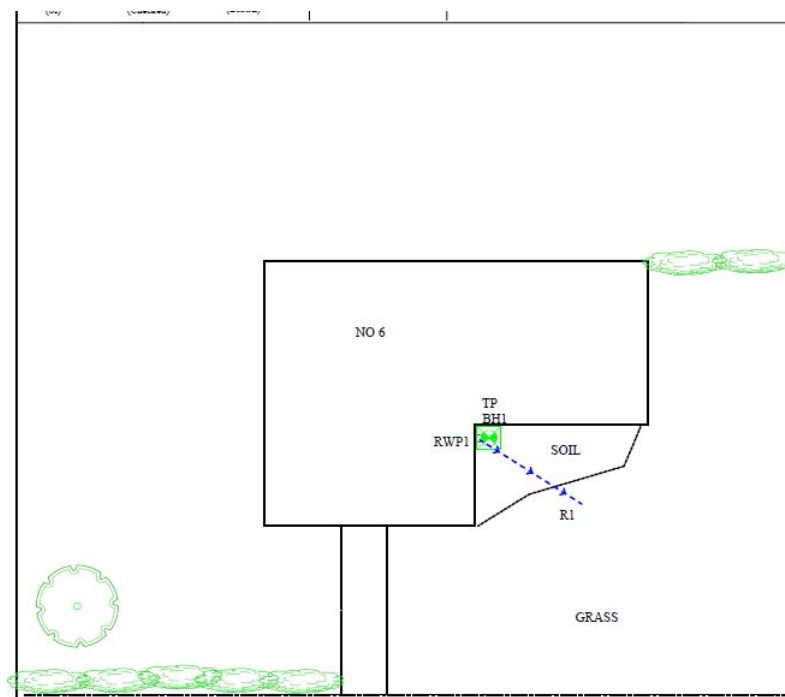
On 9/5/2023 CET Limited undertook a site investigation at the risk address to better understand the foundation arrangements and to secure soil and root samples for laboratory testing. The site investigation comprised a single trial hole in the area of movement at the front of the house. The general layout of the site and the location of the trial hole and relevant drainage run is shown below:

- TP/BH1 (Centre of property). The foundations to the front elevation are concrete strips extending to 650mm below ground level.
- The soil directly beneath the foundations has been identified as stiff moist slightly sandy clay which continued to completion of the extended borehole at 2400mm deep. The clay element of the soil varied with up to 8% being non-plastic.

- The maximum plasticity index of the soil was 41% confirming that the ground has a high plasticity index in accordance with NHBC Chapter 4.2.
- Roots of live appearance were noted a bearing level. Subsequent laboratory analysis has confirmed the roots originate from an Oak. Some of the root samples had moderate starch content indicated that they are alive.
- The closest Oak is the tree within the tree to the left hand side of the risk address owned by the policyholder as detailed within the Arboricultural Report.
- Moisture contents from the soil samples indicate that there is significant desiccation directly below bearing depth in the vicinity of the identified roots. The site investigation was undertaken in May 2023 and it is expected that moisture level would reduce further during the Summer months.

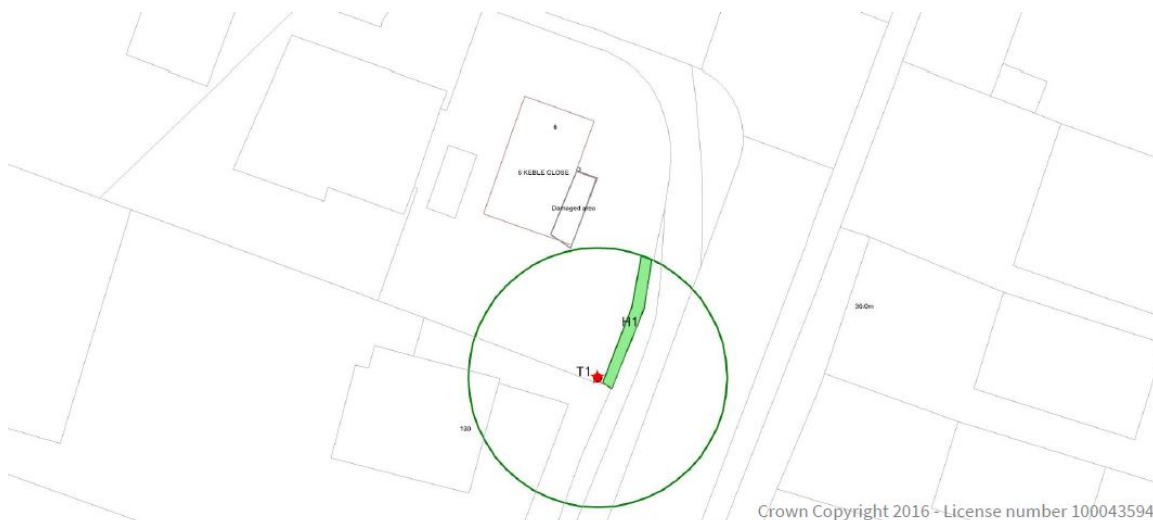
**Location:** 6 Keble Close, Chandler's Ford, Eastleigh, SO53 3AN

| Tree No: | Species | Works Required | CA | TPO | Ownership |
|---|---|---|---|---|---|
| T1 | Oak (English) | Fell and treat stump with eco plugs (broadleaved) | No | Yes | PH |

T1 is owned by [REDACTED] and is subject to a Preservation Order. Subject to a successful application to the Local Authority the intention is to fell this tree.
