One Two Tree

## Tree Report – 81 Lakewood Road, Chandlers Ford, SO53 5AD

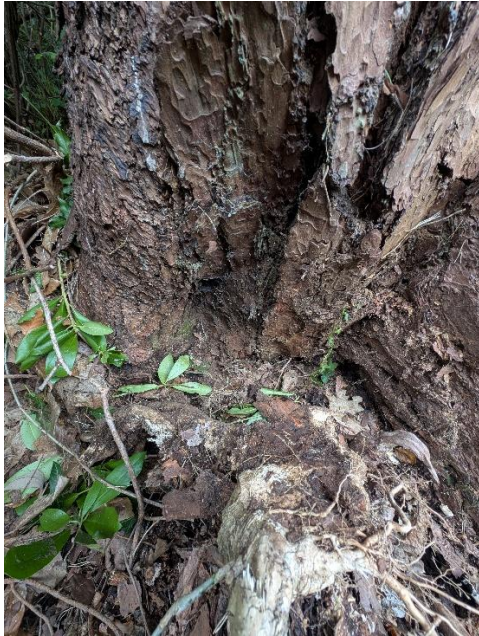
T1 Shows signs of decay at the base with heavy insect damage/activity clear around the decaying tissue (Fig 1.). From approximately 5m in height, at various intervals until the first branch bifurcation, there are numerous partially healed wounds where limbs have either been removed or have failed. Many have healed adequately and show limited signs of disfunction, however two, at approximately 12m have healed poorly, both showing extensive decay (Fig 2. & Fig 3.). Both sit at a similar level within the stem presenting a concerning lack of structural integrity at this point. Further up the stem

Fig.1 – Decay at base.

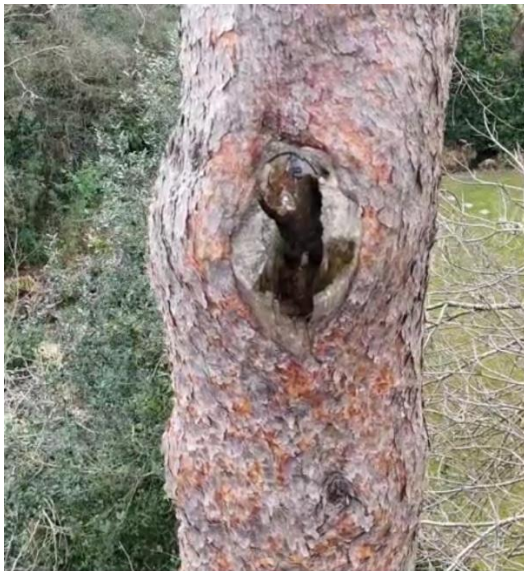
Fig 2. – Branch wound with significant decay.

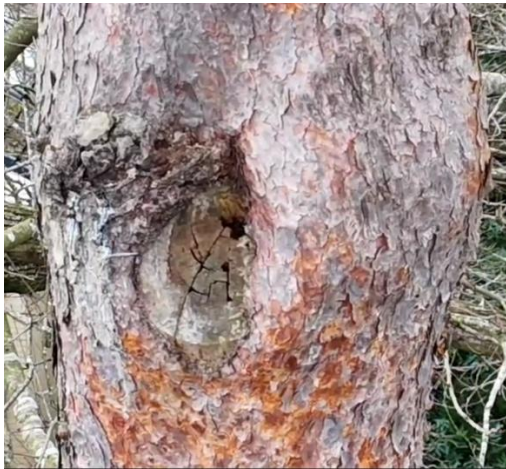
Fig 3. – Branch wound with decay

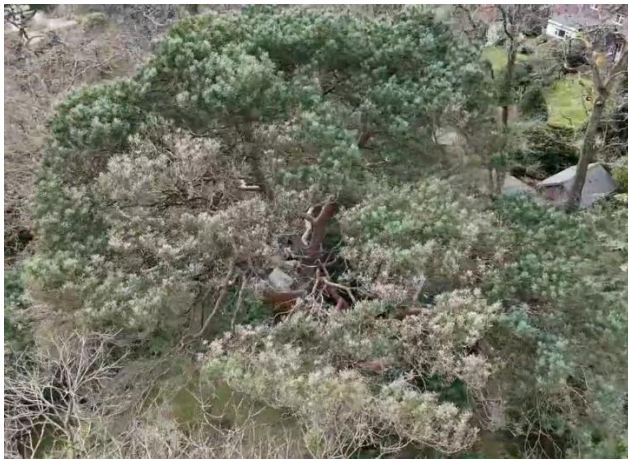
past the first bifurcation, within the canopy, there are multiple dead branches present with a noticeable lack of needles on many outer branches. Looking externally at the canopy from above large sections of the canopy have died and other sections are clearly yellowing (Fig 4. & Fig 5.).

Fig 4. – Aerial image showing areas of dead crown looking South

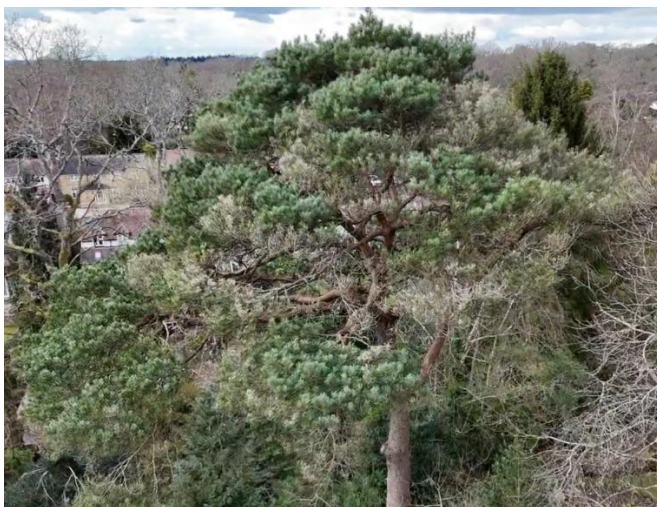
Fig 5. Aerial image showing areas of dead crown looking North West.
