# Tree Inspection and Risk Assessment

58 Brownhill Road

February 2025

# T1 – Lawson Cypress - *Chamaecyparis lawsoniana*

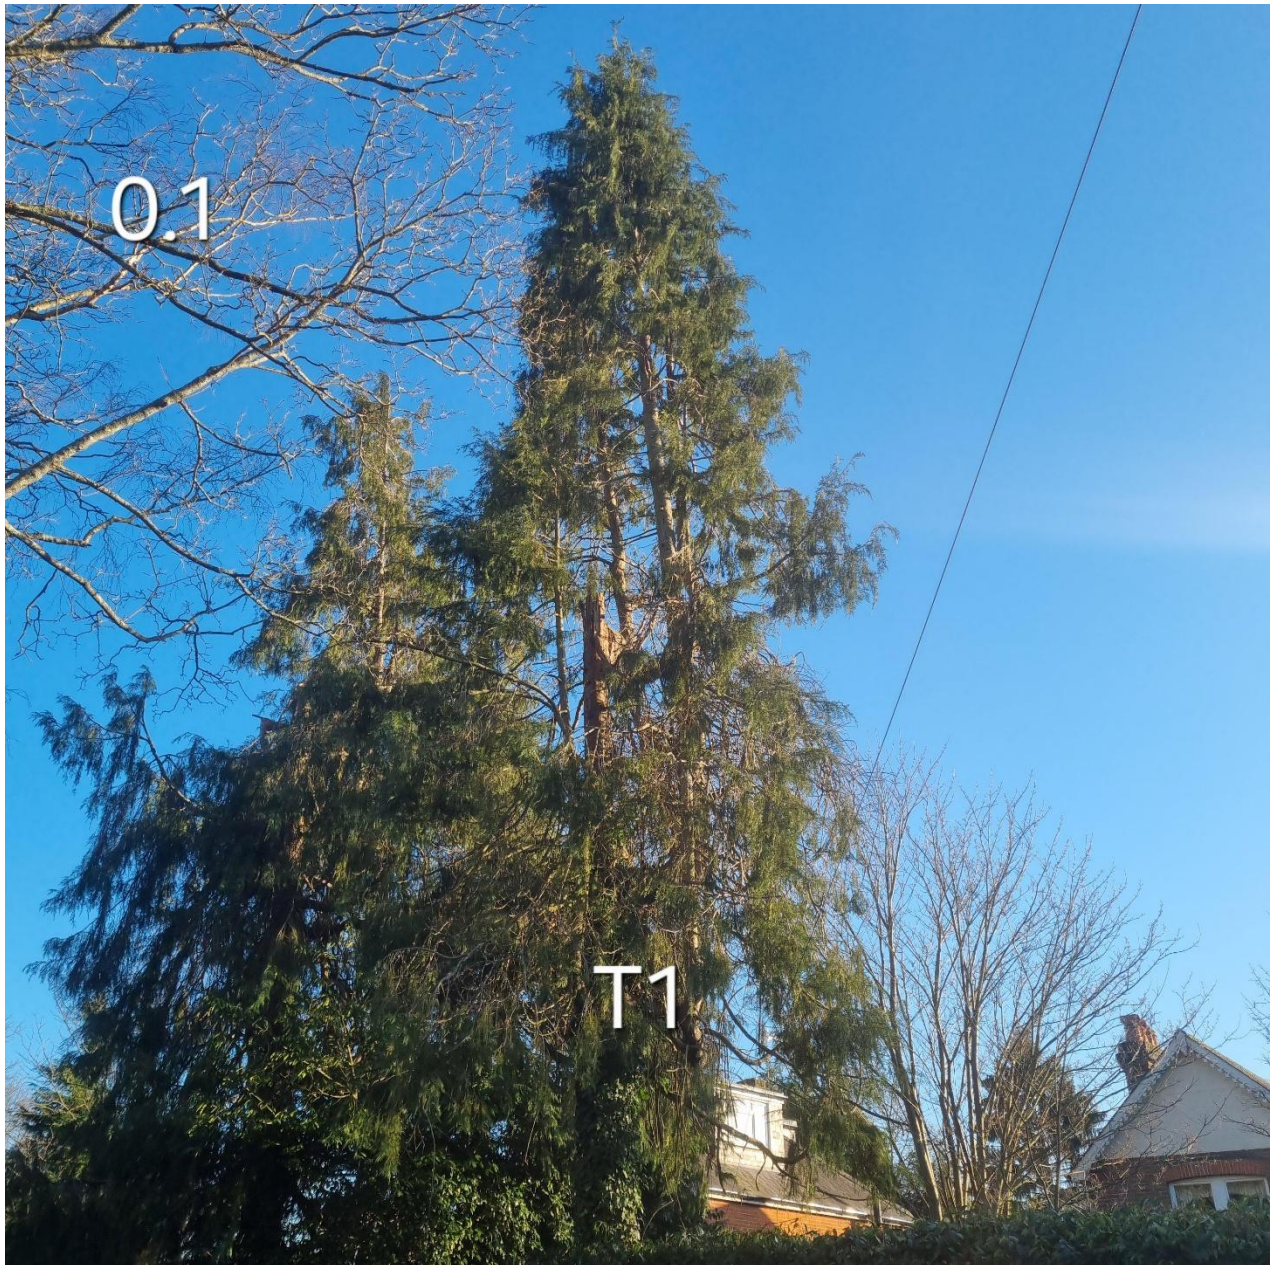
0.1

The canopy has a low leaf and small twig density in comparison to similar adjacent trees.

Western aspect of T1

Given all the issues identified and evidenced with the tree and its location in relation to adjacent targets it is considered reasonable management to remove the tree and replant with a suitable species.

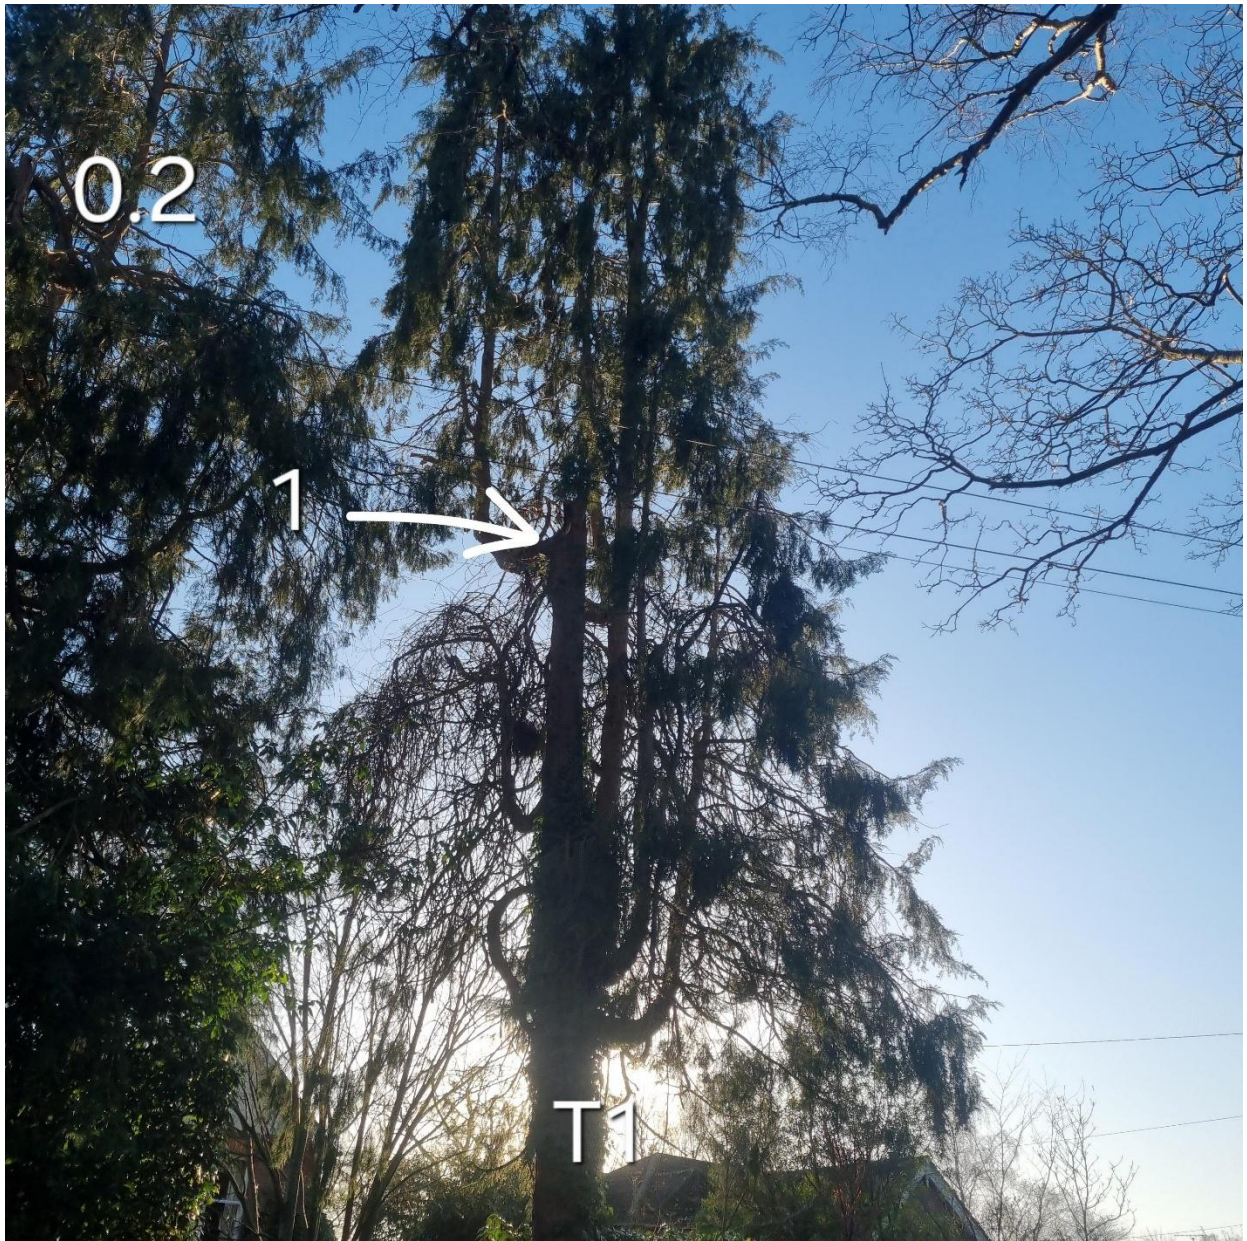
0.2

A recent stem failure has originated at this historic pruning wound. It was associated with high winds and decay at the point of attachment.

This stem failure occurred during a high wind event in early January of this year.

It was approximately 5m long with a diameter of 150mm, it landed in the highway and was cleared by the homeowner.

T1 - Eastern aspect showing recent failure point (1).

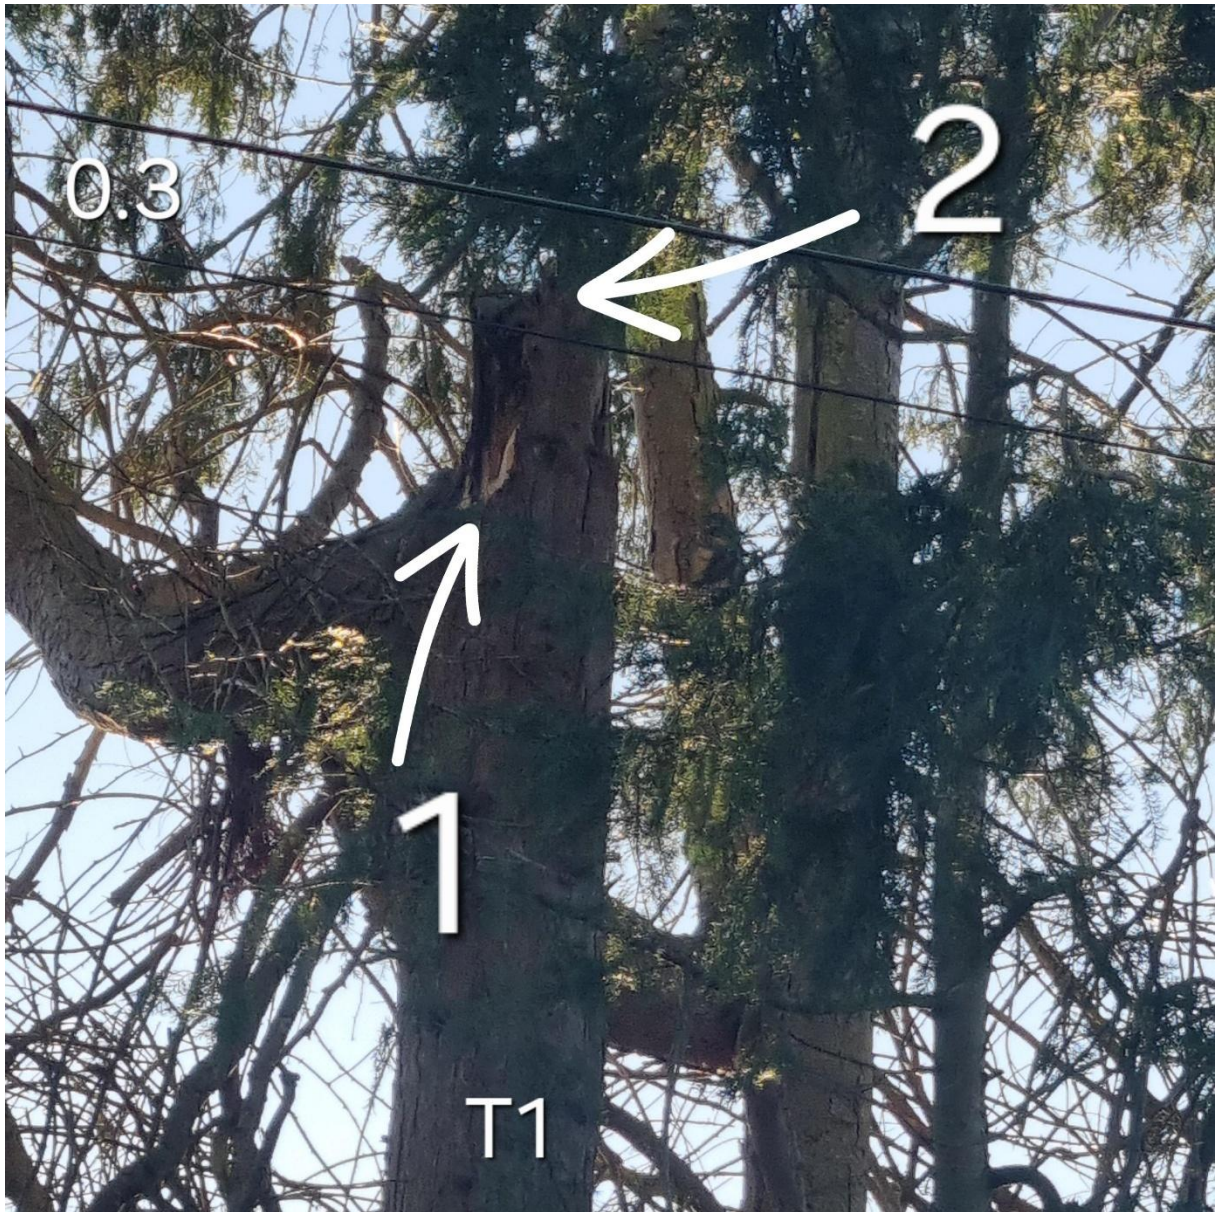
0.3

The failed stem originated adjacent the historic truncation/reduction point at 12m from ground level.

This stem is one of the regrowth points after the upper canopy was removed. This has formed a weak attachment point to the stem, as is characteristic with regrowth in coniferous species.

The historic pruning wound has also begun to decay at this point, adjacent to the failure point.

The weak attachment point, and decay have resulted in this stem failure.

Enlarged view of T1 showing (1) failure point and proximity of historic pruning wound with associated decay (2).

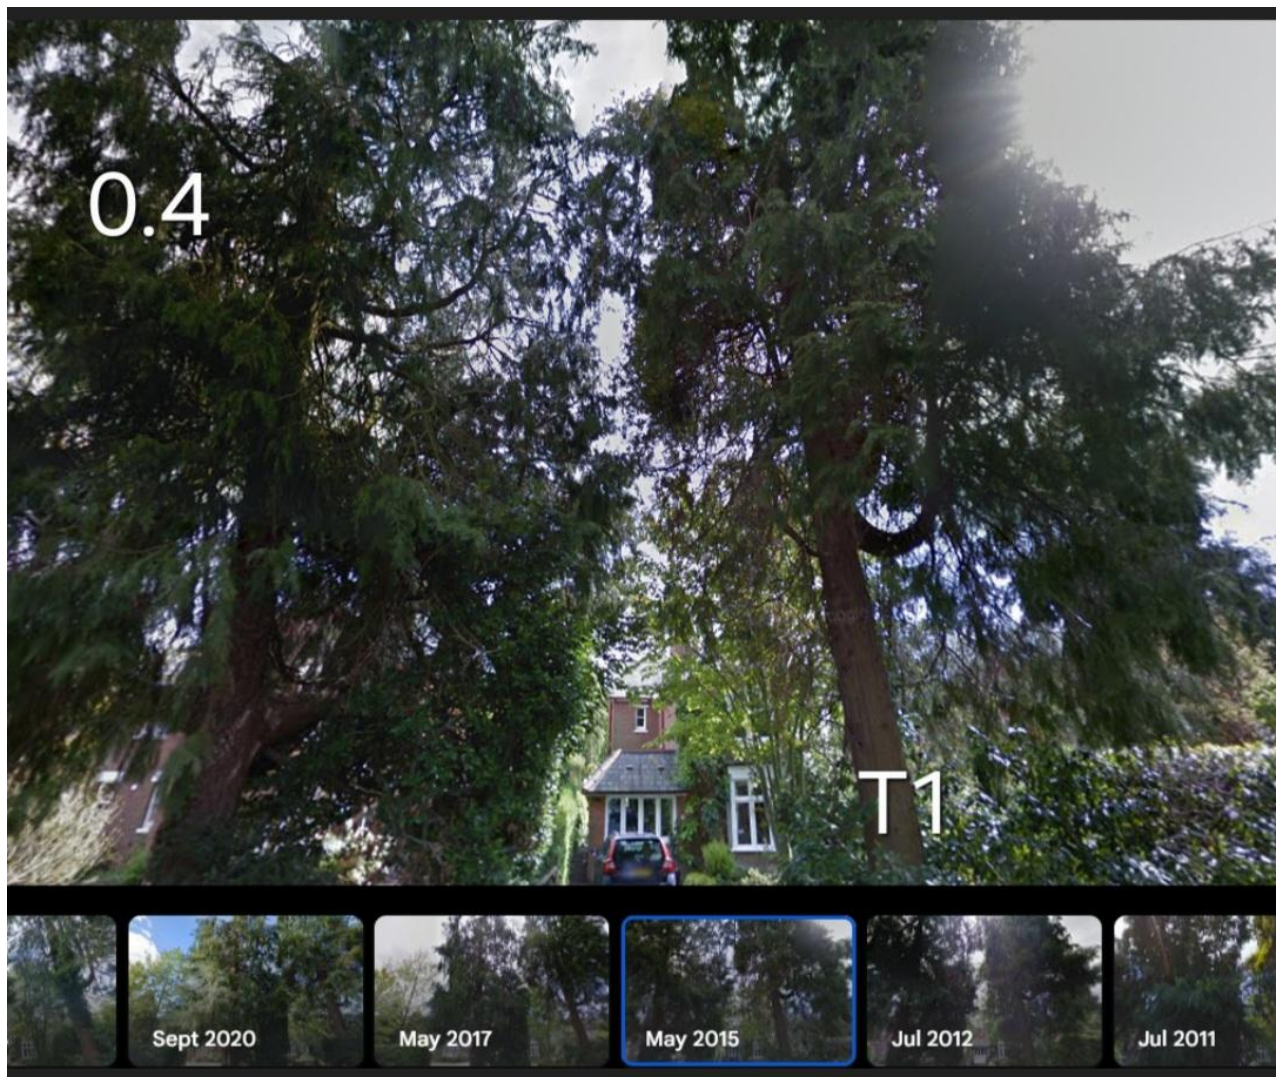
0.4

This is evidenced from street view pictures going back approximately 10 years, you can clearly see a decline in the trees canopy density over that period.

T1 - Good canopy density in May 2015

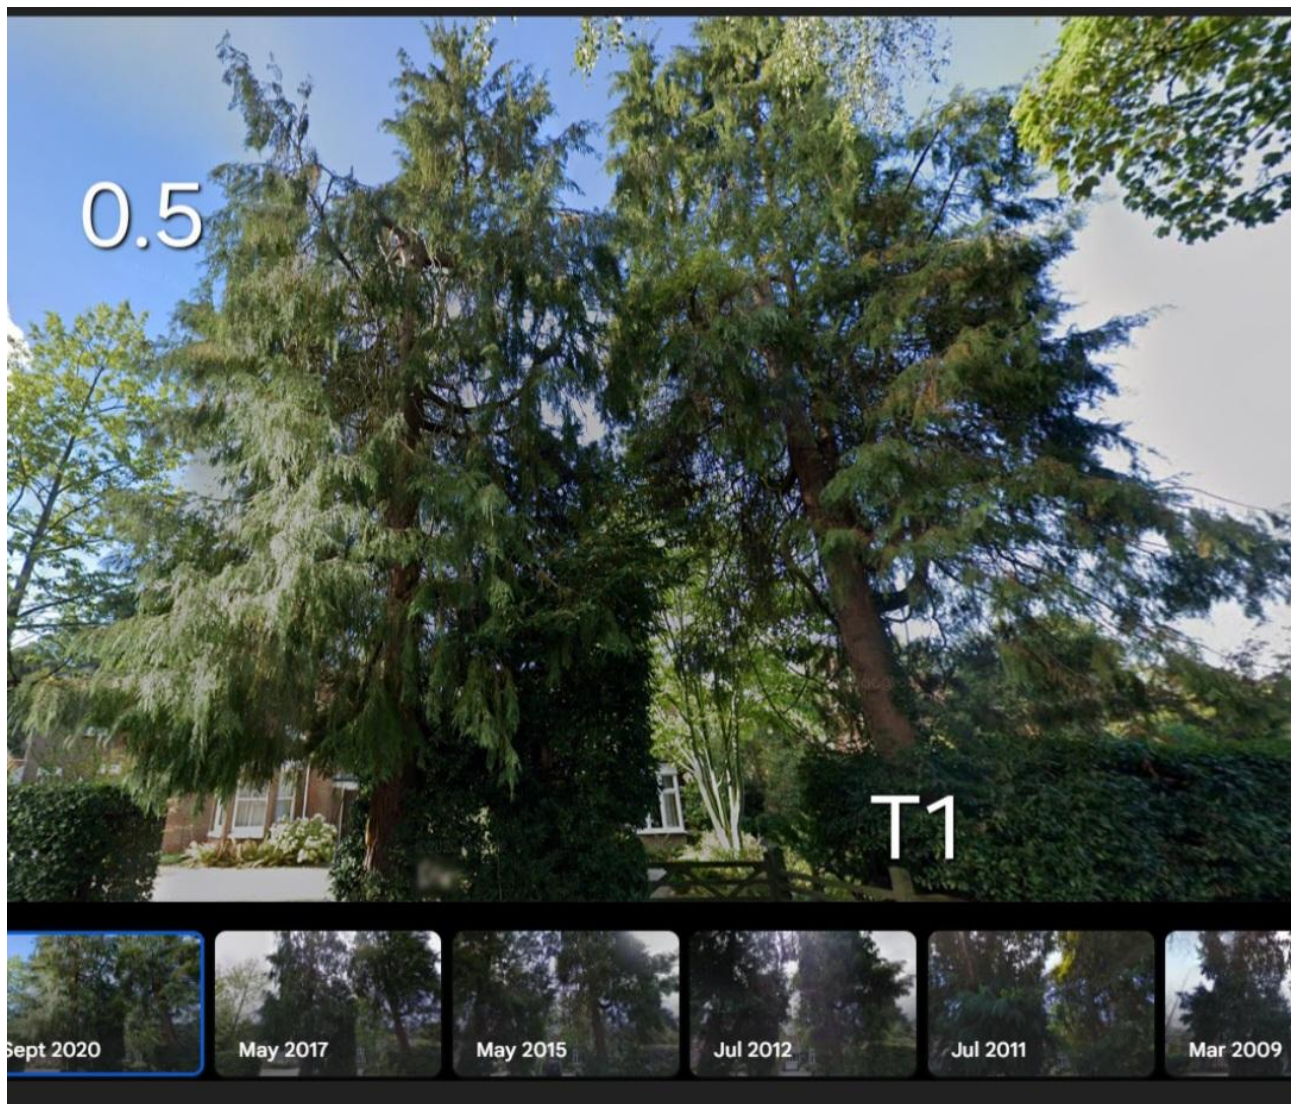
0.5

It is obvious that the density of the canopy is significantly reduced in comparison to similar adjacent trees. This due to low vigour which could be a result of many factors, disease, soil compaction or the effects of long-term drought.

T1 - Declining canopy density in Sept 2020

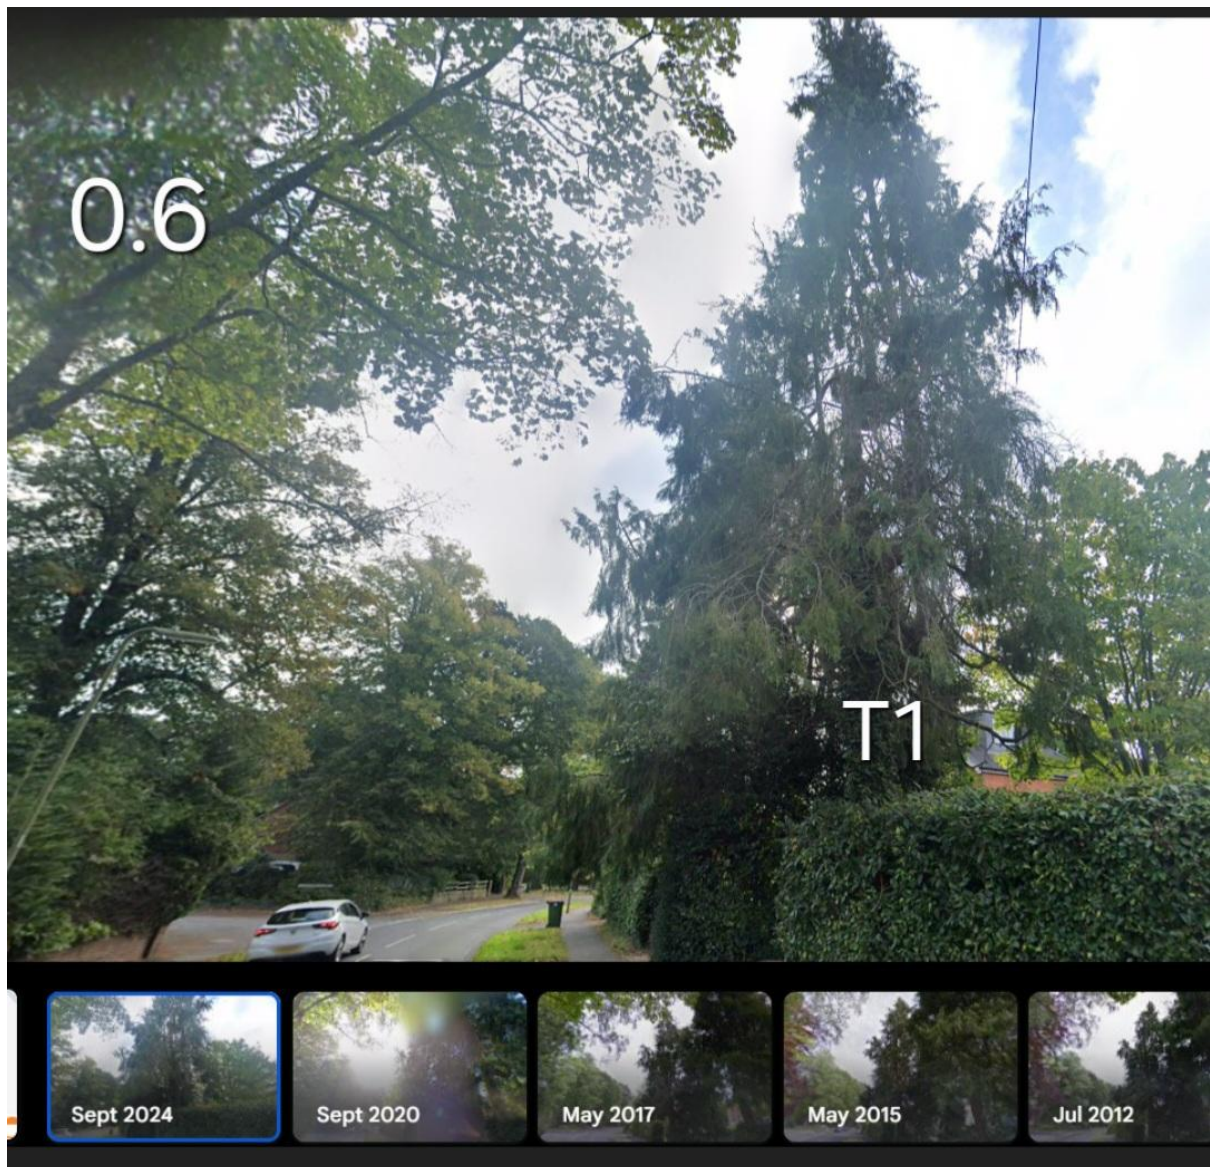
0.6

What is clear is trees significantly reduced photosynthetic area is affecting the trees vigour and long-term health and its amenity value in the street scene.

T1 - Poor canopy density in Sept 2024
