# Arboricultural Assessment of Oak Lodge, Bridge road, Bursledon, SO31 8AL

Carried out by Matthew Rowden on behalf of Arb Elite Tree Care Ltd for Dave Newell, Capital Homes (Southern) Ltd

Planning reference : F/20/87926  
Report reference: ArbEI/CH/OLB/BS5837/V2

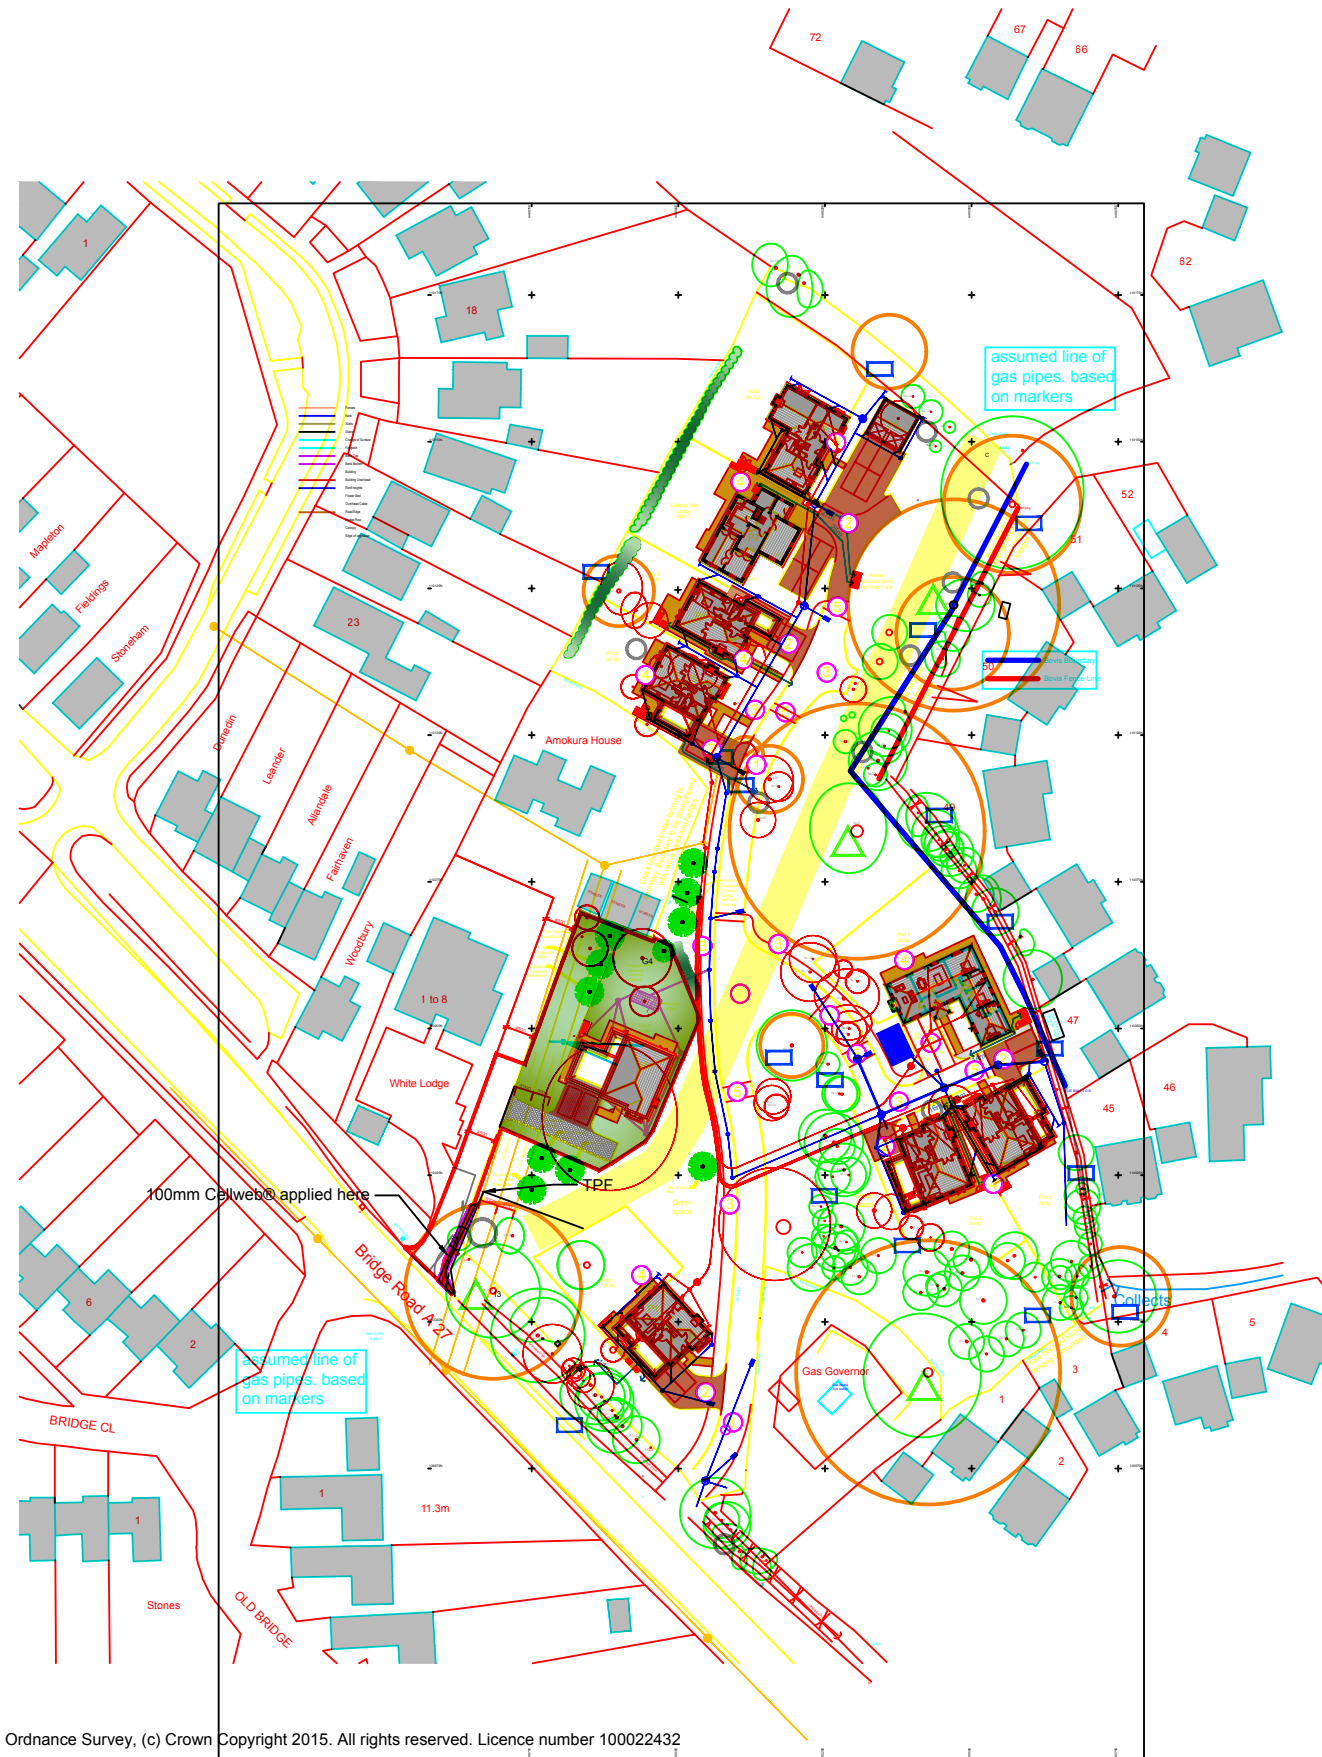
**Appendix 2: Tree location plan**

| Tree no. on plan | Species | Ht (M) | Crown spread (M)<br>N<br>E<br>S<br>W | Stem dia.<br>@1.5m (mm)<br><br>RPA radius (m)<br><br>RPA area (m2) | Life stage | Estimated remaining contribution in years | General observations<br><br>Physiological condition- P<br><br>Structural condition - S | Preliminary management recommendations | BS5837 category |
|---|---|---|---|---|---|---|---|---|---|
| G4 | <i>Chamaecyparis lawsonia</i> x 1, <i>Picea abies</i> x 2, <i>Salix caprea</i> x 1. | 17 - 18 | 4m radius | 290<br>290<br>220<br>160 | M/D | <5 | P- Poor<br><br>S- Poor<br><br>Both spruce trees are dead, low value, non native specimens.<br>No cavities or habitat niches present within any trees and canopies are not over-sailing any vegetation.<br>Cypress is heavily ivy clad and a poor specimen.<br>Goat willow has minimal value to the area and will cause issues with the development as it matures. | Fell | U |
| 13 | <i>Quercus robur</i> | 22 | 9<br>12<br>9<br>10 | 1100<br><br>RPA radius = 16.5<br><br>Area = 855 | V | >40 | P- Fair<br><br>S- Fair<br><br>Veteran tree. Ivy clad with some minor deadwood throughout canopy.<br><br>Proposed driveway access bisects RPA, and will require no dig solutions to enable the access route to be installed. The occupied area of permanent hard surfacing is less than 20%, however. | Remove deadwood.<br>Sever ivy.<br><br>Install driveway access using 100mm cellweb® membrane.<br><br>Erect TPF as per TPP. | A2 |
