# **Report on Trees Removal and Replacement Planting**

**Date:** 22/04/2025

**Location:** Botleigh Grange Hotel & Spa

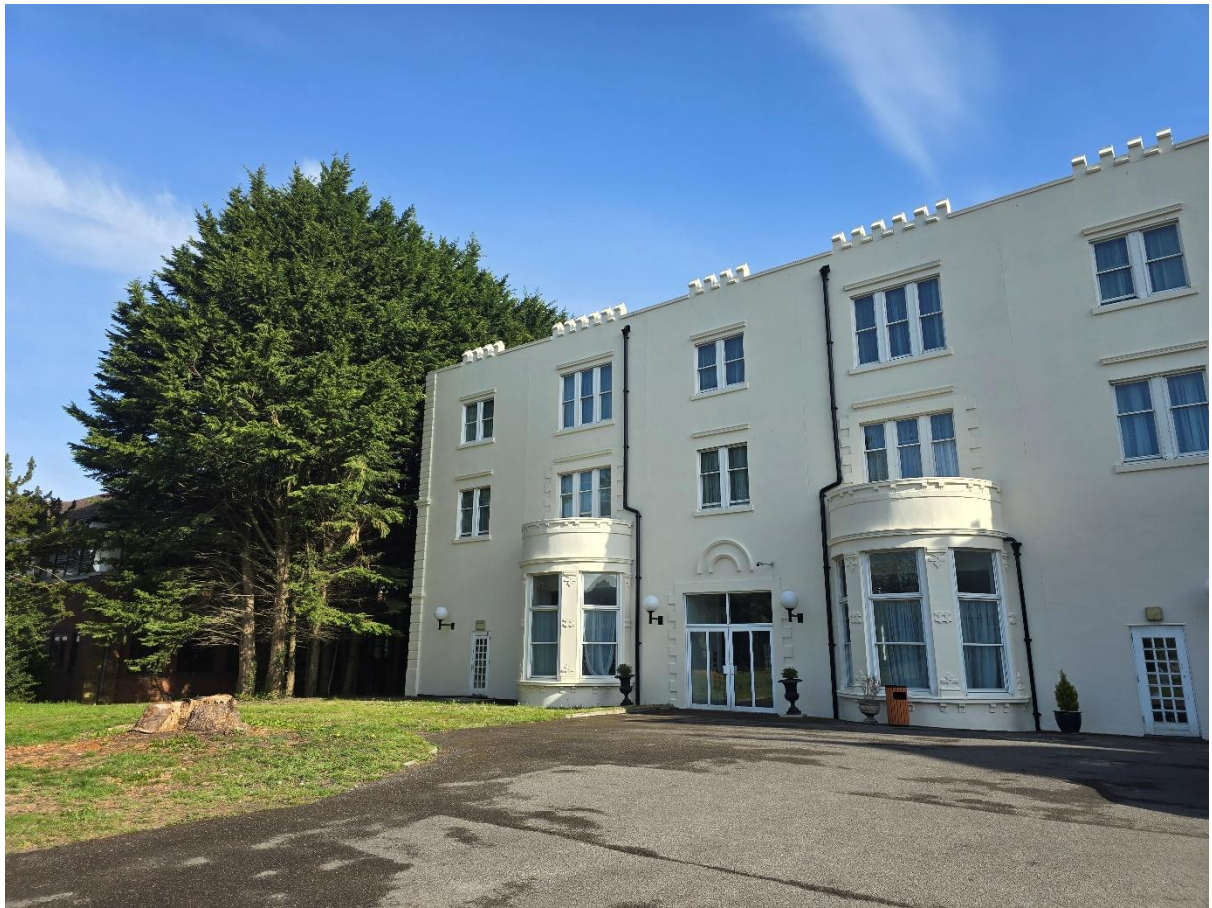
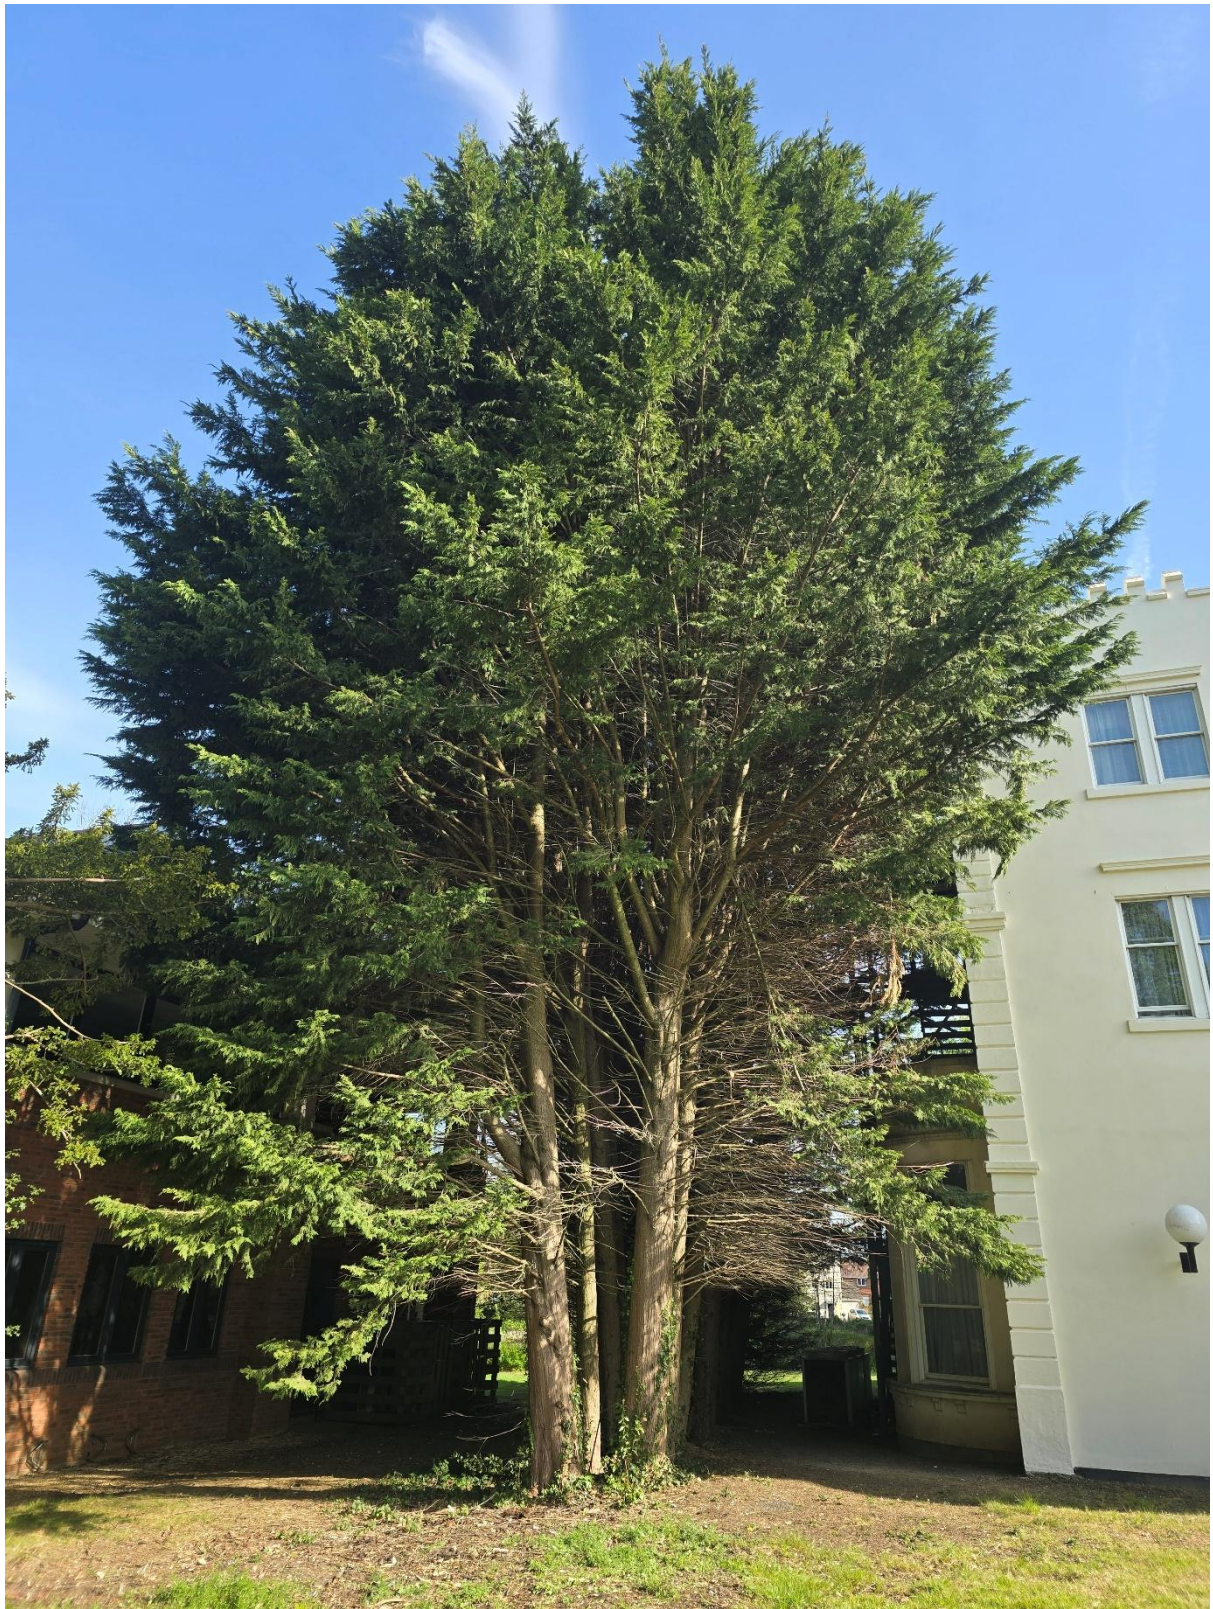
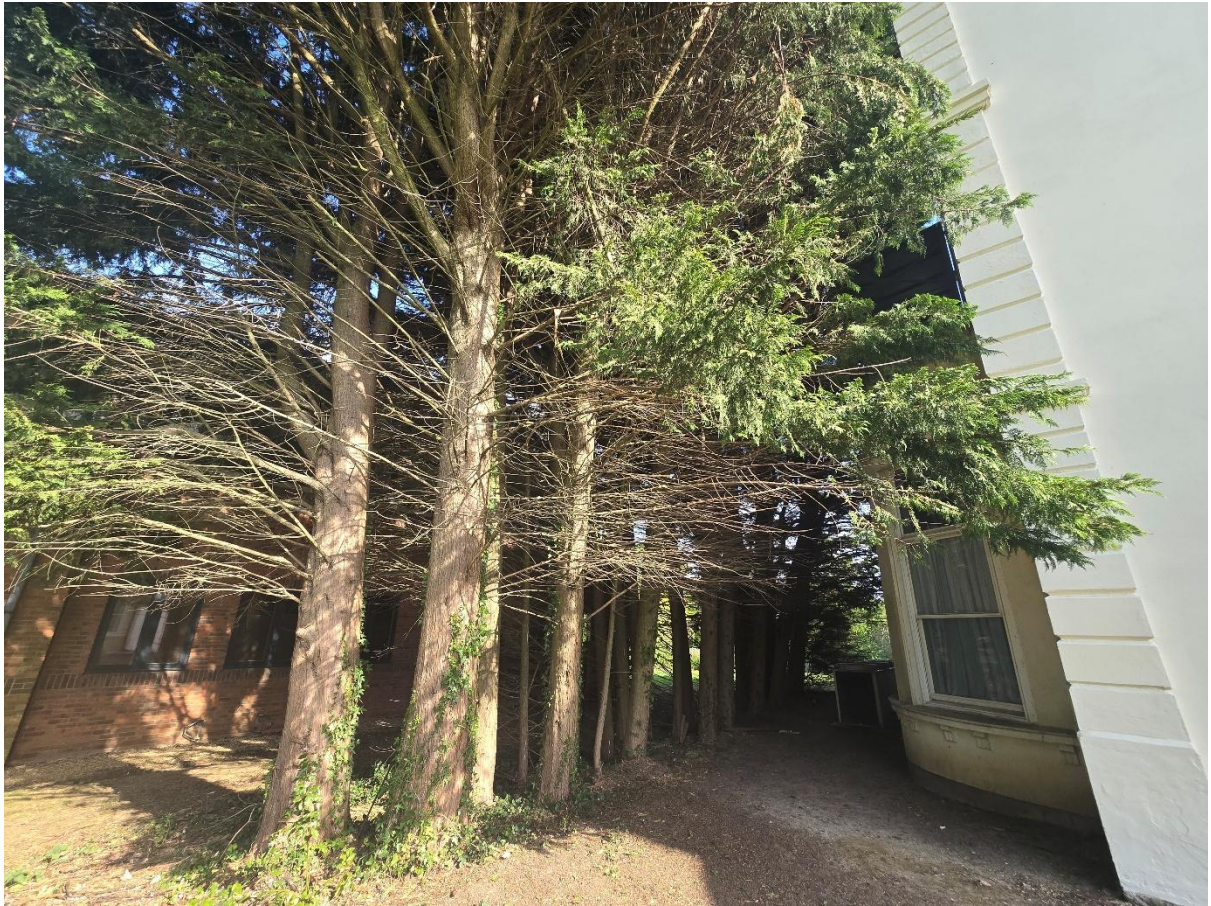
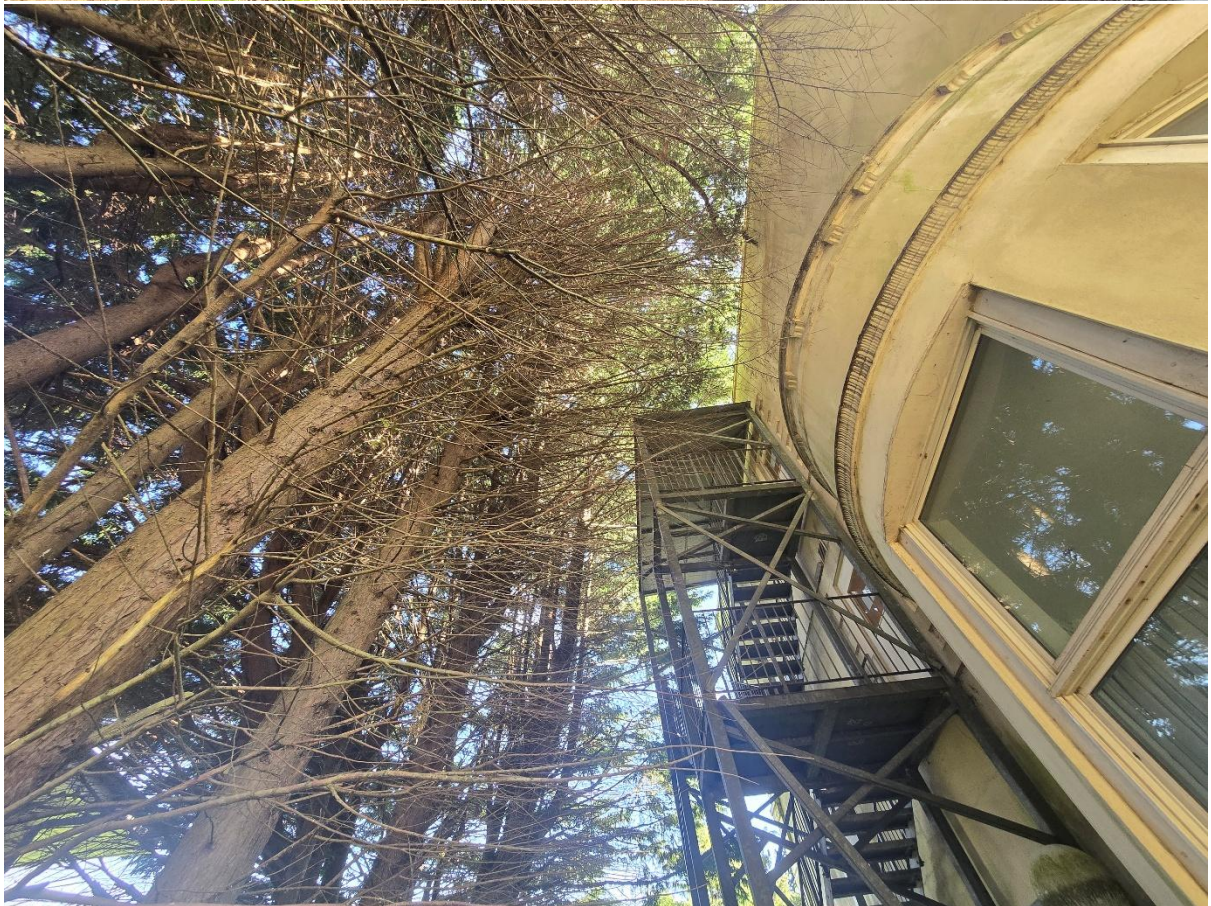
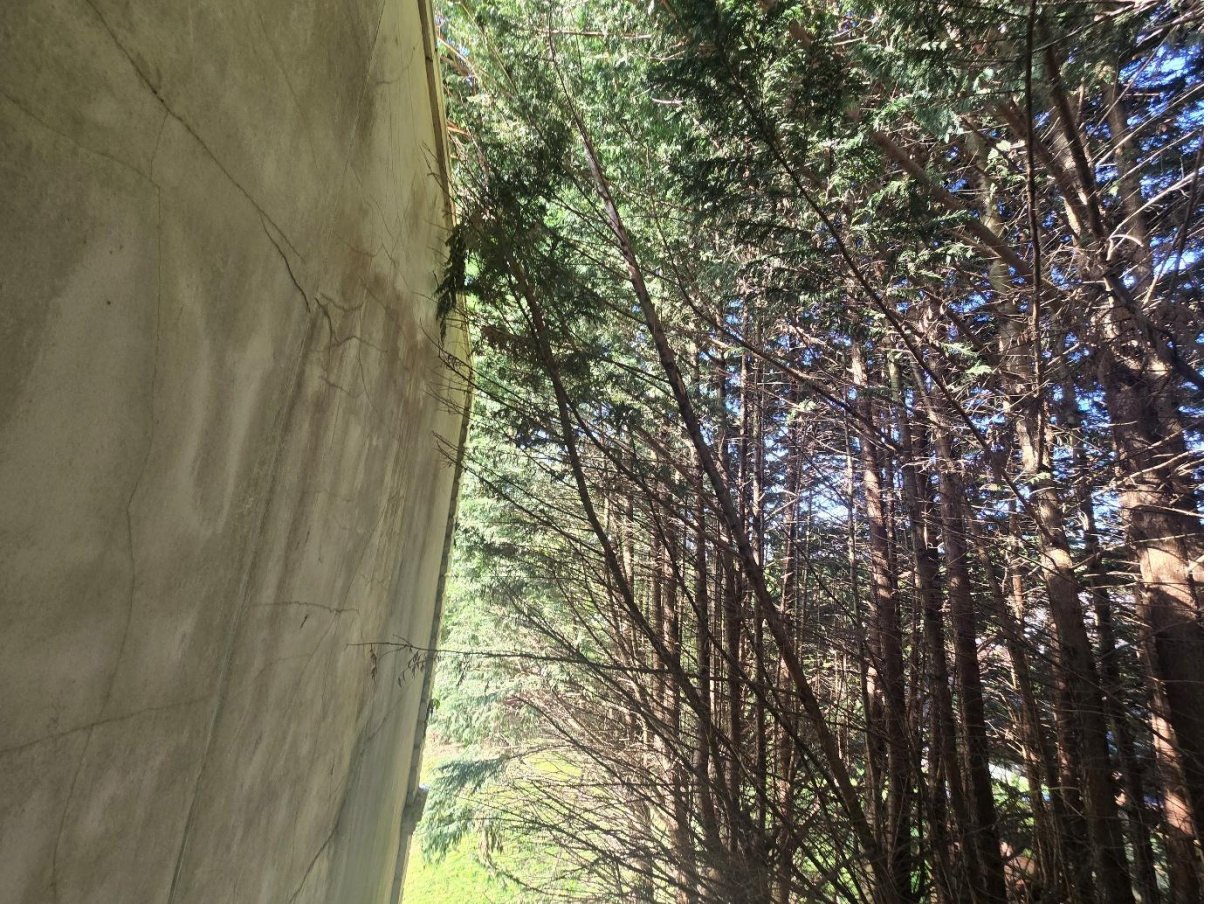
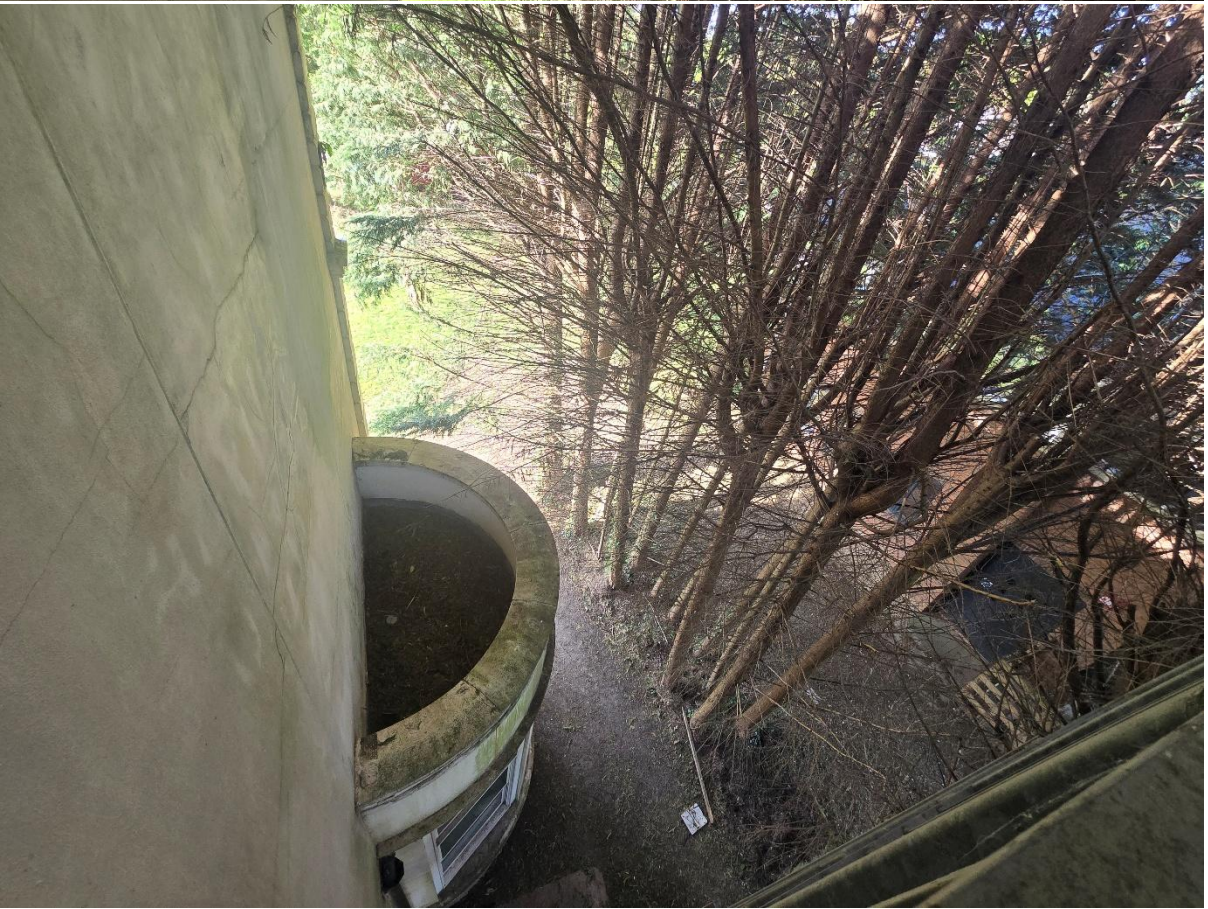
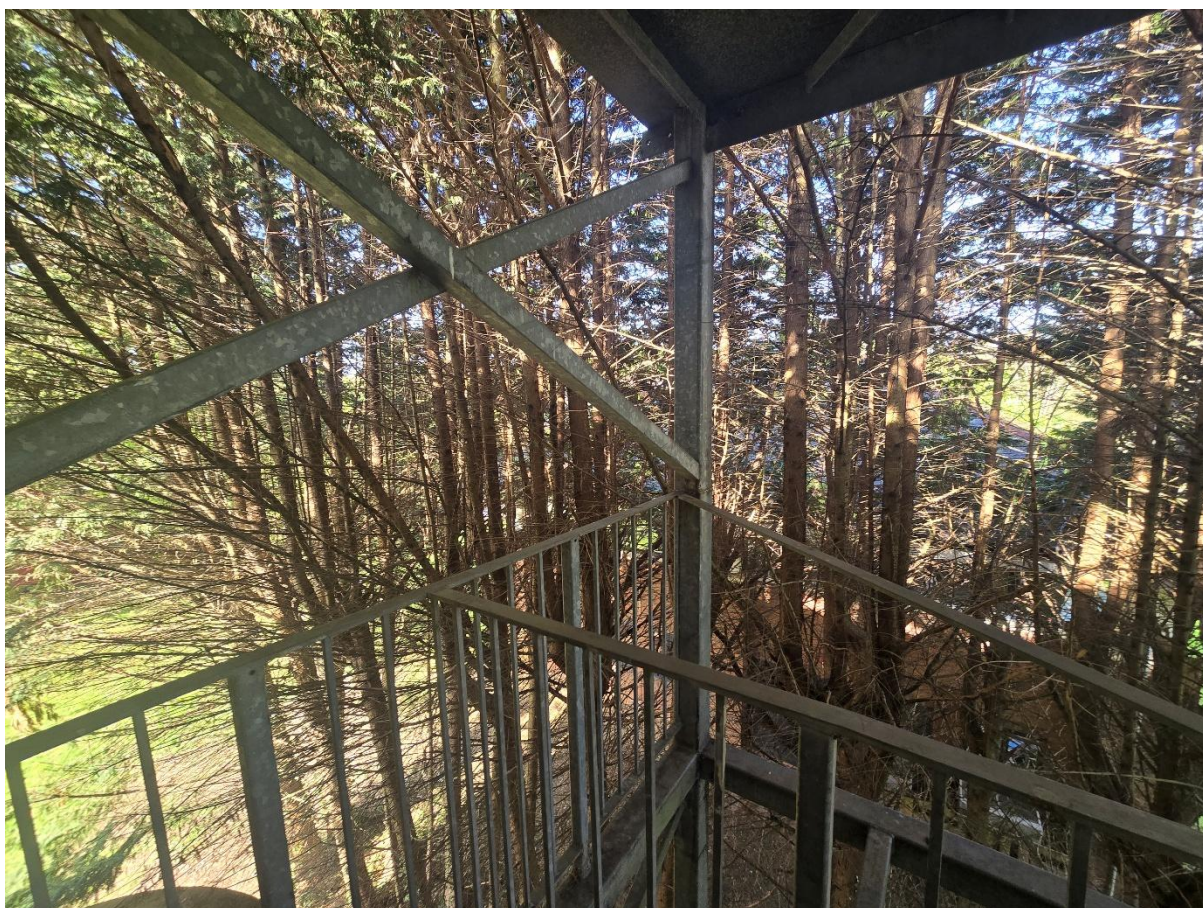
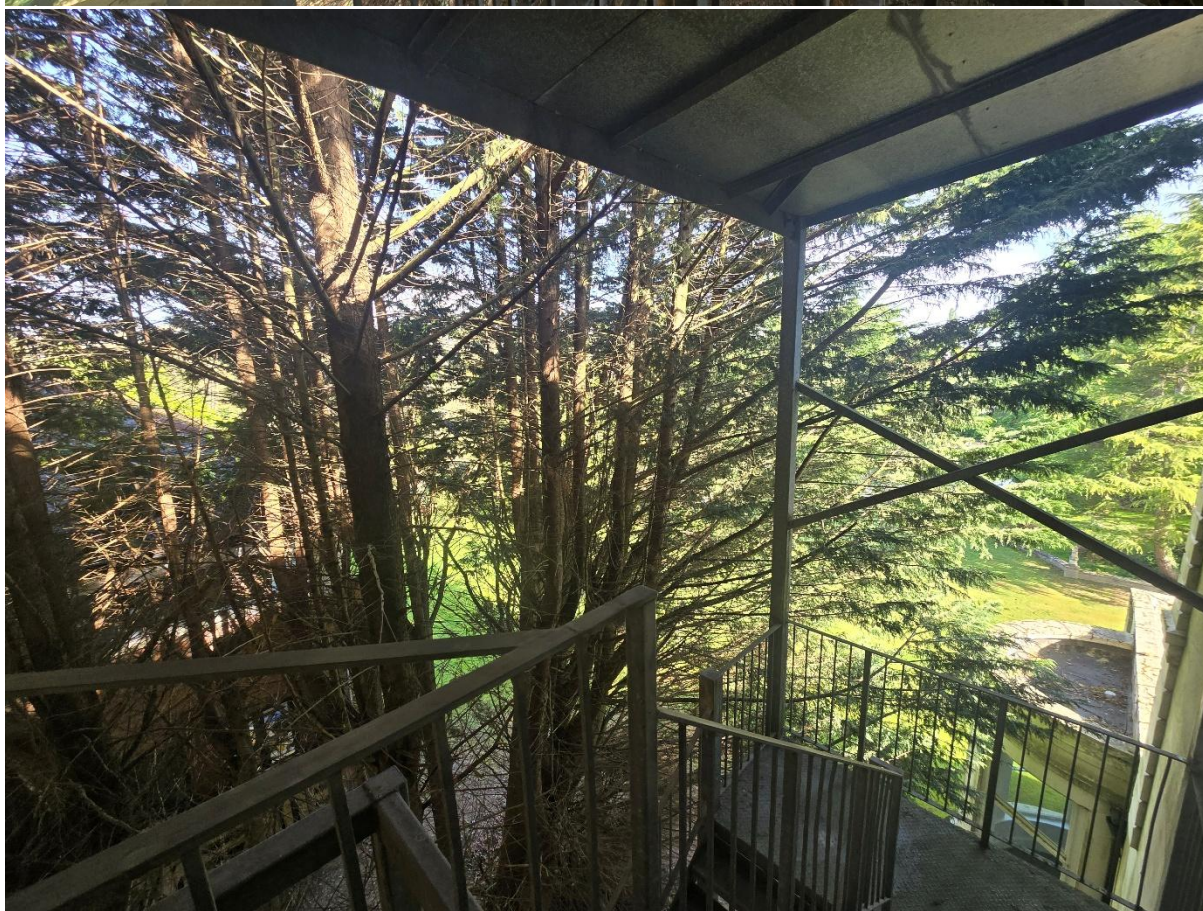
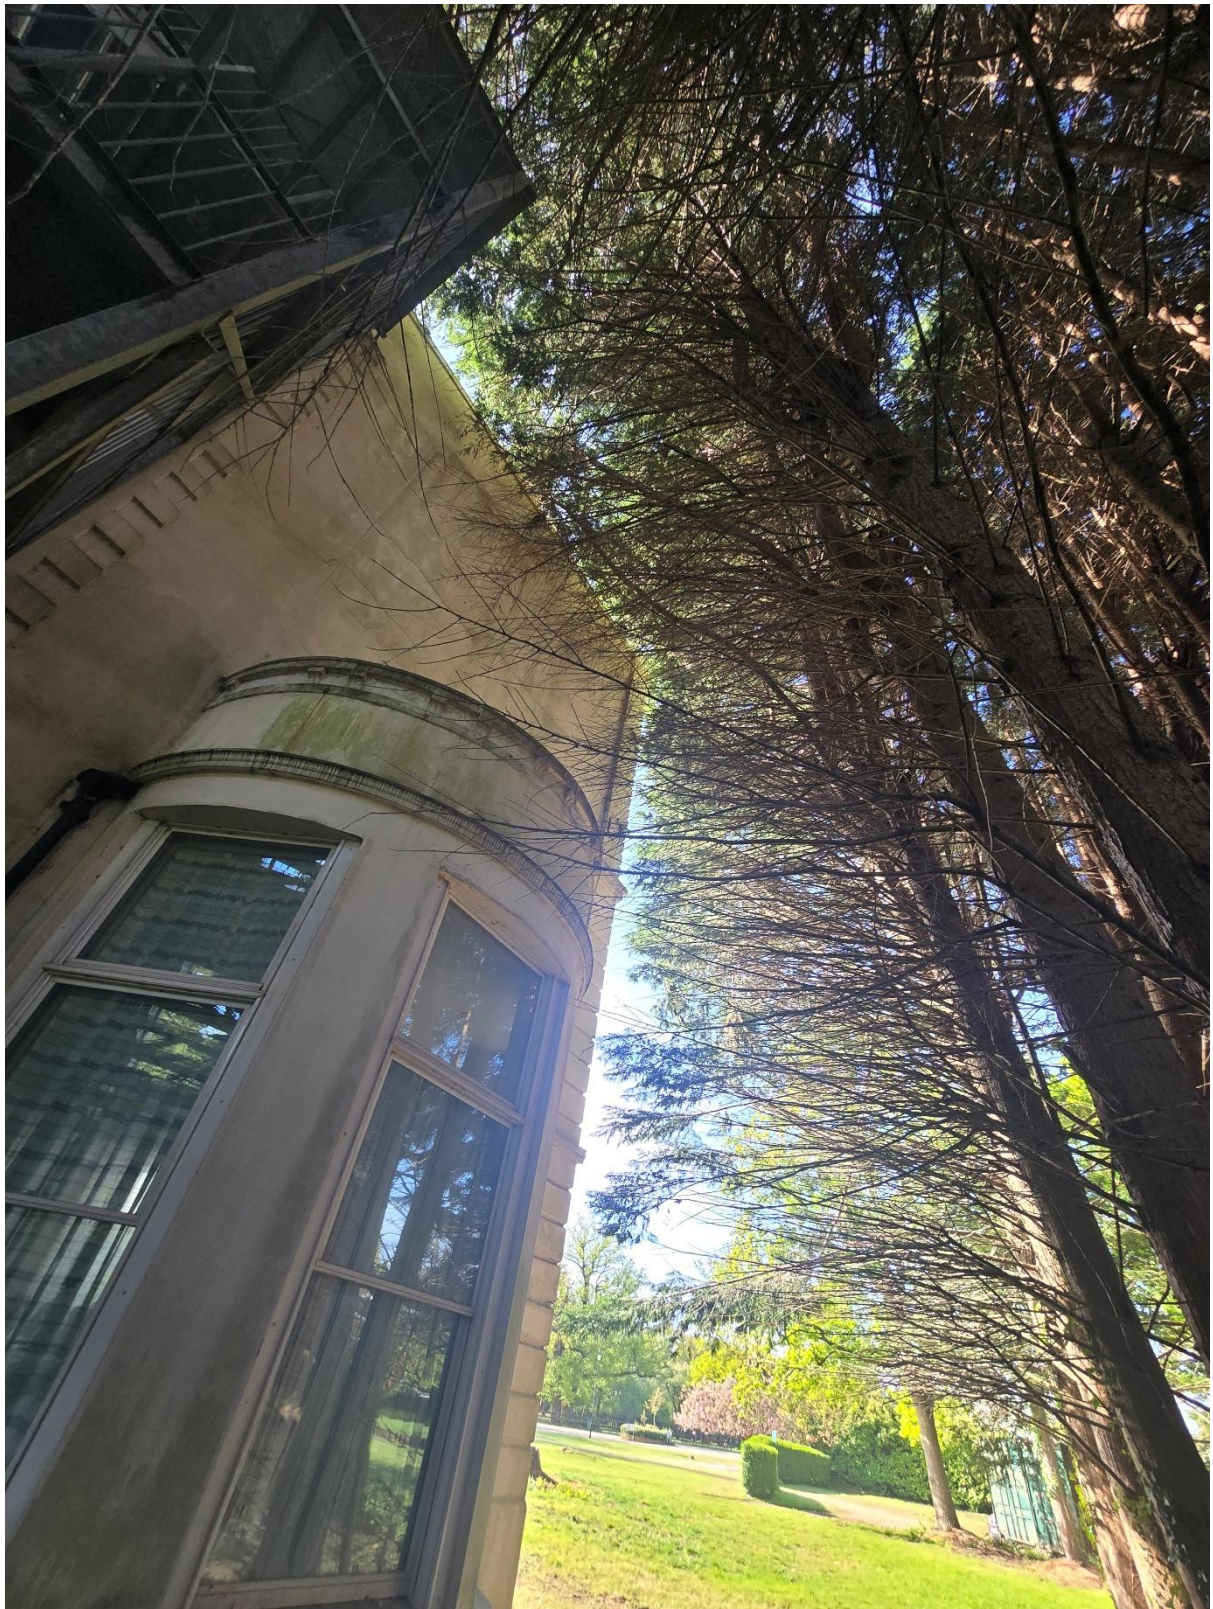
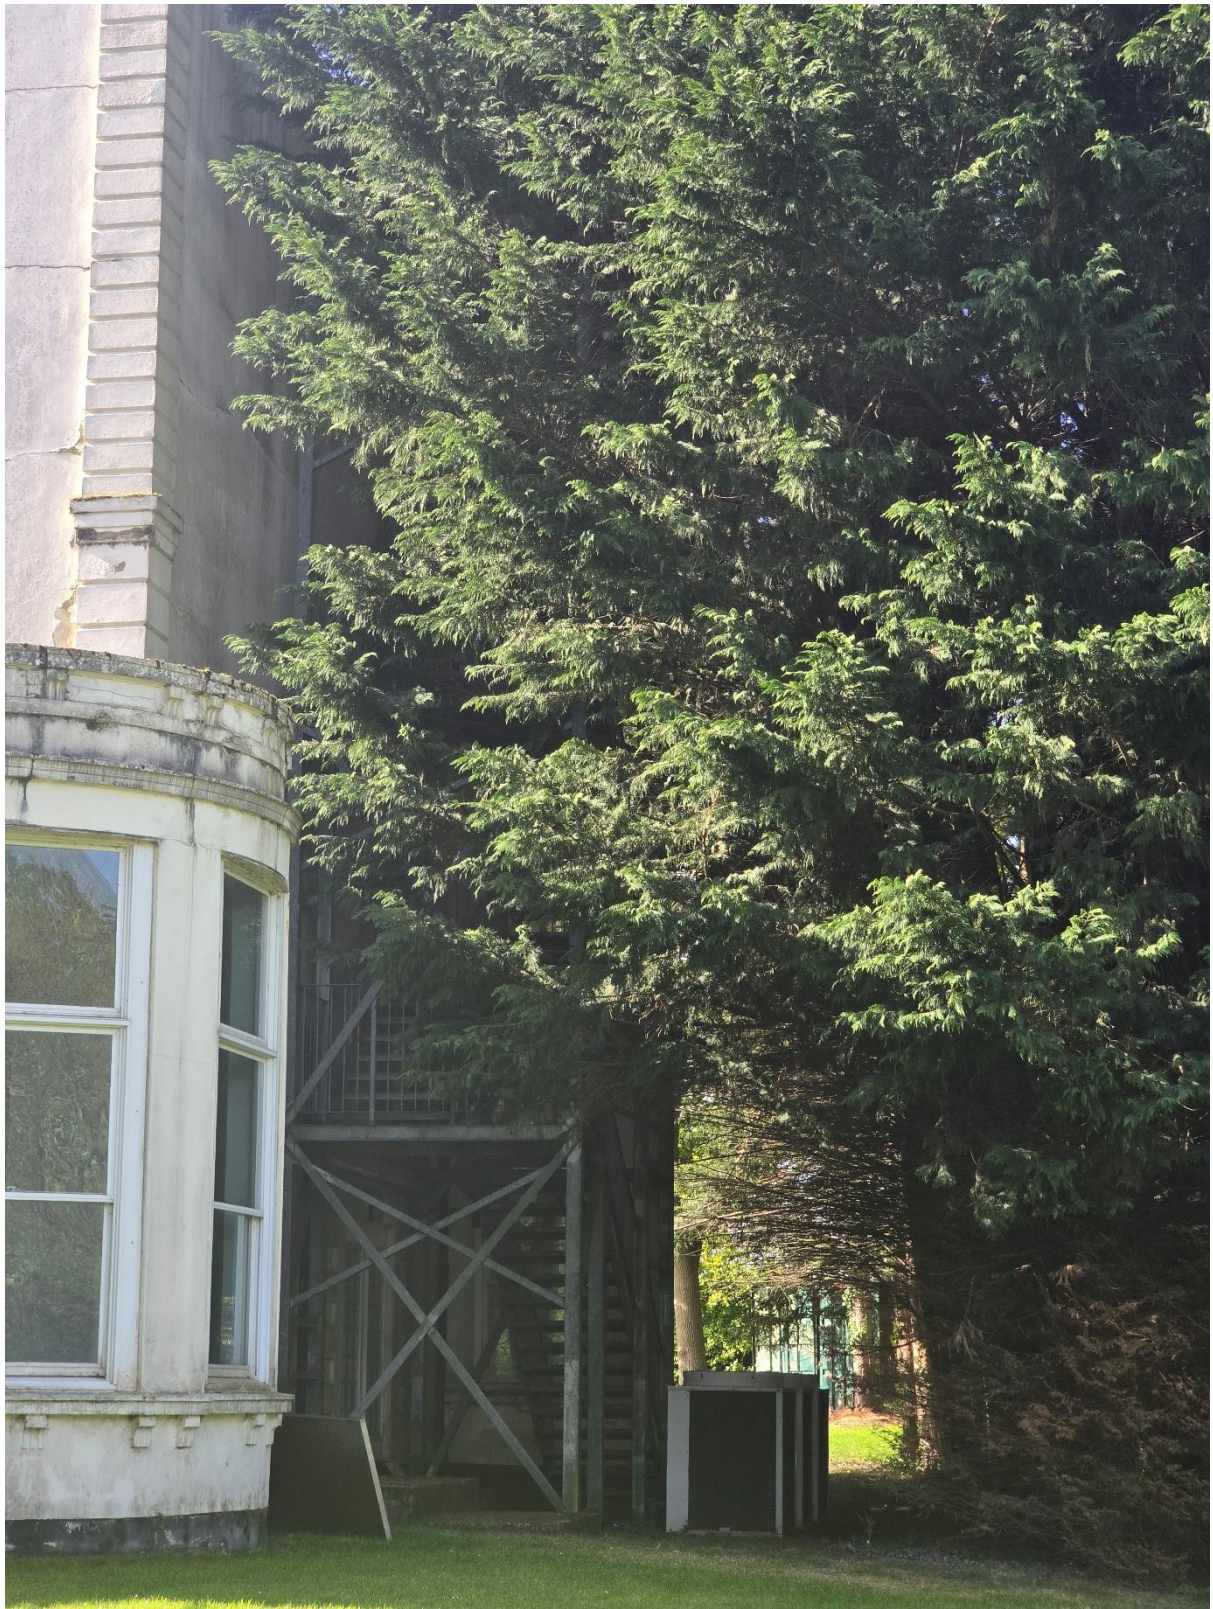
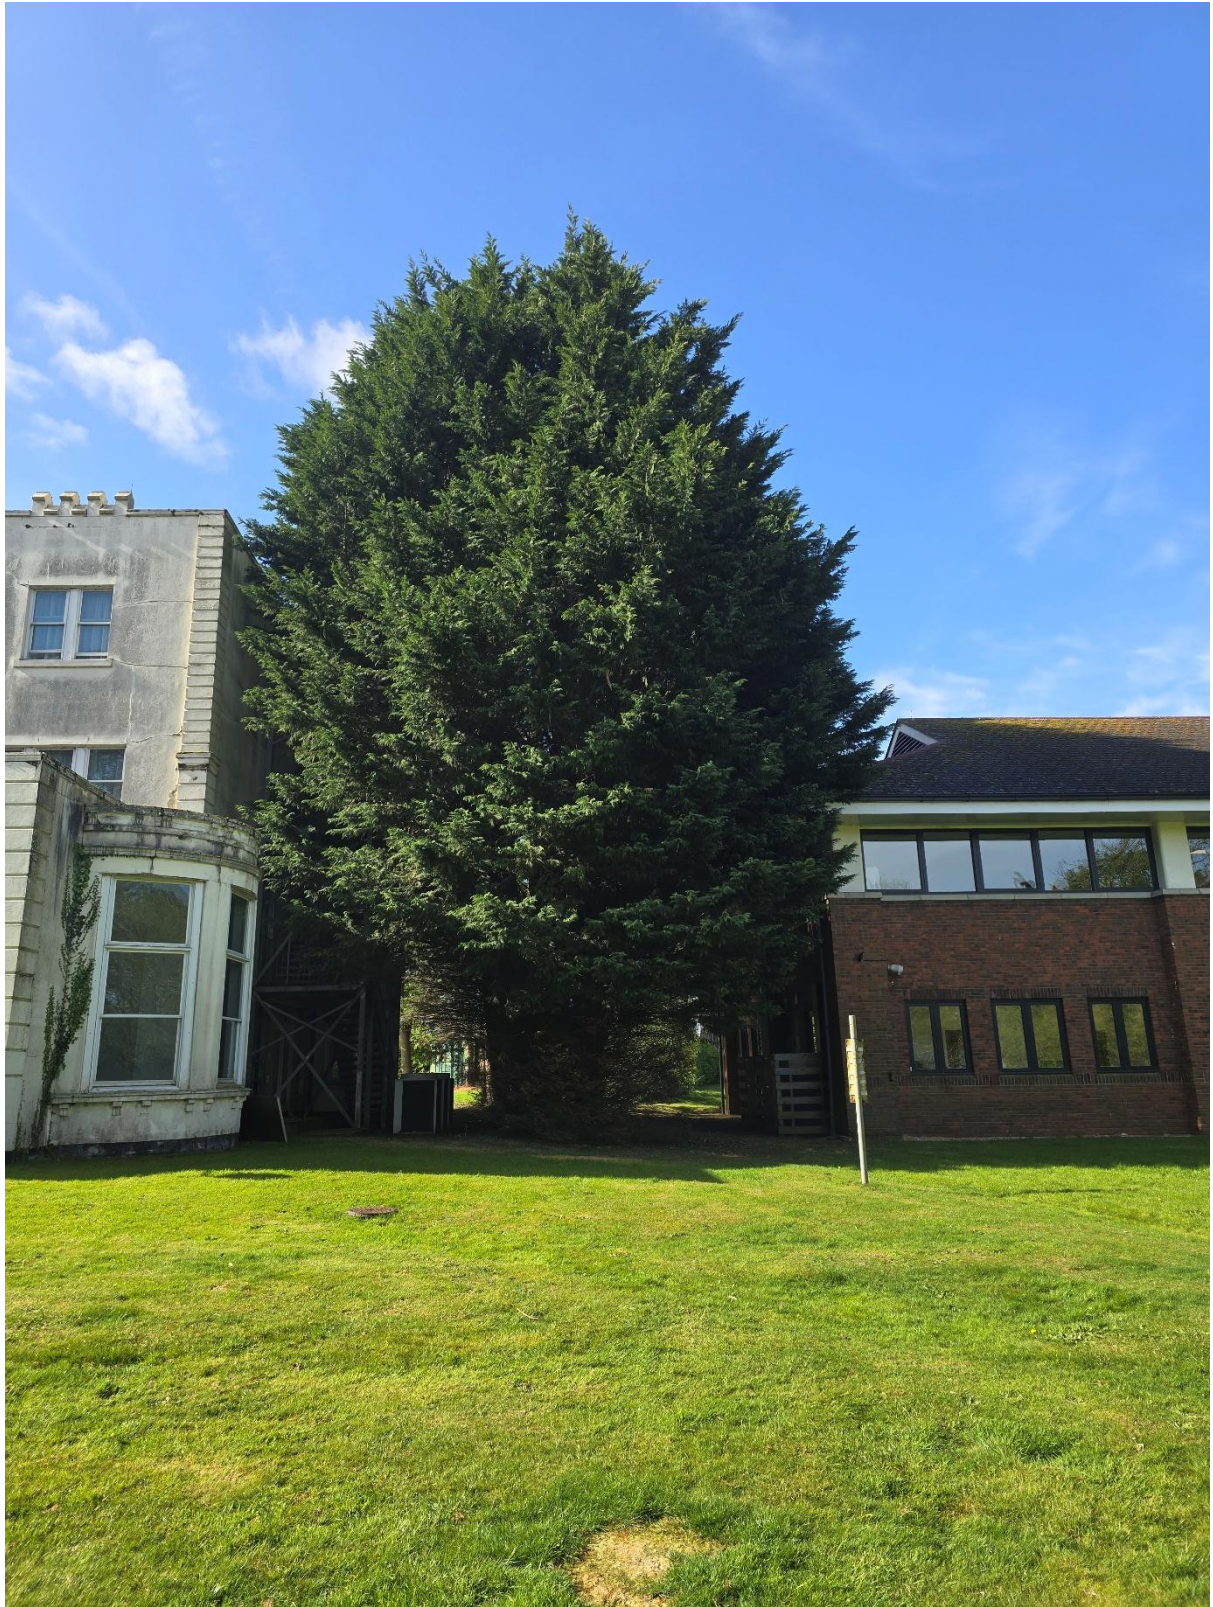
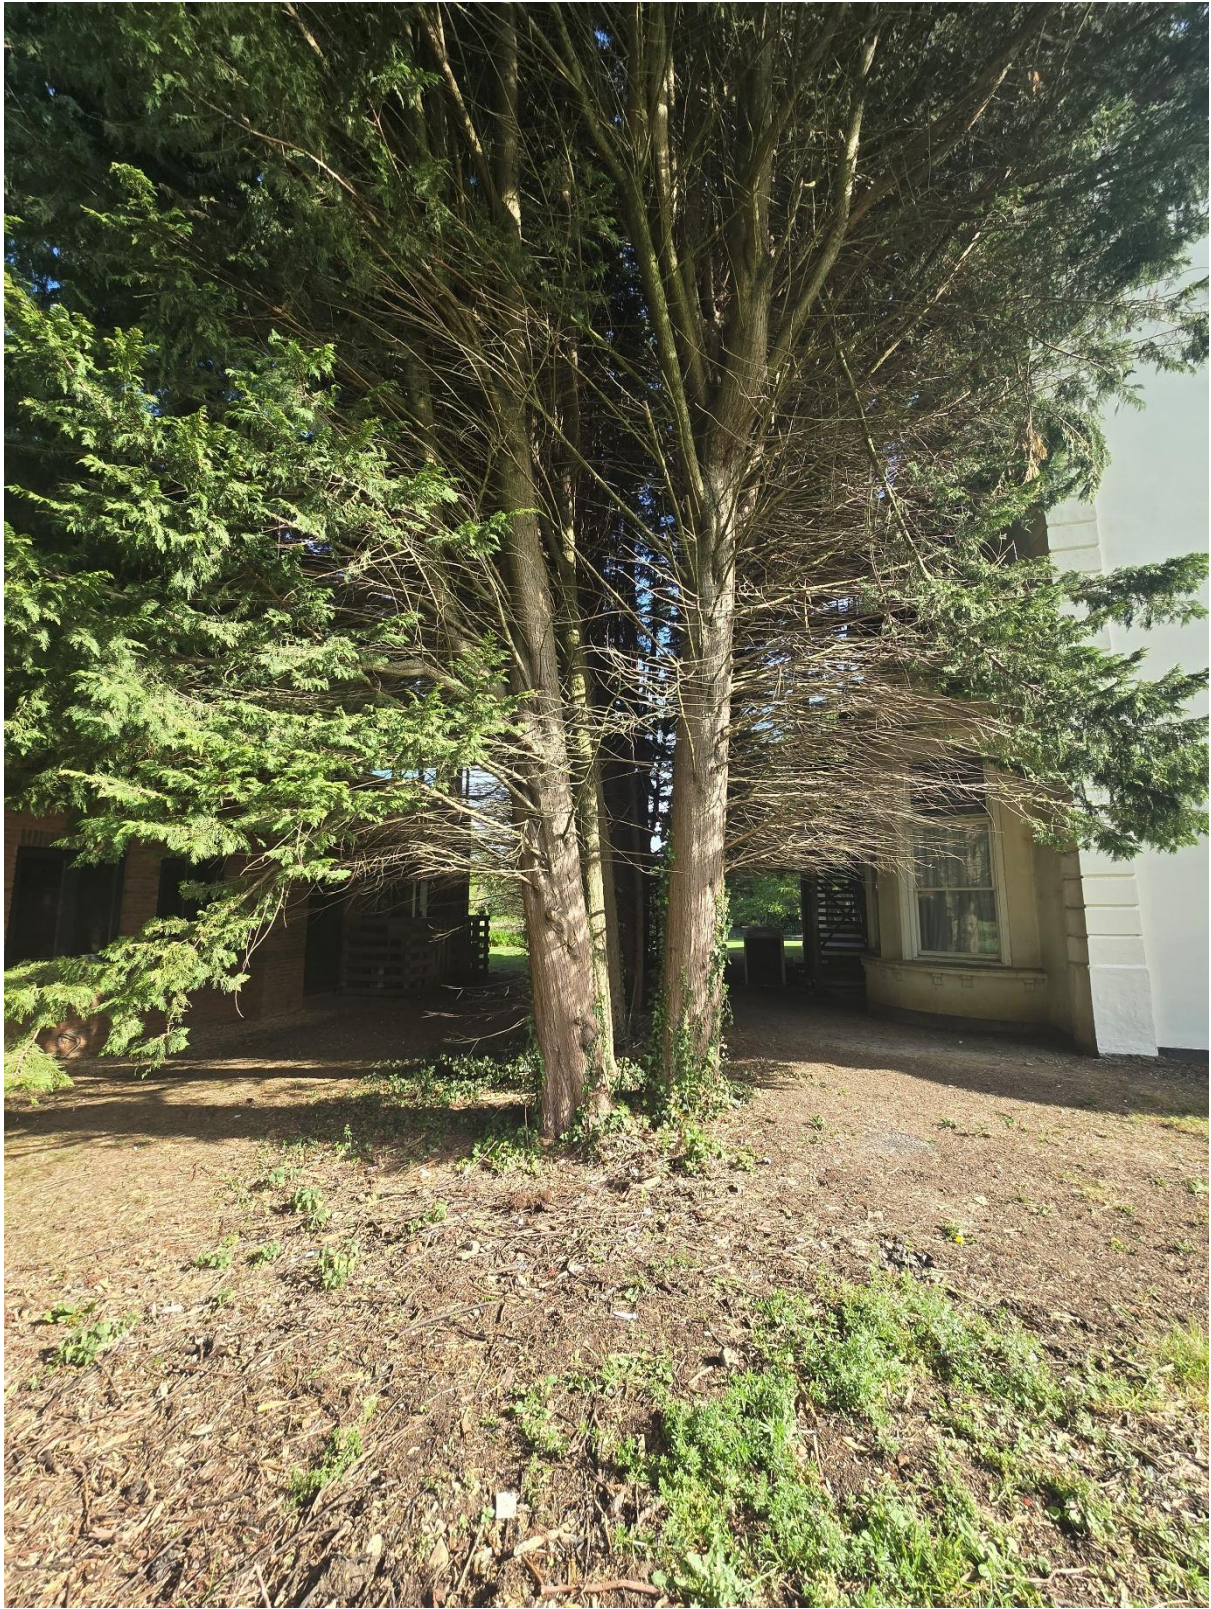
- **Obstruction of Fire Exit:**  
The trees' branches directly obstruct the hotel's designated fire exit, potentially delaying emergency response and compromising the safety of the hotel occupants.
- **Roof and Gutter Interference:**  
Several branches extend onto the roof, coming into contact with the gutter system. This interference may hinder proper water drainage and create further structural concerns, particularly during adverse weather conditions.
- **Encroachment on Adjacent Building:**  
Additional branches have been observed encroaching on the roof of an adjacent building, which poses a risk of structural damage to that property.

**Note:** This report is based solely on a visual inspection; no detailed assessment of the tree's root system has been conducted. Please refer to the attached pictures for visual documentation of these observations.

- **Tree Removal:**  
It is recommended to proceed with the expedient removal of the trees to eliminate the hazards identified, particularly the obstruction of the fire exit and the structural interference on the roofs.
- **Replacement Planting:**  
In order to honor our commitment to environmental sustainability, new trees should be planted as replacements for the removed vegetation. The location and species for

the replacement trees will be carefully selected to prevent future conflicts with building structures or safety protocols.
