# Eastleigh Borough Council Tree Preservation Order and Conservation Area Assessment Form

| <b>Application Number</b> | T/25/99191 |
| <b>Address</b> | 88 HILTINGBURY ROAD, CHANDLER'S FORD, EASTLEIGH, SO53 5NZ |

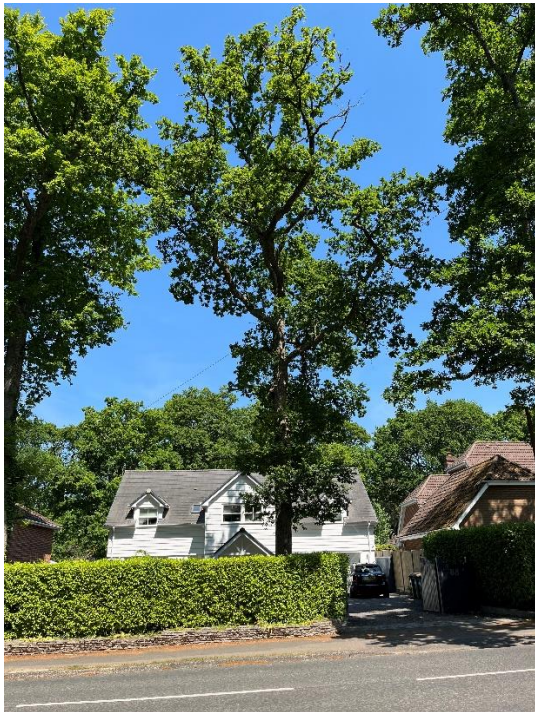
| <b>Officer comments</b> | <p>The application oak is protected within G5 of TPO ref: 265-E, confirmed 5<sup>th</sup> May 1994.</p> <p>The tree is sited in a private front garden, adjacent to Hiltingbury Road. It is clearly visible to the public. There are many large trees of similar species and maturity along this road and this gives the area a pleasant, leafy character. On the face of it, the subject oak offers a high level of public, visual amenity.</p> <div style="text-align: center;"> </div> <p>Fig 1. 14<sup>th</sup> May 2025, looking north from Oakwood Road junction</p> <p>The tree measures approx. 16m tall and has a stem diameter of approx. 65cm dbh (both dimensions estimated by eye). The crown leans slightly</p> |

towards the road. It shows signs of reduced vitality as it is becoming stag-headed and many of the leaves chlorotic. There is dysfunction evident around much of the root collar and black bark bleeds on the lower stem.

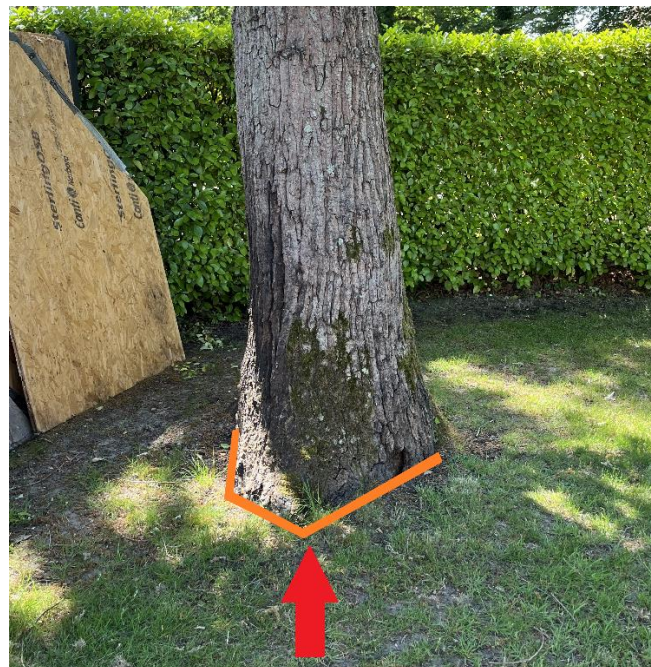
Fig 2. 14<sup>th</sup> May 2025, facing south

I’ve tapped around the base with a mallet and used a probe to assess the condition. There is loose, necrotic bark from the east – north – west aspects of the root collar. The northern buttress is decayed. This buttress is subject to tension as it is on the opposite side of the lean. The below image shows the extent of bark necrosis as an orange band and the position of the decayed tension root marked with a red arrow. Black bleeds visible on left side of stem:

There is a large patch of bark bleeds on the east side to 1.2m above ground level. There can be multiple causes for these, including *Phytophthora*, bacterial wetwood, honey fungus and drought. No formal

| | <p>diagnosis has been provided but regardless it is indicative of vascular dysfunction in the affected area. This can occur due to attack by root pathogens such as honey fungus and/or due to water stress.</p> <p>The extent of dysfunction broadly matches with the alignment of the driveway. It seems likely that historic root damage is now having a noticeable impact on the tree; water stress caused by root damage/dysfunction and/or colonisation of damaged/dysfunctional roots by honey fungus (although no toadstools or rhizomes were observed).</p> <p>Unfortunately, the death of the tension buttress, widespread dysfunction around the root collar and signs of stress in the crown do not give me confidence in its stability. Had the root collar dysfunction only affected a discrete area and/or there had been signs of significant woundwood formation, this would have led to be believe that recovery could be expected. Similarly, if the vitality of the tree had been normal, this might imply that the root system was still functioning as it should. Unfortunately, this is not the case.</p> <p>There seems to be a material risk of the tree failing at the base due to deterioration of buttressing and connected structural roots. The tree leans towards a residential road junction and the consequences of whole tree failure could be severe. The risk of tree failure could be reduced in the short term by reducing the crown. This would reduce loading on the presumed compromised root structure. However, the tree is clearly in poor physiological health and this work would only increase the amount of dysfunction and accelerate decline. For these reasons, the proposal to fell the tree is reasonable. This can be conditional on replacement planting.</p> | | | | | |

| Conditions | Replace with elm, maidenhair or Acer x freemanii. | | | | | |
