W76846\241213 SSI (1/6)  
13 December 2024

## SPECIFIC STRUCTURAL INSPECTION

118 PARK ROAD  
CHANDLERS FORD  
EASTLEIGH  
SO51 1HY

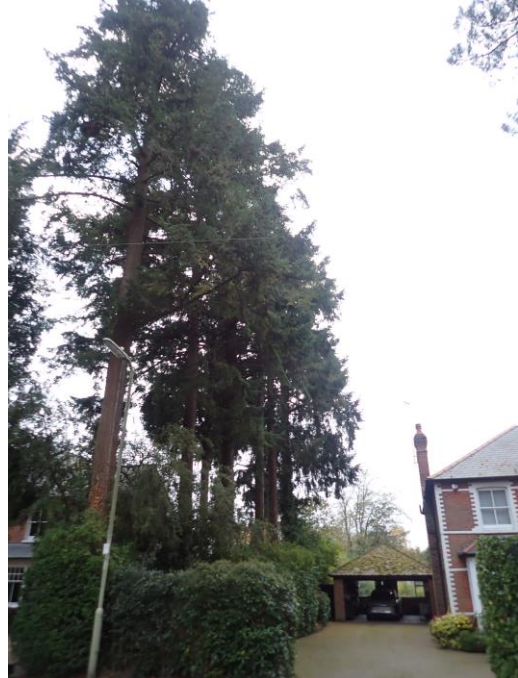
- 3.1** The trees of concern are located about 8m from the left side of the house. The ground between the trees and the houses is a block paved driveway.

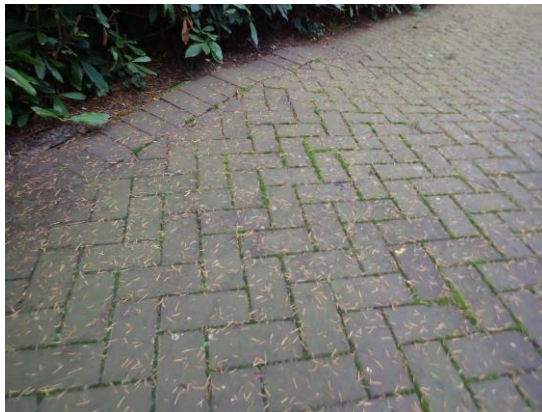
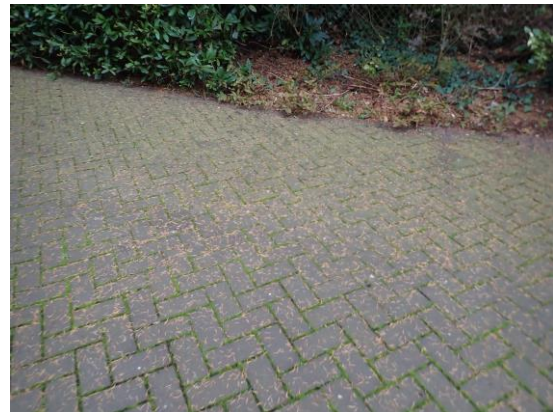
- 3.2** The driveway is being lifted by the root growth from the trees.

- 4.1** The roots from the neighbour's trees are damaging the driveway by means of their roots lifting the block paving.
- 4.2** The foundations of the house are not deep enough to cope with the soil conditions and close proximity of the neighbour's trees.
- 4.3** The roots of the neighbour's trees are likely to be causing foundation movement, by means of drying out and shrinking the clay soil, resulting in the external and internal cracking to the left side of the house.
- 4.4** It is recommended that the neighbour's trees be removed to prevent further and more serious damage to the driveway and building.

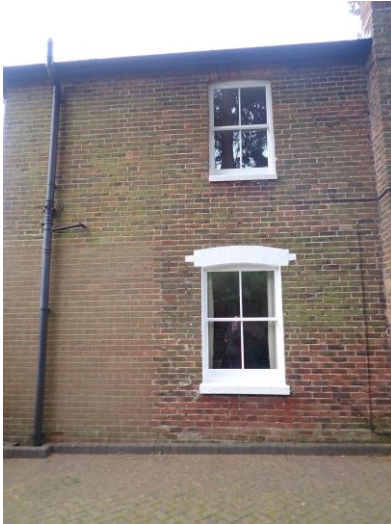
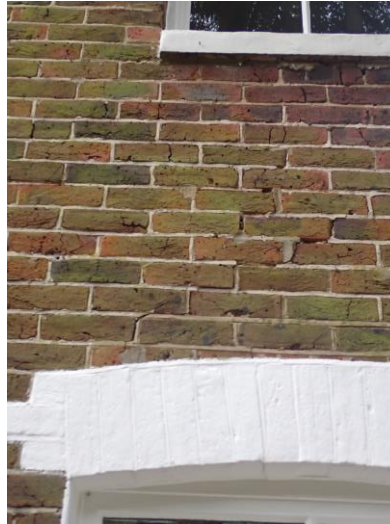
- 3.3** To the left side wall there is stepped diagonal cracking over the ground floor window opening.

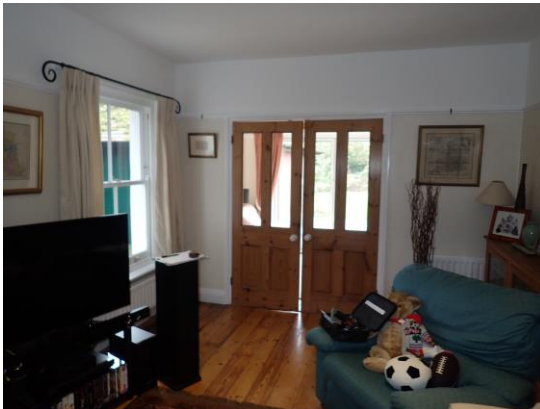
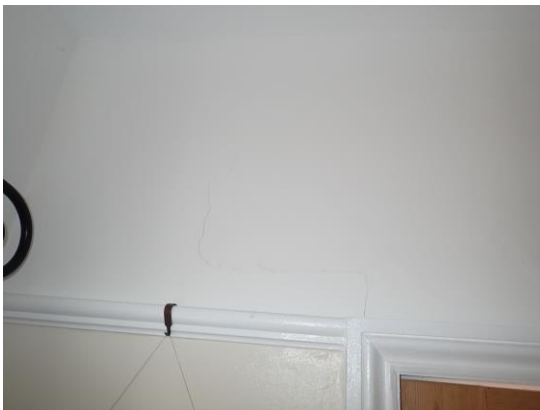
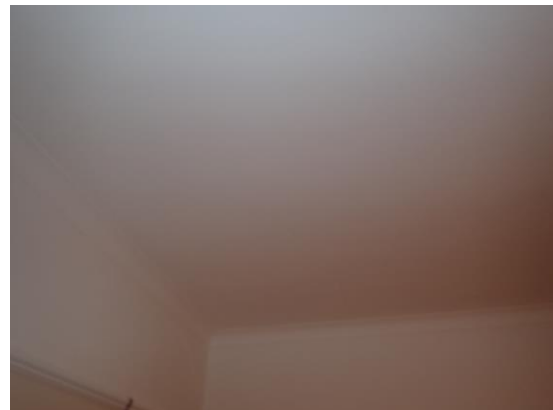
- 3.4** In the left side living room there is cracking to the rear wall, above the picture rail, either side of the double-door opening.

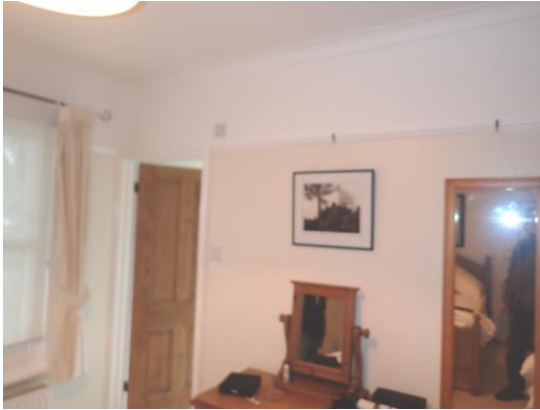
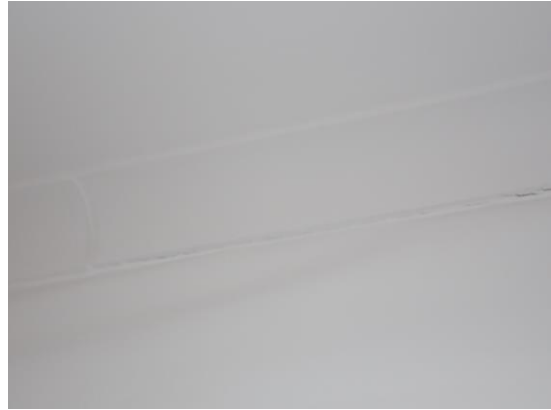
- 3.5** In the left side, first floor, bedroom there is cracking along the coving of the rear wall, close to the left side.
