**VERIFICATION REPORT**

**BOORLEY GARDENS, WINCHESTER ROAD**

**HEDGE END, SOUTHAMPTON, SO32 2UA**

**BELLWAY HOMES**

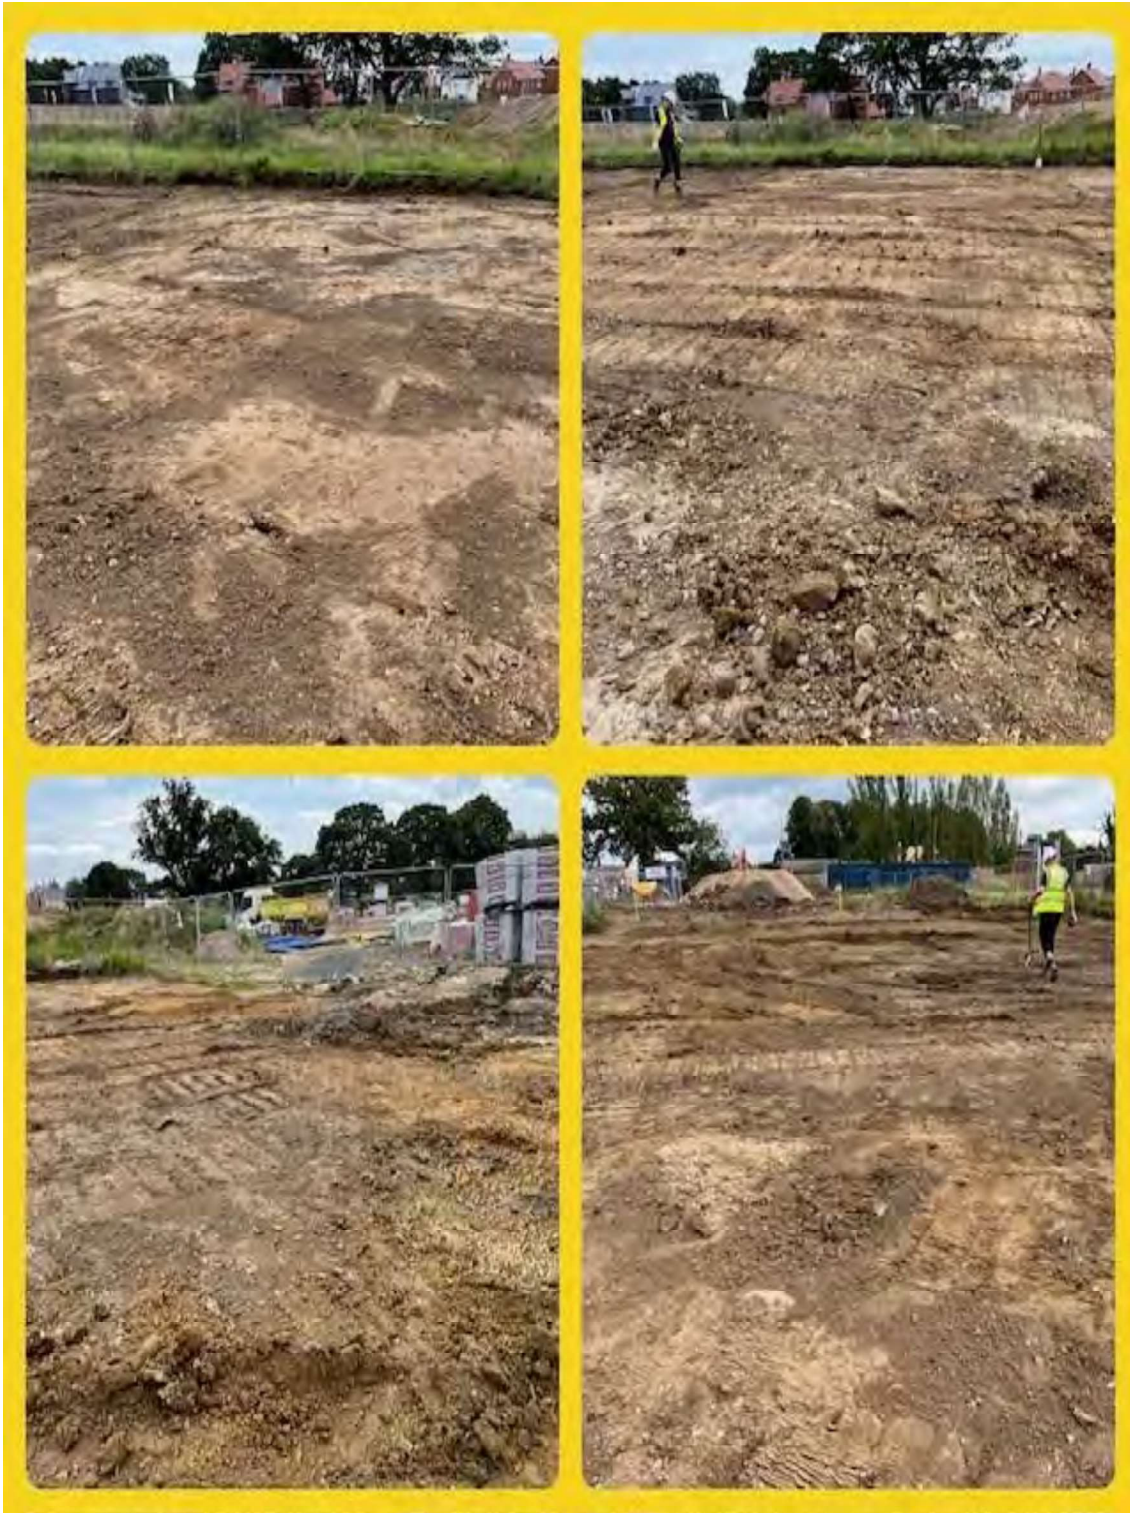
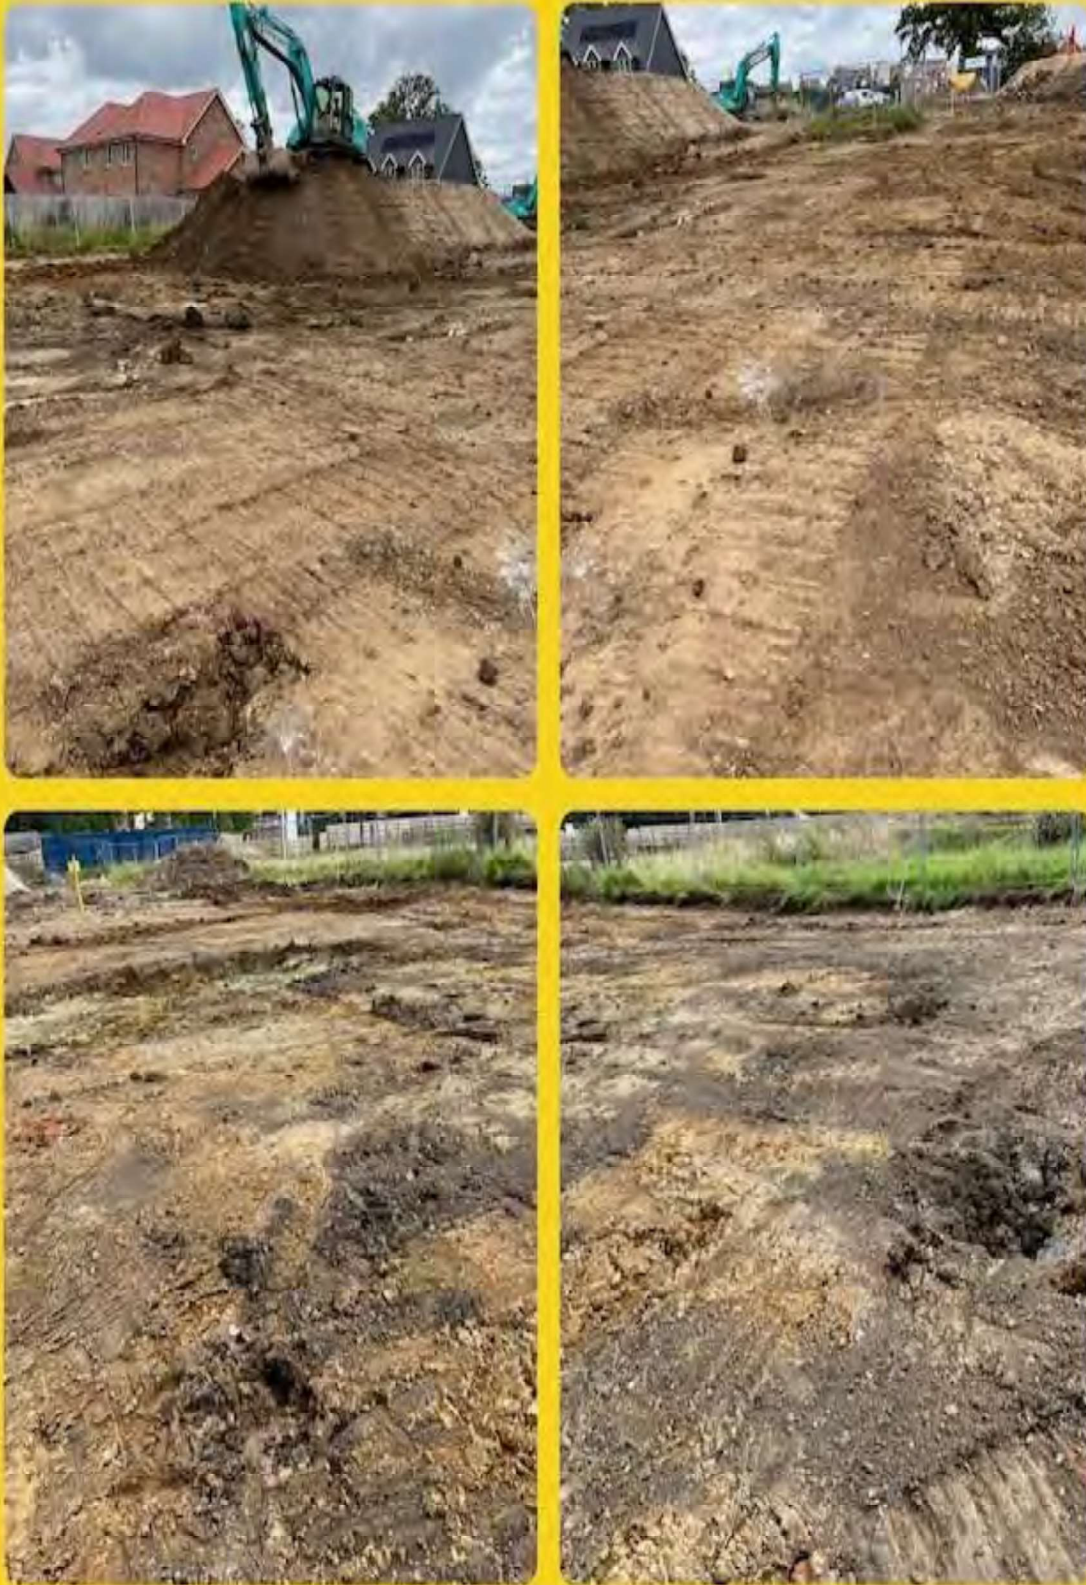
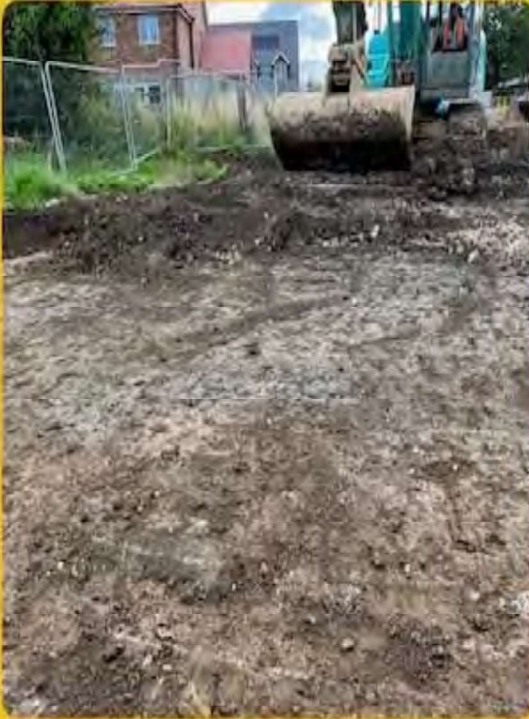
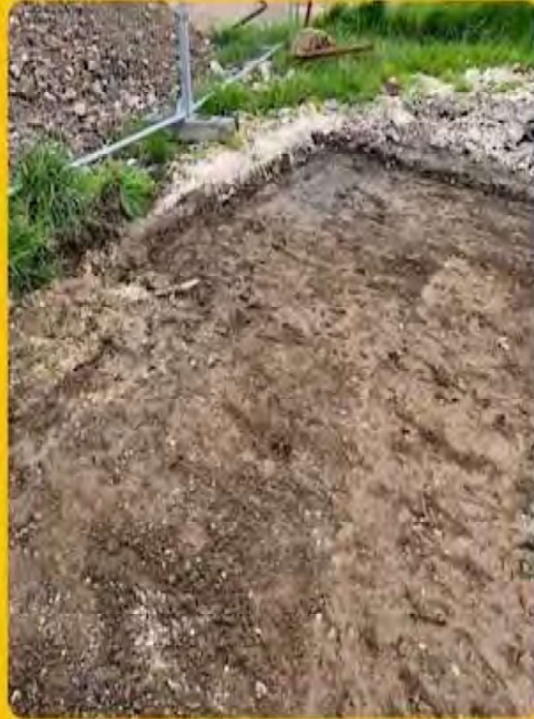
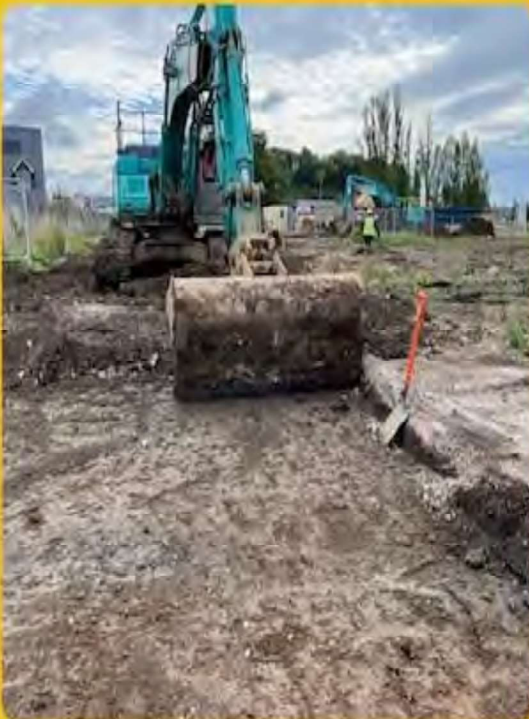
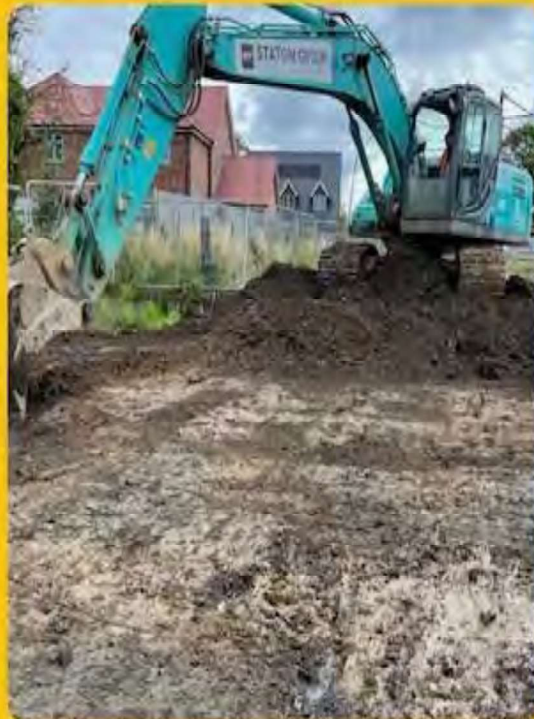
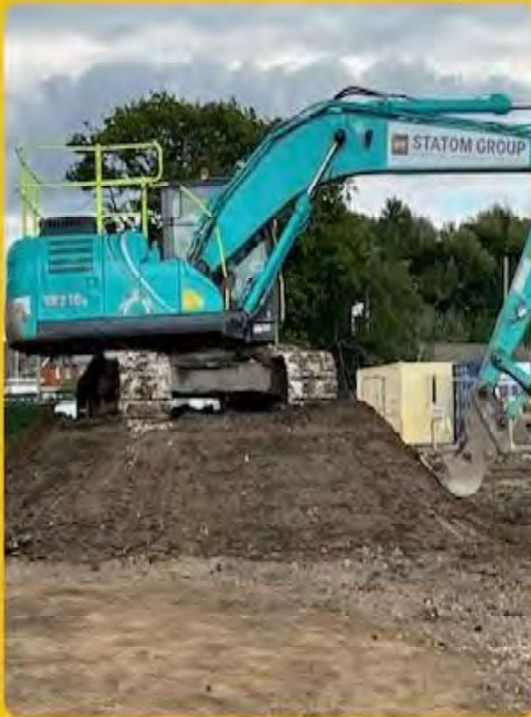
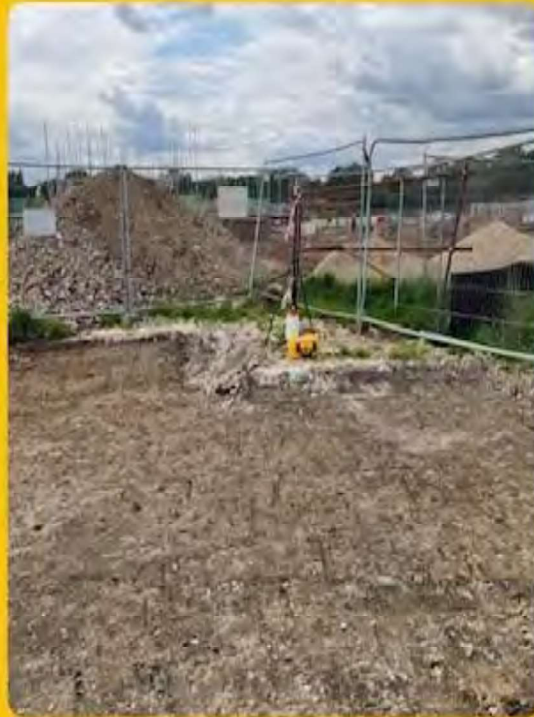
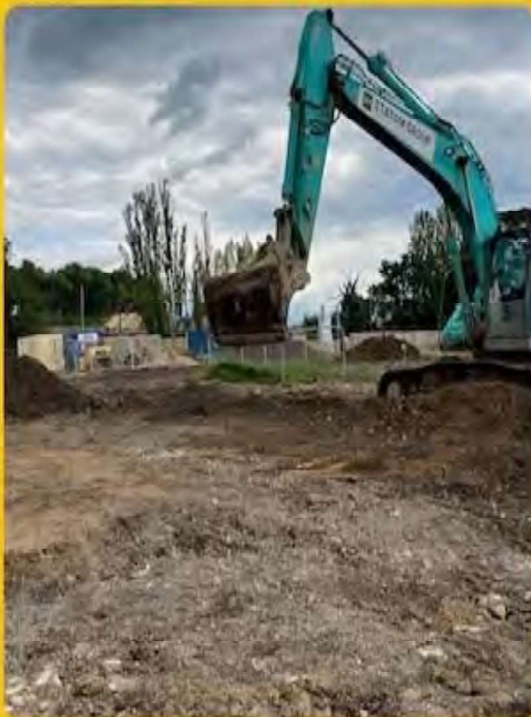
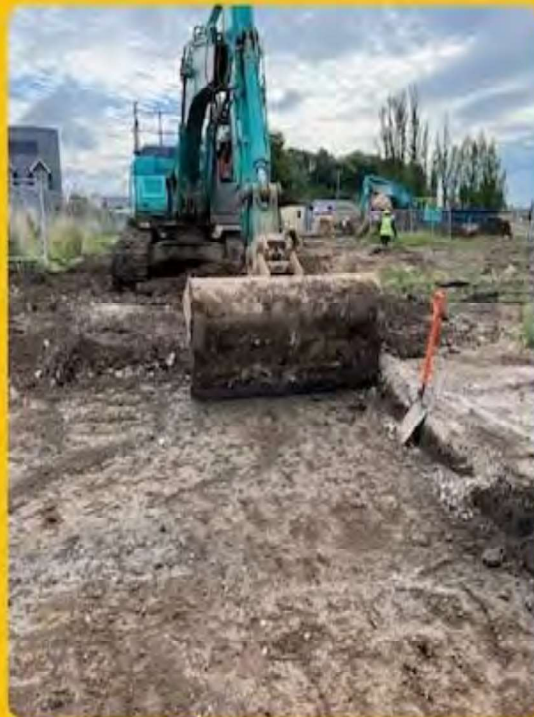
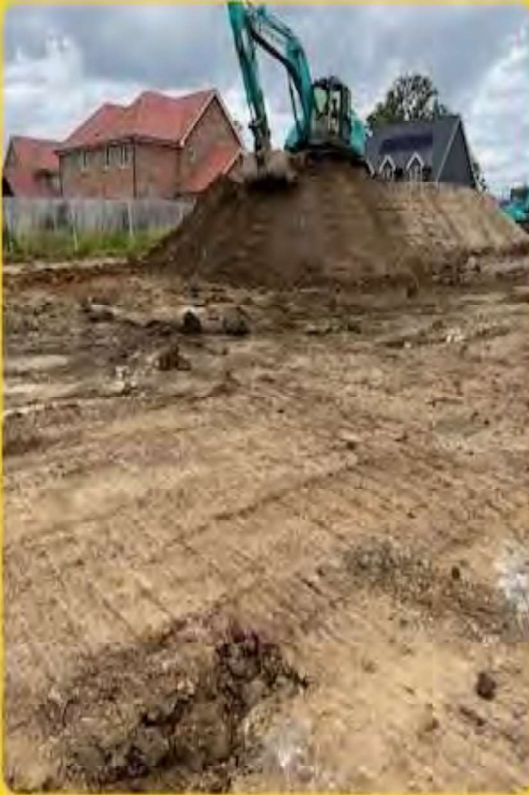
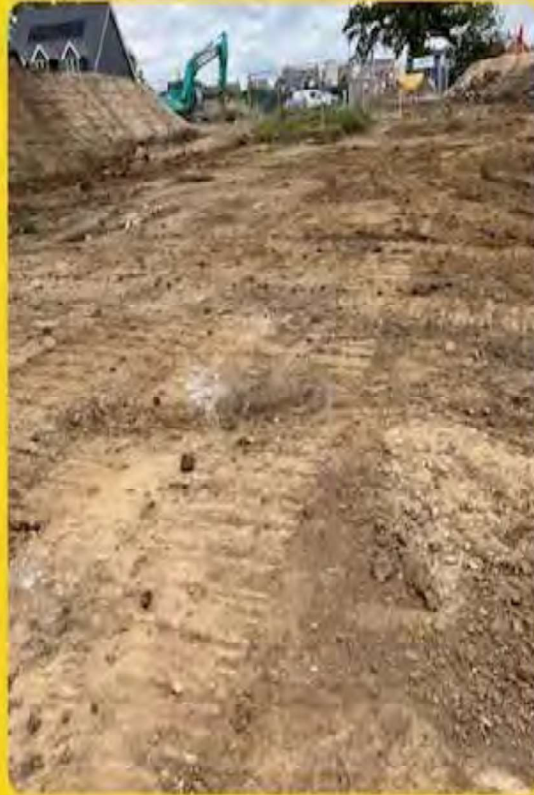
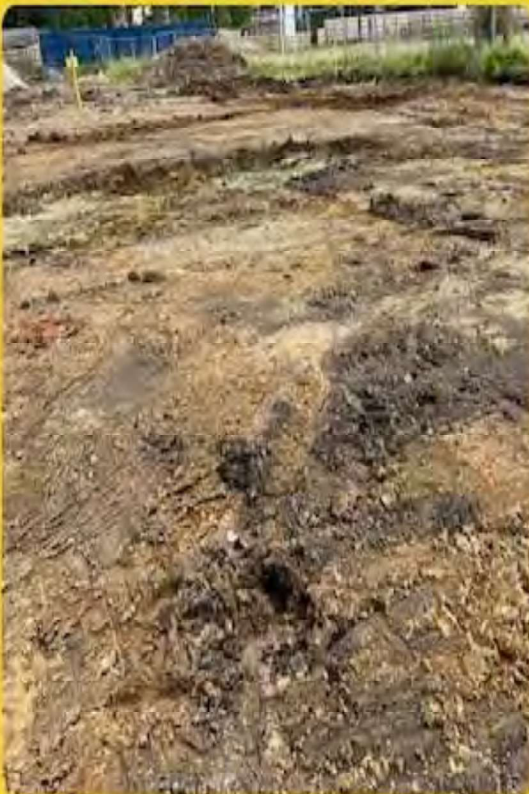
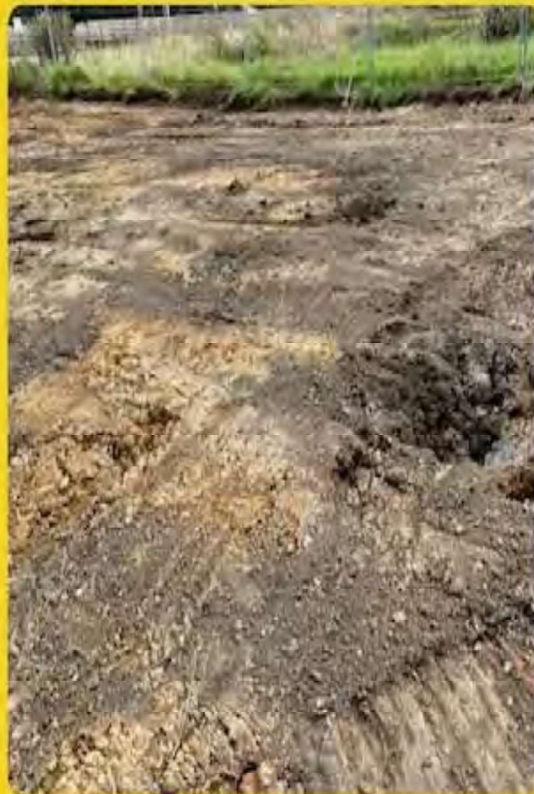
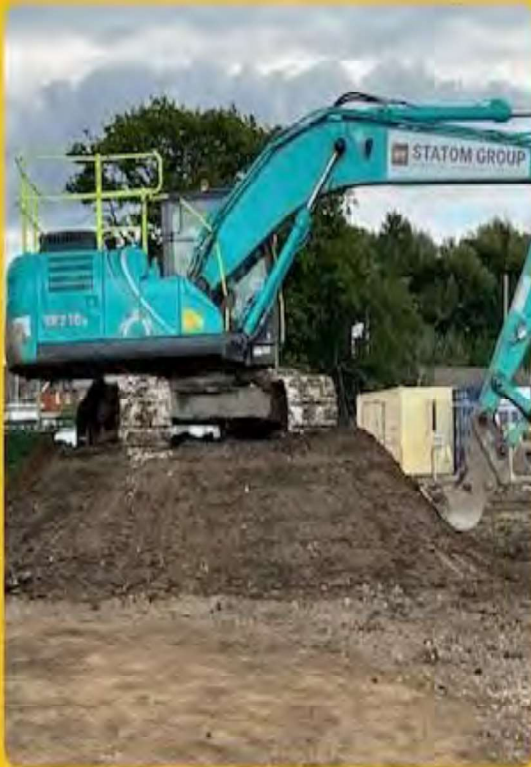
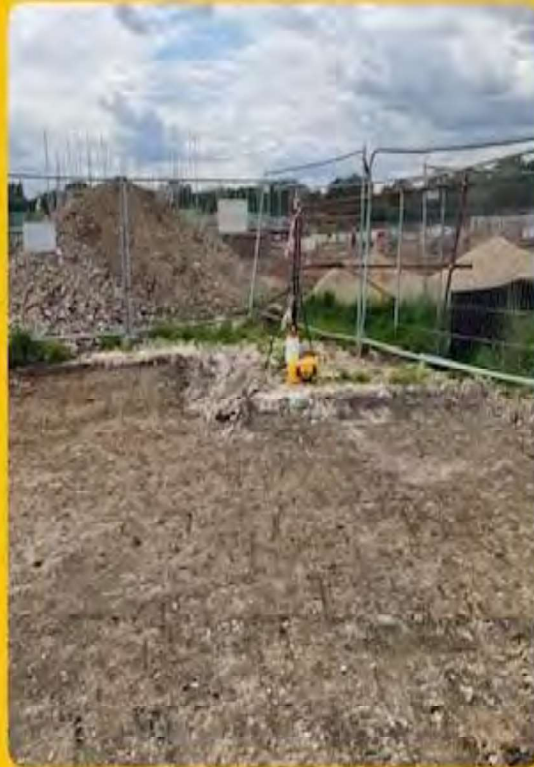
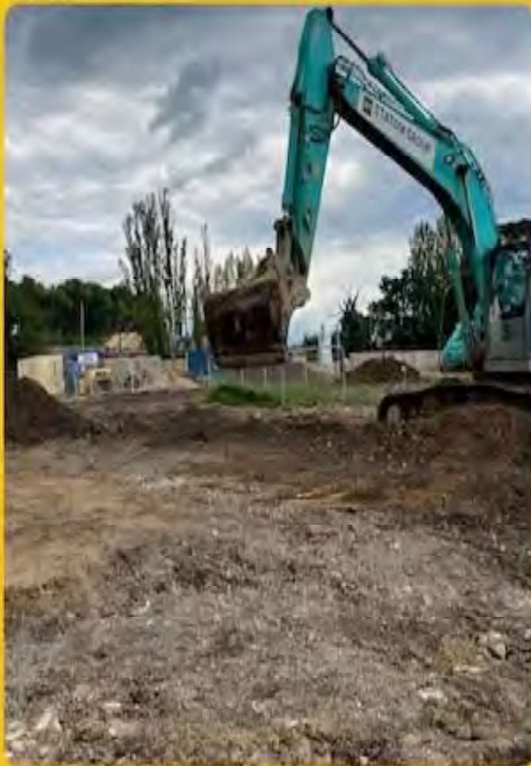
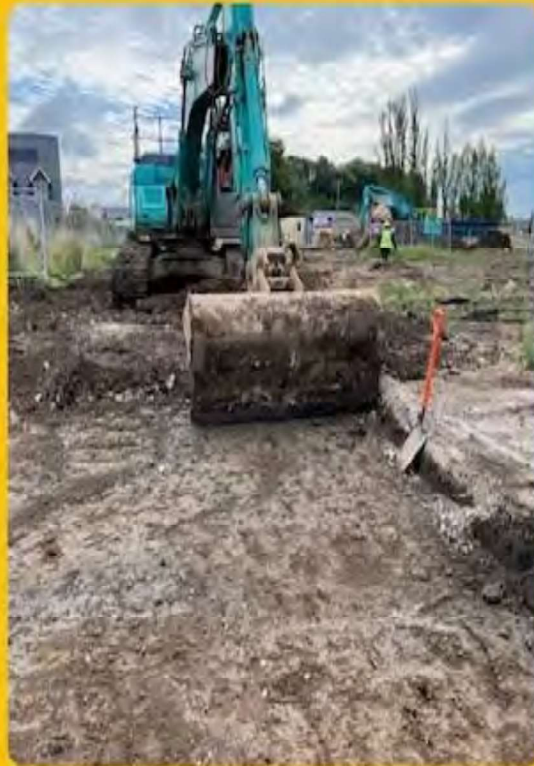
**ST176 Park Farm QA - ITP photo Library of Area A RLD back to Virgin ground**

- From the testing some of the material in Area A was identified to contain visible chrysotile asbestos fragments. This area was dampened down with water suppression and real time air monitoring set up. The material was then carefully segregated out and disposed of site to Dunton Technologies Waste Treatment Facility using an 8-wheel tipper lorry. Hazardous Waste Consignment Notes were issued during this process as shown in Appendix D. All hazardous soils removal from this area occurred on the 9<sup>th</sup> August 2023.
