# Geotechnical Survey Report

| FSI Ref: | 26255 |
| Risk Address: | 34 Lakewood Road<br>Eastleigh<br>Hampshire<br>SO53 1EW |
| Claim Ref: | SU2206173 |

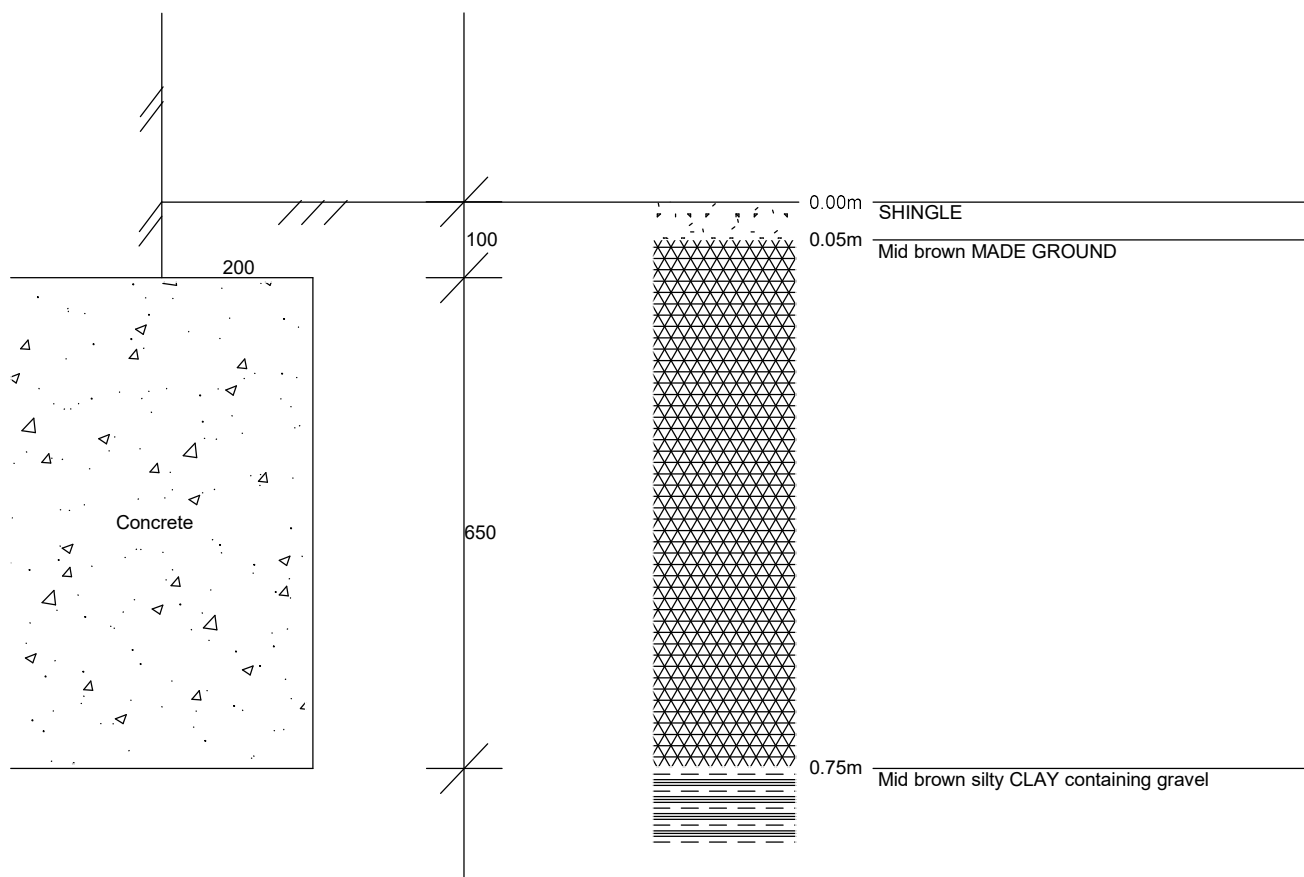
## TRIAL PIT 1

D1 @ F.L. (0.75m)

V = 58-65kPa

Founding strata: Mid brown silty CLAY containing gravel

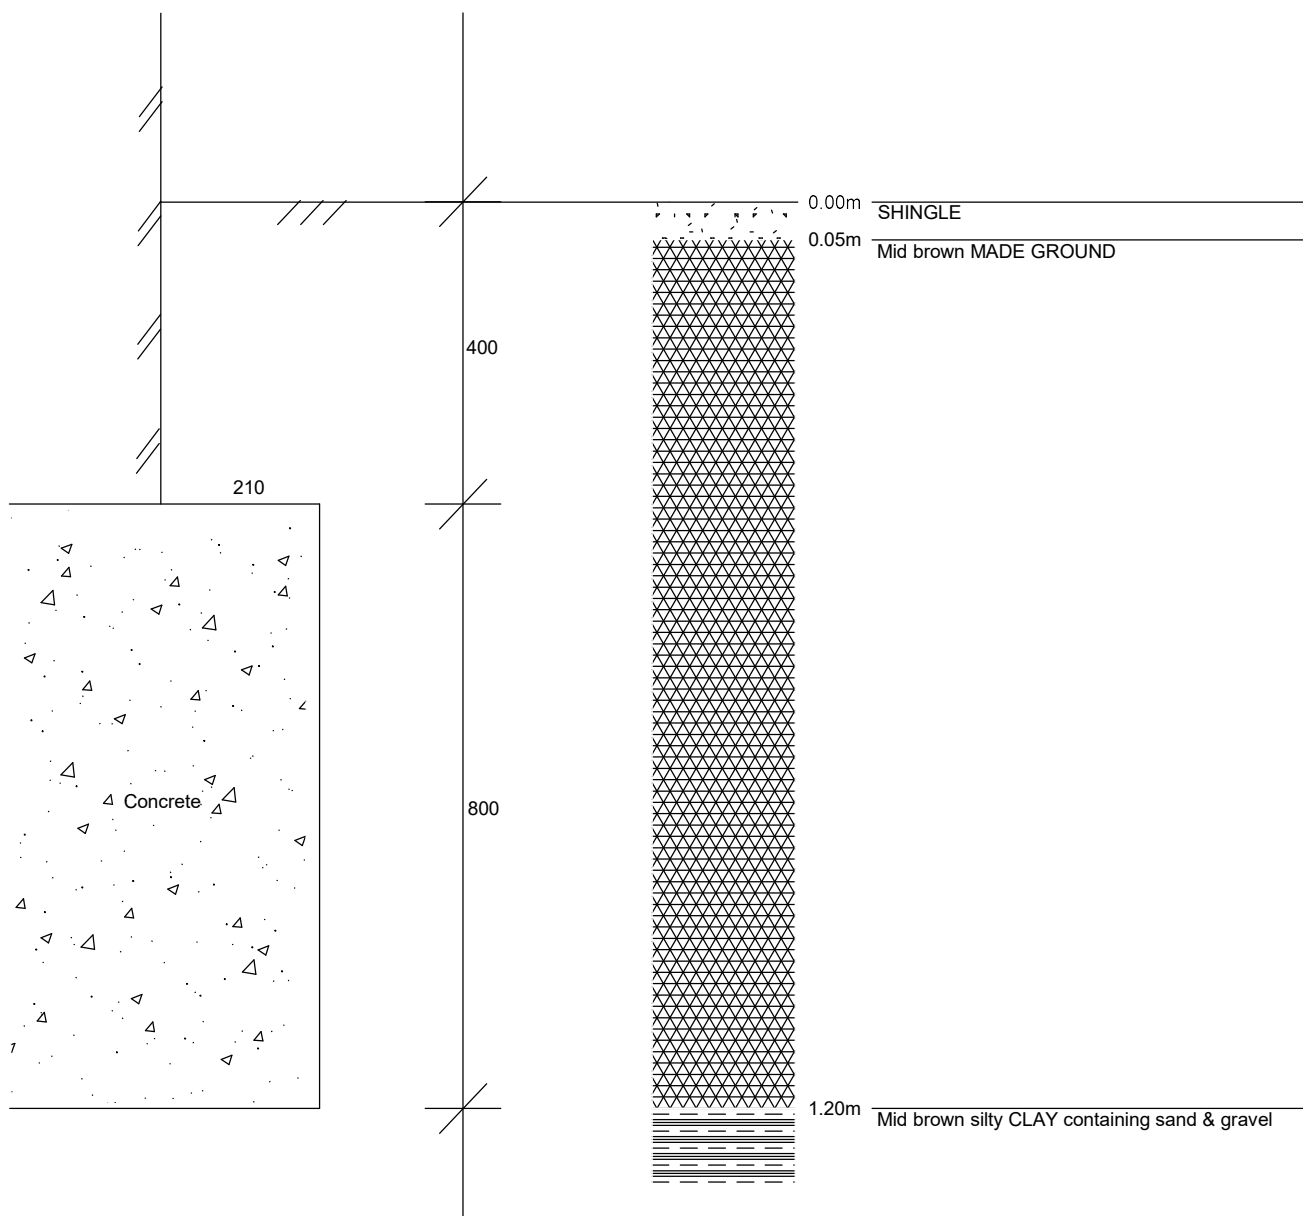
## TRIAL PIT 2

D1 @ F.L. (1.20m)

V = 54-59kPa

Founding strata: Mid brown silty CLAY containing gravel and sand
