# Arboricultural Report

## SUBSIDENCE INVESTIGATION AT:

5 Clausentum Close  
Chandlers Ford,  
Hampshire SO53  
2AQ

| Report Date: | 12 <sup>th</sup> of May 2023 |

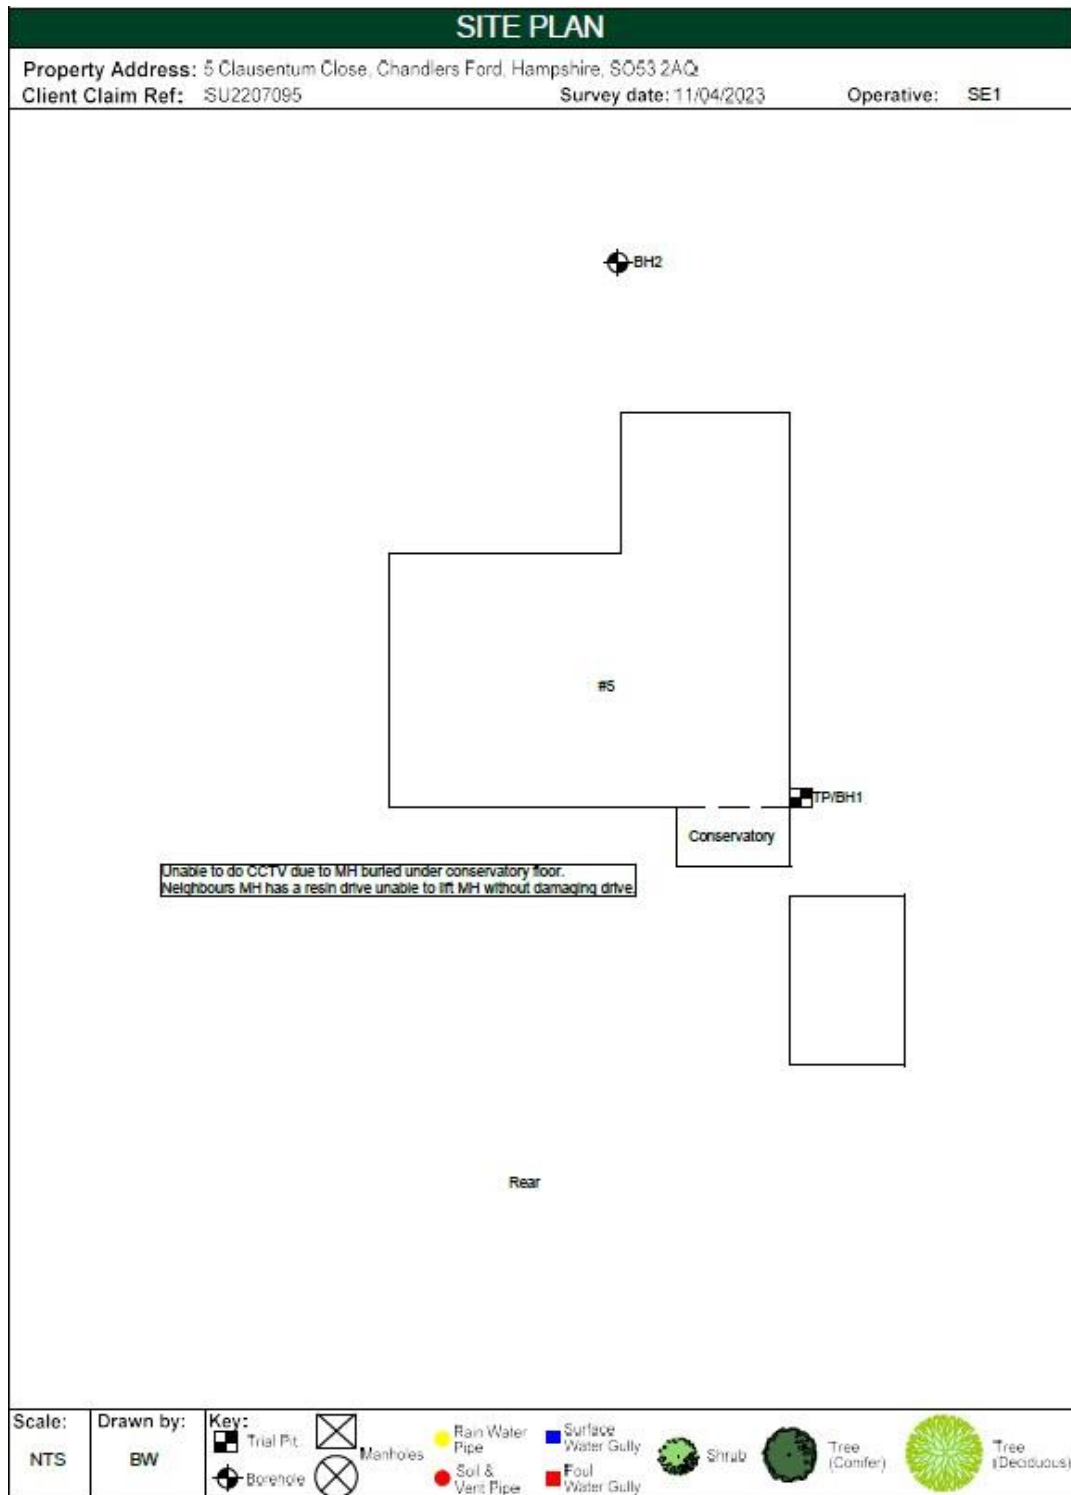
## Site investigation plan showing location of boreholes

Site investigations were carried out by FASTTRACK on 11/04/23 where a trial pit was excavated to reveal the foundations, with a borehole sunk through the base of the trial pit to determine

subsoil conditions. A second borehole was also sunk at the front of the property. The results are summarised in the plan and tables below.

| TP/BH Number | Roots observed to depth (mm) | Identification | Starch |
|---|---|---|---|
| BH1 | 550 | either Quercus spp. or Castanea spp. | Low |

| TP/BH Number | Description | Plasticity Index % | Volume Change Potential (NHBC) |
|---|---|---|---|
| TP1 | Light brown, brown sandy clay | 40-45 | High |
| BH2 | Light brown, brown sandy clay | 45-51 | High |

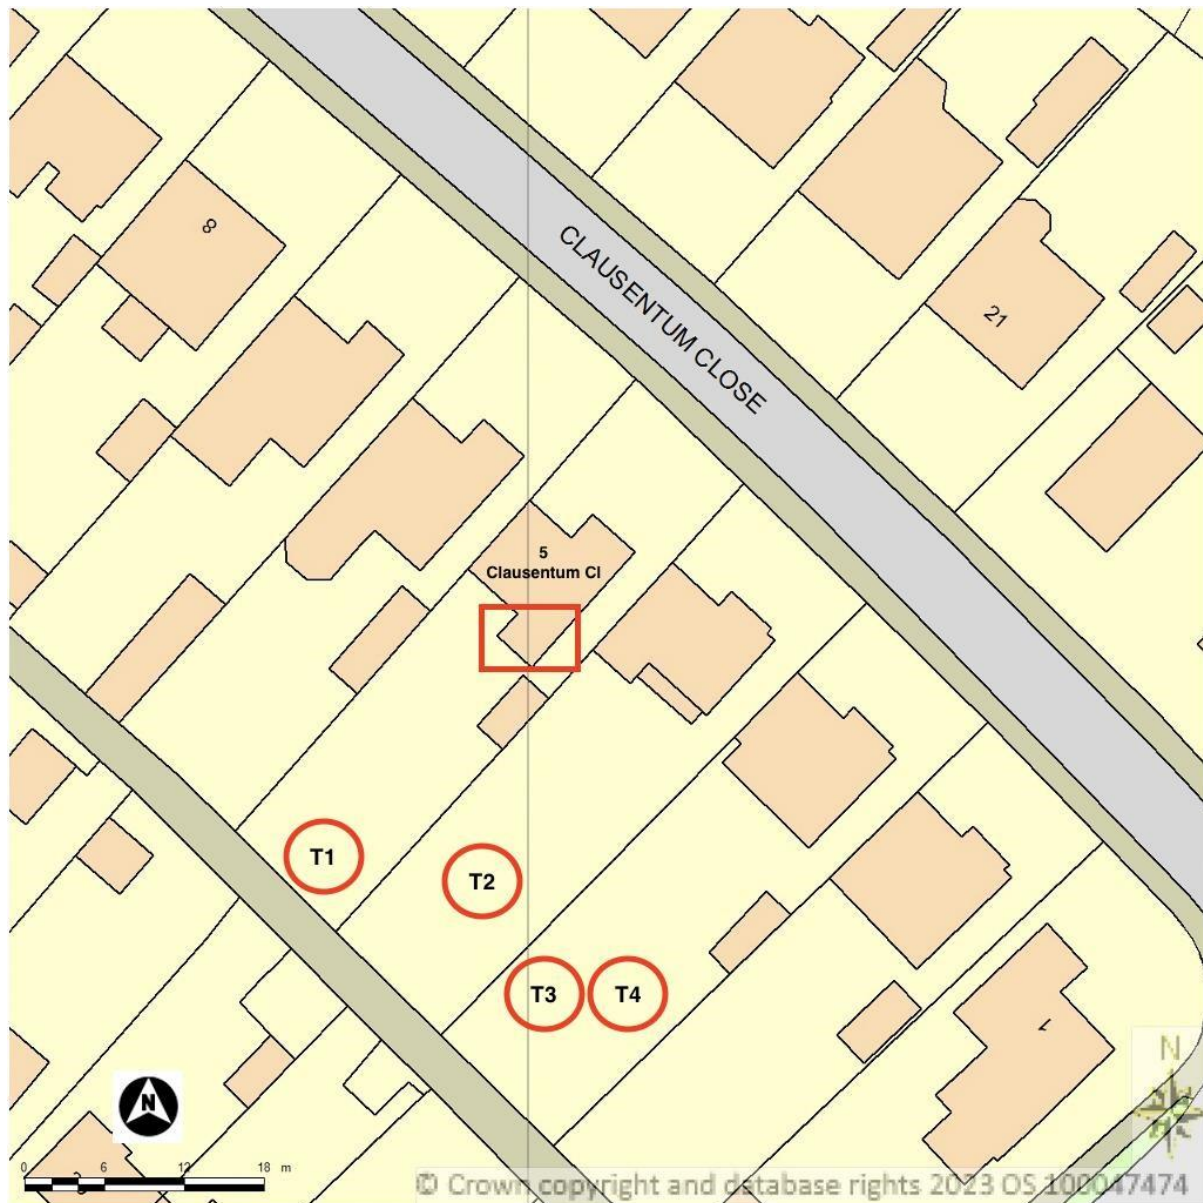
The cracking was first noticed summer 2021, the area of damage is the rear left corner of the bungalow (southerly corner), at five internal locations. The pattern and nature of the cracks is indicative of an episode of subsidence. The cause of movement has been diagnosed to be clay shrinkage.

Tree plan showing area of damage inside red box.

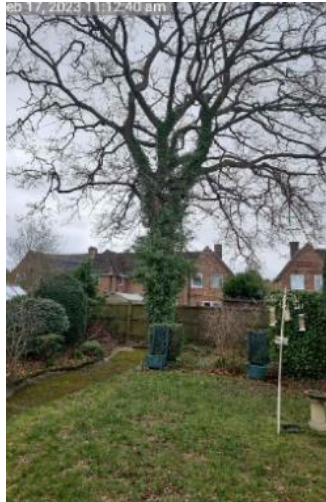
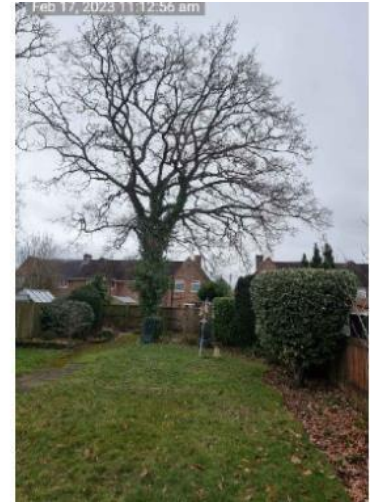
**T1**

| Ref. | Species | Height (m) | Canopy radius (m) | DBH (mm)<br>No. of stems | Life stage | Age relative to property | Distance to property (m) | Tree owner/ location | Vitality, condition, previous works | TPO/ CA |
|---|---|---|---|---|---|---|---|---|---|---|
| T1 | Oak | 20 | 7 | 560<br>1 | Mature | Older | 23 | Insured | Good. Previous light pruning | TPO |

Trees T1, and T2 are both within influencing distance of the property (the radius of the zone of influence is taken from “Tree Roots & Buildings” Cutler, D.F. and I.B.K. Richardson, (1989) or determined in accordance with NHBC Standards Chapter 4 (2021)). English Oak are well recognised as having a high-water demand (NHBC Standards Chapter 4 (2021)) and are capable of causing subsidence damage during drought conditions.

| Ref. | Species | Tree owner/<br>location | Dist. to<br>prop. (m) | Zone of<br>influence<br>(m) | Recommendation |
|---|---|---|---|---|---|
| <b>T1</b> | Oak | Insured | 23 | 30 | Installation of a root barrier to isolate the insured property from all the oaks across several gardens. Removal is unlikely to be effective as there is another closer oak in the neighbouring garden. |

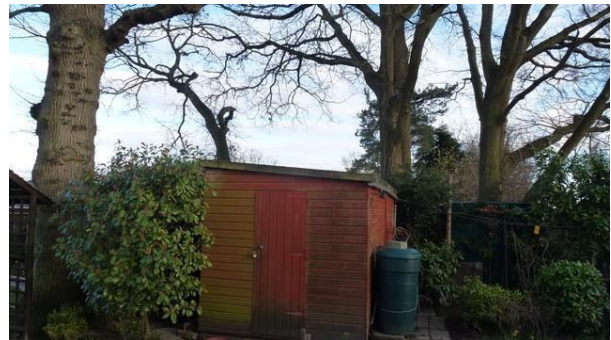
| Ref. | Species | Height (m) | Canopy radius (m) | DBH (mm)<br>No. of stems | Life stage | Age relative to property | Distance to property (m) | Tree owner/ location | Vitality, condition, previous works | TPO/ CA |
|---|---|---|---|---|---|---|---|---|---|---|
| T2 | Oak | 24 | 8.5 | 600 | Mature | Older | 17 | Neighbour at number 4 | Tree is a dominant species across the 2 properties. The tree has had previous pruning works undertaken to remove lower limbs and reduce back from house. | TPO |

**T2, T3 & T4**

| Ref. | Species | Tree owner/<br>location | Dist. to<br>prop. (m) | Zone of<br>influence<br>(m) | Recommendation |
|---|---|---|---|---|---|
| <b>T2</b> | Oak | Neighbour at<br>Number 4 | 17 | 30 | Installation of a root barrier to isolate the insured property from all the oaks across several gardens OR as the closest oak,<br><br>Remove close to ground level and treat stump with systemic herbicide to inhibit regrowth. |

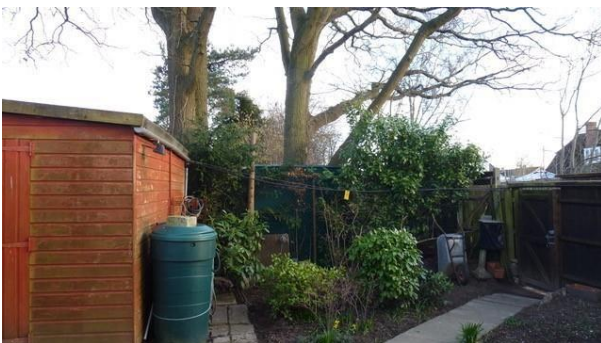
**T3 & T4**

Trees (T3), and (T4) both also Oak are close to, but outside of the zone of influence but they are high water demand species capable of causing subsidence damage during drought conditions.

| <b>T3</b> | Oak | Neighbour<br>at number<br>3 | 28 | 30 | Maintain the tree within $\pm 10\%$ of its<br>current size through periodic pruning. |
| <b>T4</b> | Oak | Neighbour<br>at number<br>3 | 28 | 30 | Maintain the tree within $\pm 10\%$ of its<br>current size through periodic pruning. |
