## Eastleigh Borough Council Tree Preservation Order and Conservation Area Assessment Form

| <b>Application Number</b> | T/25/99400 |
| <b>Address</b> | 4 ASHLEY COURT, PROVIDENCE HILL, BURSLEDON, SOUTHAMPTON, SO31 8AT |

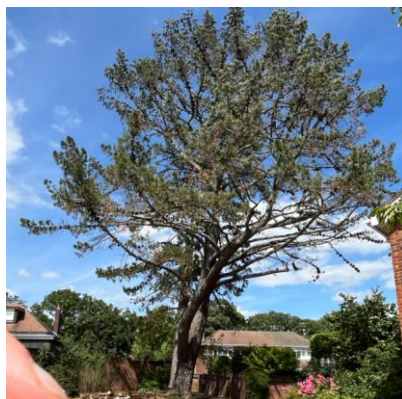
Declining health: I agree with the Arborist's appraisal of the health of the tree; in particular, the larger stem has a very sparse crown with multiple dead branches throughout. Most of the remaining live branches have become lion-tailed, that is to say live twigs and needles exist only at the branch ends. The internal twigs/needles have mostly died. The Arborist suggests that this may be attributable to red band needle blight (*Dothistroma septosporum*). I couldn't confirm this as all needles on the ground were completely dead and live needles with potential symptoms out of reach. However, Forest Research notes *Pinus radiata* as being particularly susceptible to this disease. Its symptoms are first noticed at the base of the crown on older needles which develop yellow/tan spots and bands which later turn red. As the disease progresses, the ends of the needles turn red/brown while the needle base remains green. Eventually, the needles are shed and branches can acquire a lion-tailed appearance. This is at least partially consistent with the condition of the subject tree.

Taken from outside 4 Ashley Ct, showing sparse needle coverage (note: much of the fullness of the crown is clumps of large cones)

| | <p>The visual appearance of the tree has been severely impacted by the needle loss. The smaller stem is becoming sparse but is considerably better foliated than the larger. The dead branches can be removed without application or notice. However, doing so will leave the tree even less attractive. It is unlikely that the tree will make significant recovery.</p> <p><u>Leaning tree:</u> This is long-term and naturally adopted. The tree is expected to have developed a root system and overall structure capable of supporting itself. There is no evidence that the tree is likely to fall in the near future due to the lean. No decay, no recent root damage reported.</p> <p>The Applicant proposes to fell the tree and is open to replanting; whilst the tree is certainly prominent within the Ashley Court development, visibility from Providence Hill/A27 is relatively low. The sparse needle coverage of the tree is such that it's aesthetic appeal is considerably reduced. Overall, the loss of the tree would not be particularly detrimental in terms of public, visual amenity and the application should be granted permission.</p> | | | | | |

| Decision notice | GRANT: 1no. Pine (twin stemmed) - Dismantle & remove to ground level. | | | | | |
| Conditions | Replacement planting (elm, field maple or sweet gum) | | | | | |
