Tree Report for :  
Hamble Yacht Services  
Marina Drive  
Hamble  
Eastleigh  
SO31 4NA

Date of report: 02/08/2025  
Completed by: Fraser Moncrieffe

# List of Trees and details of recommended work

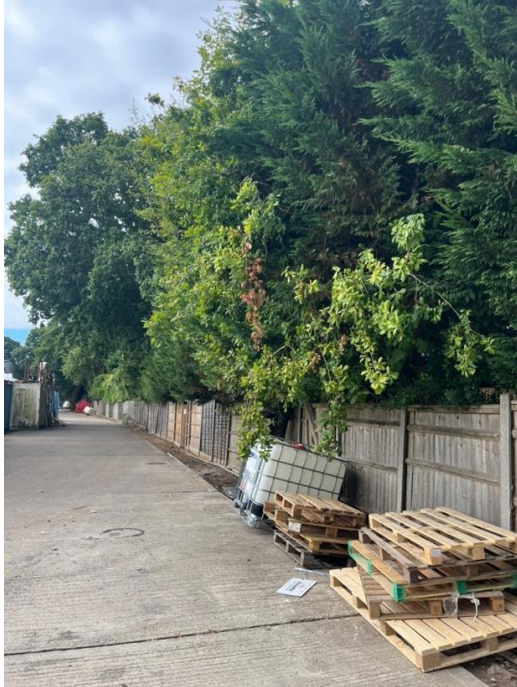
G1 - Group of conifers trees - Cut back to give sufficient clearance of rear road.

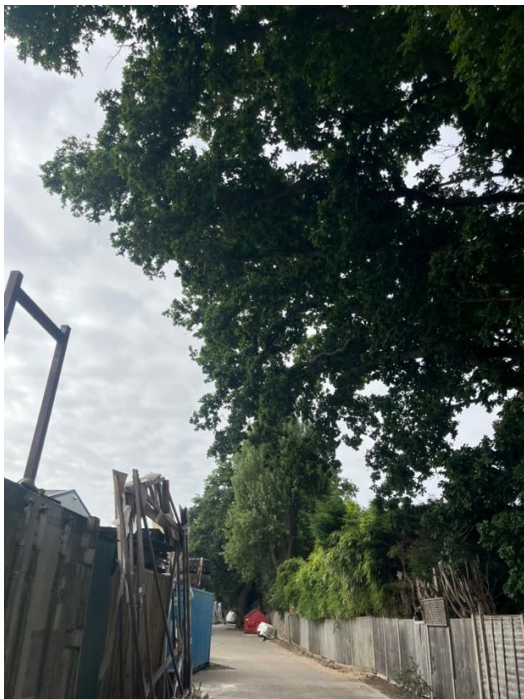
G2 - Group of 3 Oak trees - Raise canopy to 10m to allow clearance for vehicles and plant.

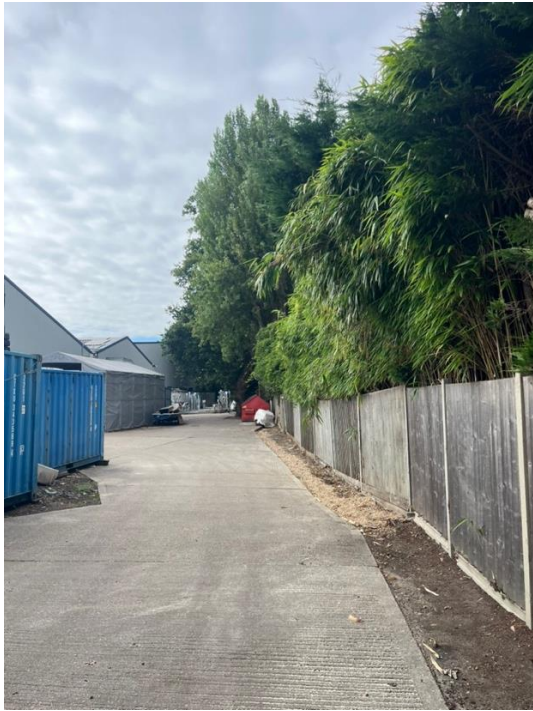
G3 - Group of bamboo and conifer - Cut back to give sufficient clearance of rear road.

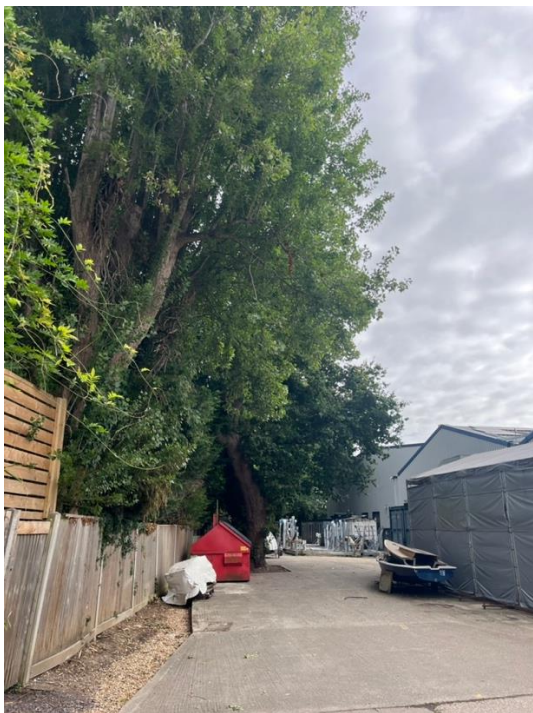
T1 - Poplar - Raise canopy to 8m to allow clearance for vehicles and plant.

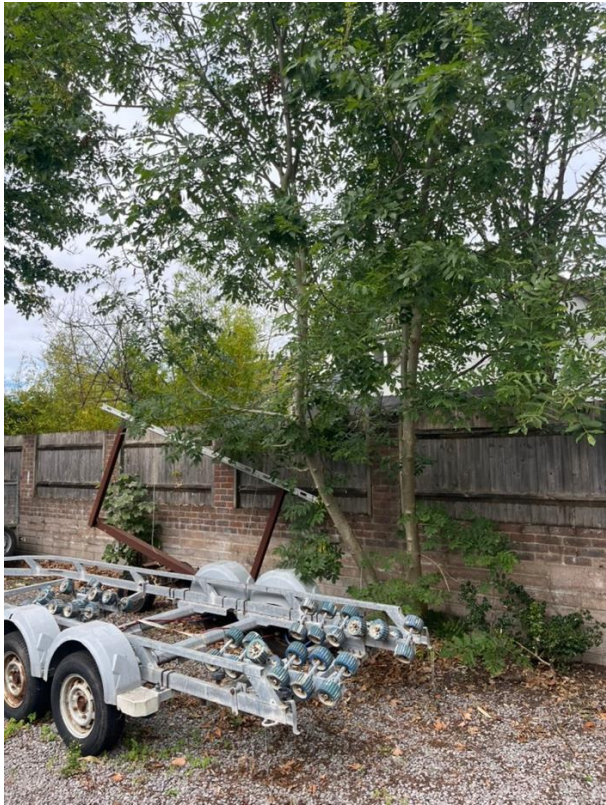
T3 - Ash - Raise canopy by 5m to allow clearance for vehicles and plant.

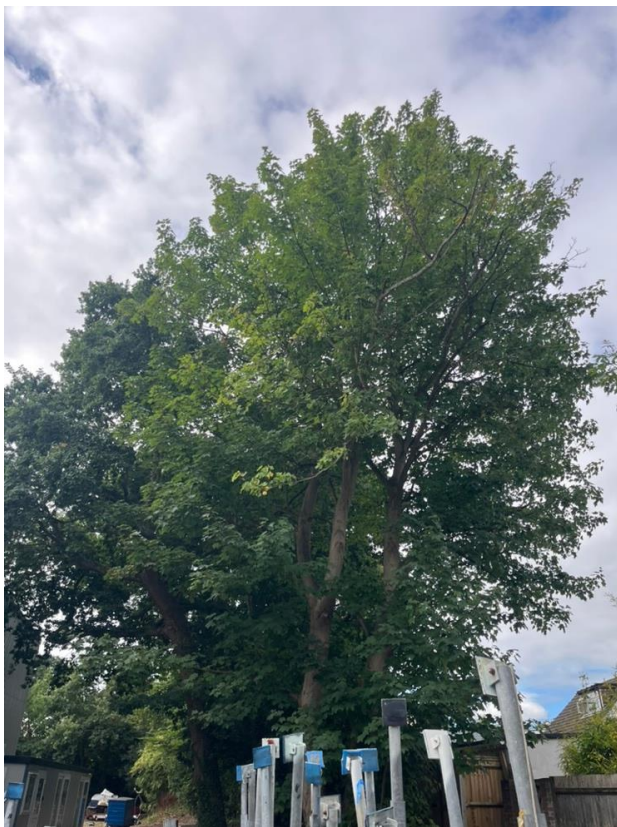
T4 - Sycamore - Raise canopy to 6m to allow clearance for vehicles and plant.

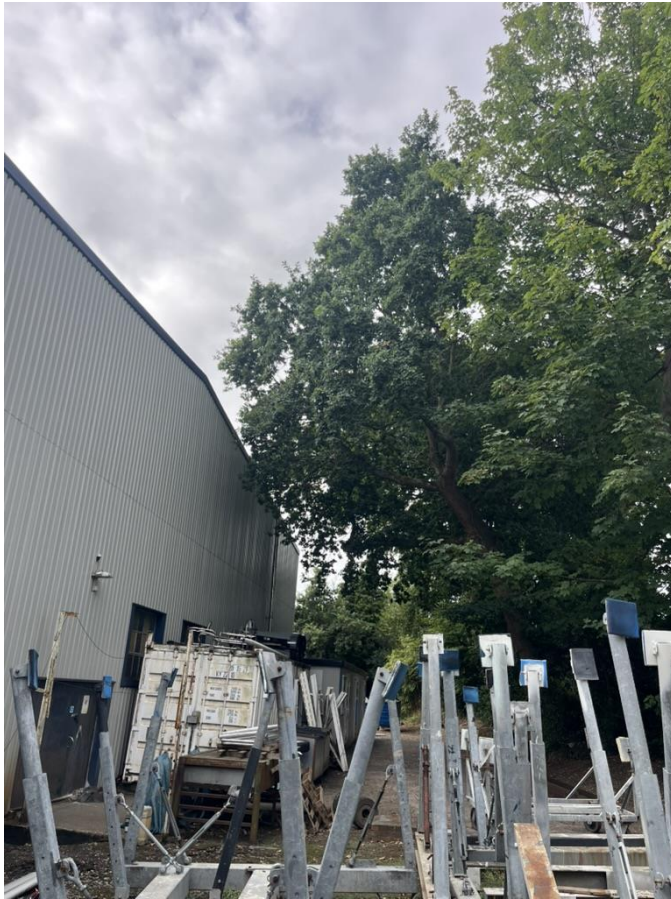
T5 - Oak - Tree could be removed as its very close to the building and leaning over. However, if permission isn't granted to remove then suggest a 3m reduction.

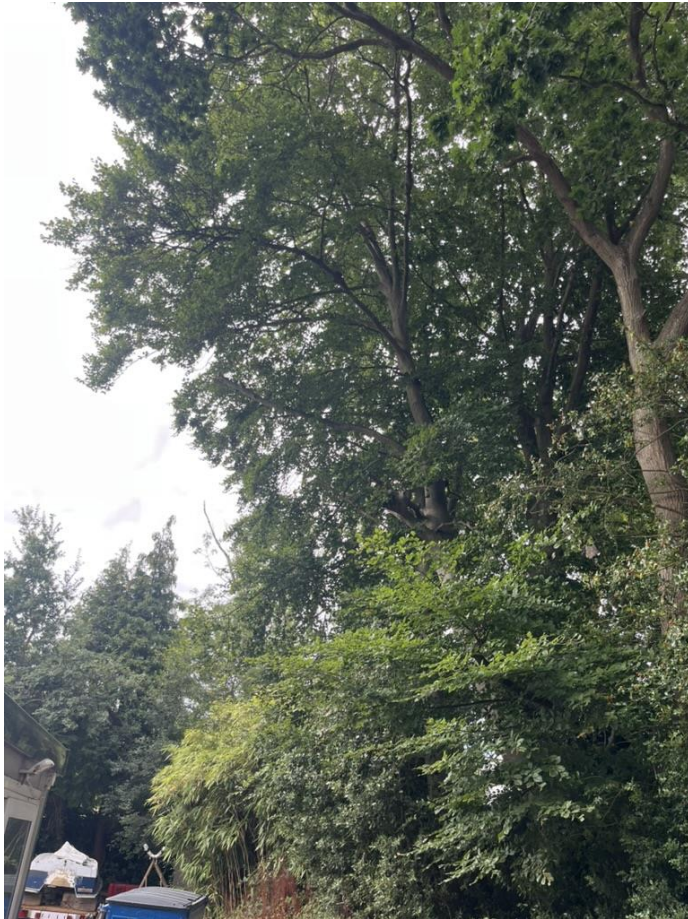
T7 - Beech - Remove deadwood and damaged limb. Reduce eastern side by 3m and crown raise by 8m to allow clearance of building and vehicles.

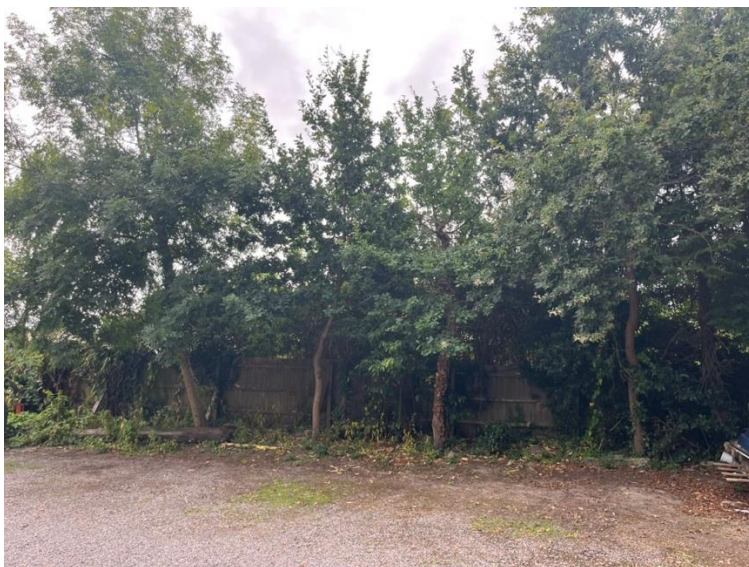
G4 - Ash and Oak trees - Raise canopy by 3m to allow clearance for vehicles.

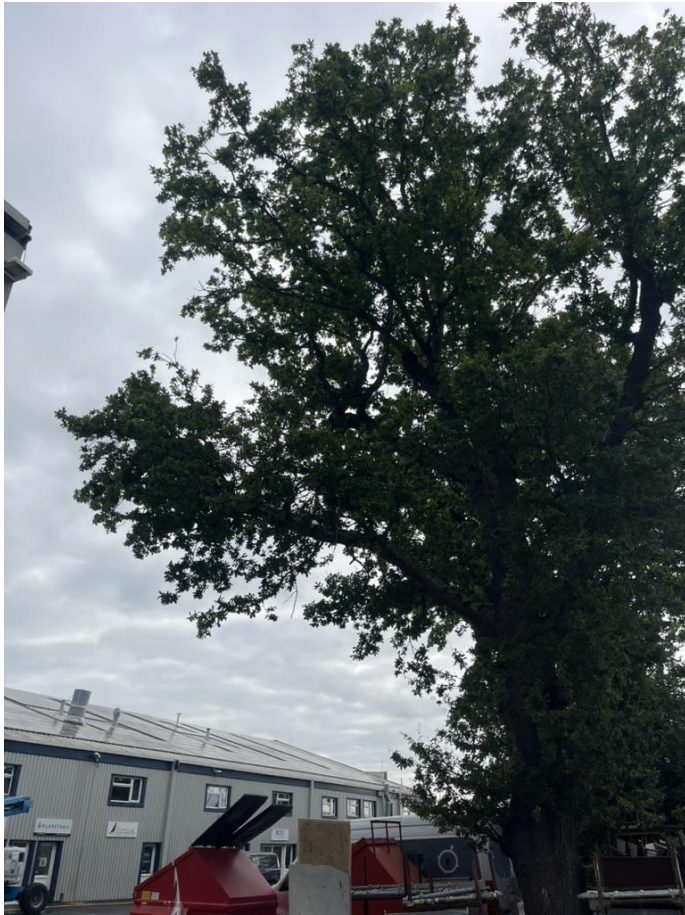
G5 - 4 Oaks - Raise canopy by 5m. Remove Deadwood. Reduce first oak by 3m on northern side to allow clarence from the building.

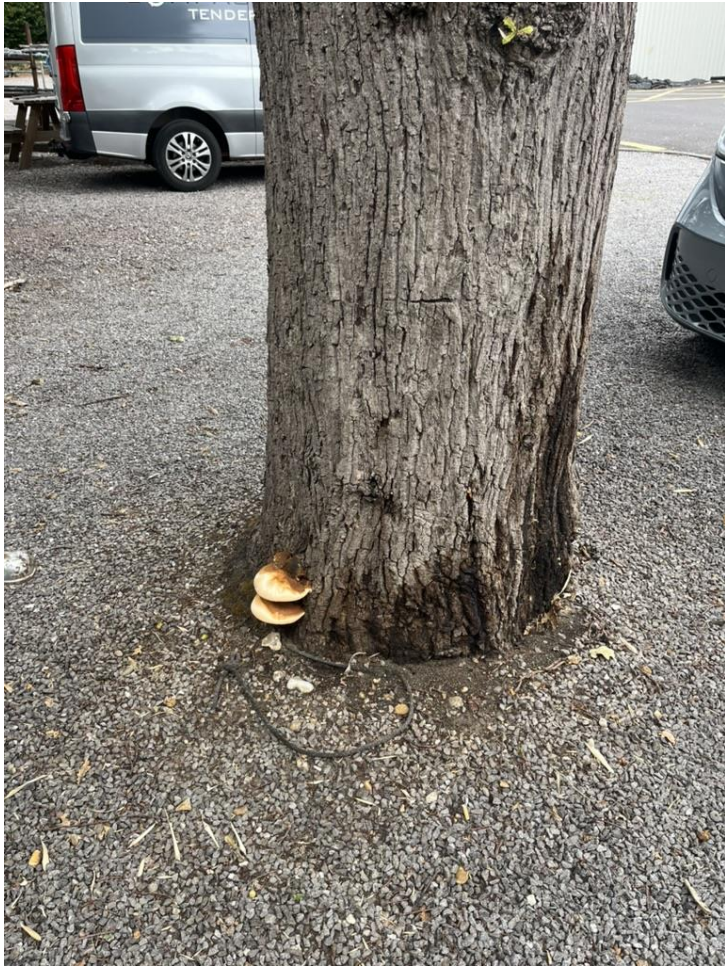
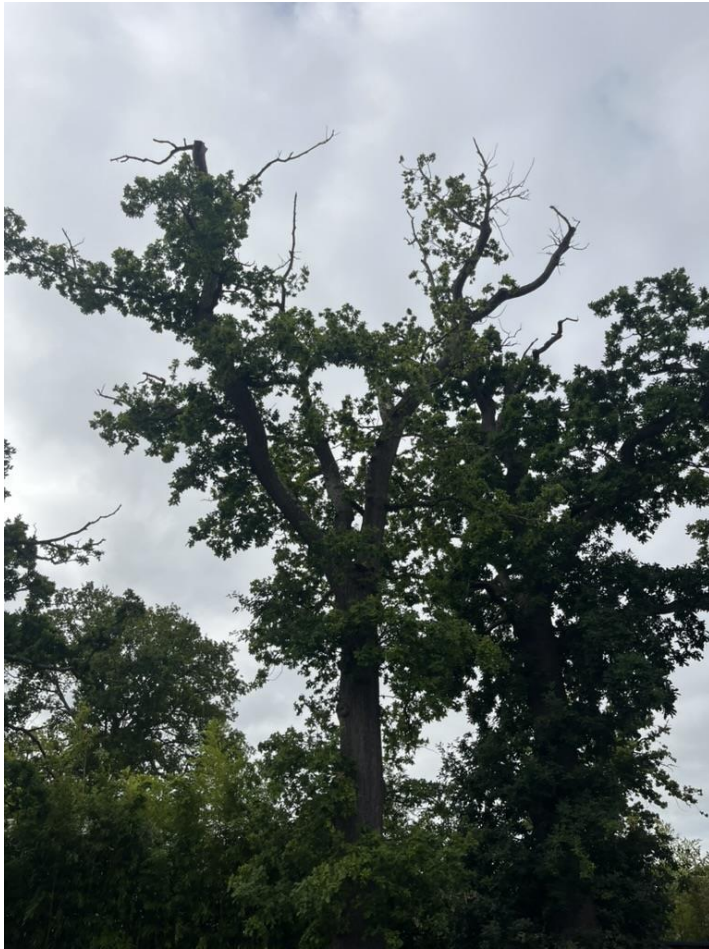
G5 - T3 - Oak - 3<sup>rd</sup> tree in the group has fungus bracket (Ganoderma) at the base of the tree which suggests the tree is compromised as Ganoderma feeds on dying wood. Canopy is in decline, with lots of deadwood in the upper canopy.

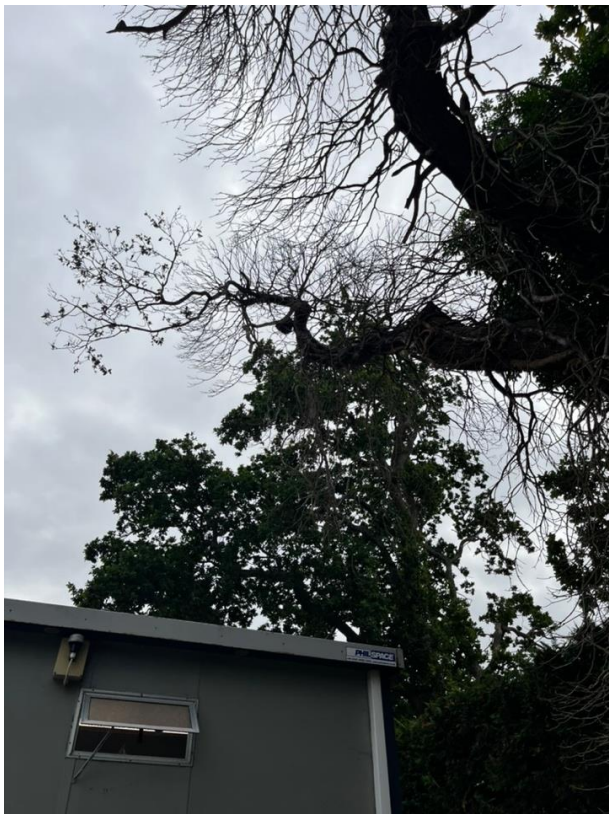
T8 - Oak - Remove Dead limb over toilet block. Remove deadwood.

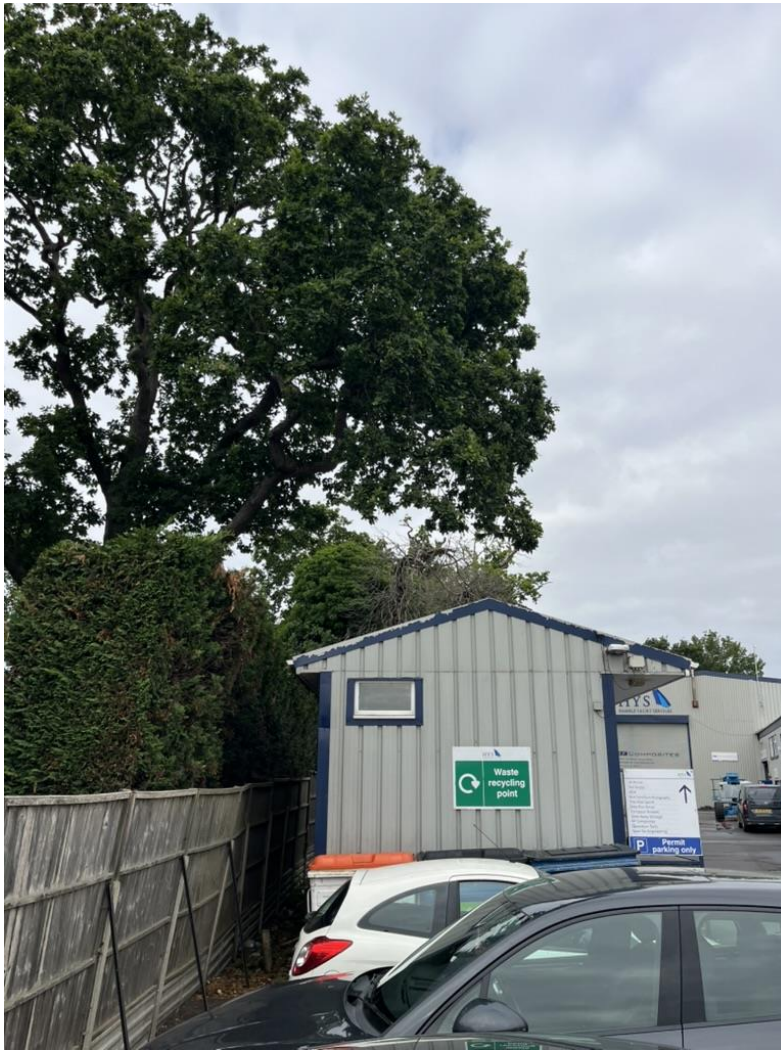
T9 - Oak - Raise canopy of toilet block.
