# STRUCTURAL DEFECT REPORT

## STROUDWOOD FARMHOUSE

| Document Information | |
|---|---|
| Document ref. | 14184-01 |

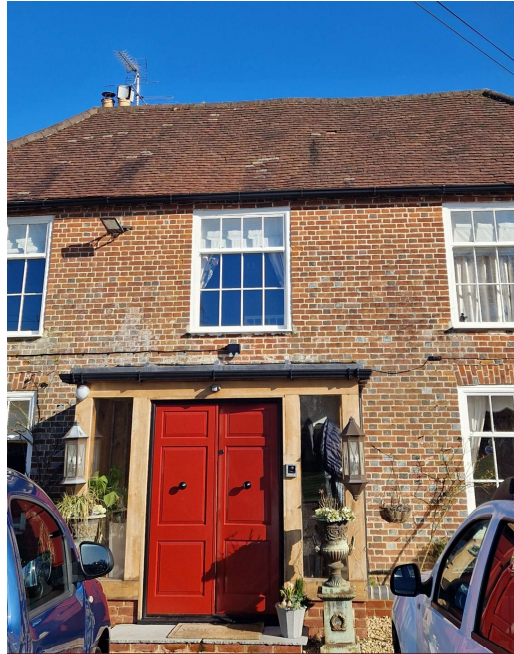
*Figure 1 – Front (South) elevation of Stroudwood Farmhouse*

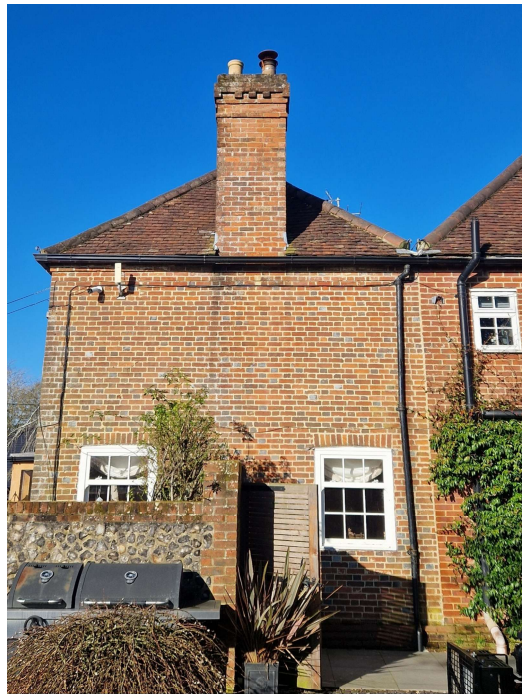
*Figure 2 – Side (East) elevation of Stroudwood Farmhouse*

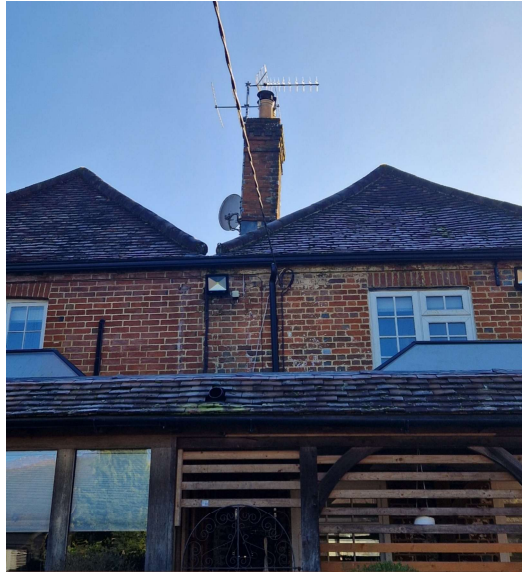
*Figure 3 – Side (West) elevation of Stroudwood Farmhouse. Chimney observed to be severely out of plumb*

3. Scaffolding should be erected to provide safe access to the roof structure. This will facilitate the removal of existing tiles, battens, and impermeable felt, as well as the installation of new materials. The existing leaning chimney will require closer inspection as to whether it will require reconstruction or additional support.

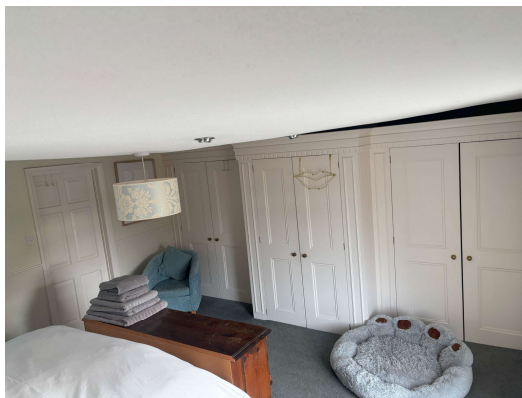
The first-floor ceilings exhibit significant sagging and linear cracking in the plasterboard, with the most pronounced deflections occurring centrally within the affected bedrooms. These issues have reportedly worsened in recent months. The centre of the bedroom ceiling is approximately 110mm lower than the hallway (Figure 4).

*Figure 4 – Ceiling deflection of first floor bedroom*

The vertical displacement of the bedroom ceiling joists is the product of two issues;

2. Install temporary Acrow props with bearing plates beneath the affected ceiling joists to provide immediate support and prevent further deflection. This will mitigate the risk of structural failure while repairs are carried out.

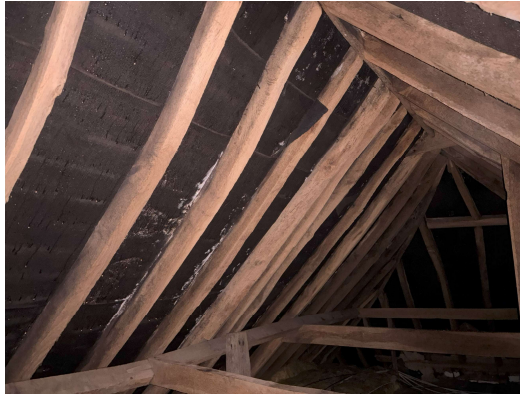
The loft space displayed signs of dampness, with condensation visible across most surfaces. Timber elements were found to be soft to the touch, indicating possible wet rot. Green and white mould growth was prevalent on rafters and the felt (Figure 5).

*Figure 5 – Impermeable roof felt with internal condensation*

- i. The lack of adequate ventilation in the loft space has created a conducive environment for dampness. The impermeable bitumen felt installed beneath the clay tiles prevents vapour from escaping, trapping moisture within the roof structure. This has led to widespread condensation, dampness, and mould growth on timber elements. Prolonged exposure to moisture has caused the timber to soften, reducing its load-bearing capacity and contributing to the deflection of ceiling joists. Additionally, the rockwool insulation, while dry at the time of inspection, has previously been saturated, adding unnecessary weight to the already compromised ceiling joists. The absence of soffit ventilation exacerbates the problem, as there is no airflow to regulate humidity levels or expel moisture. This has resulted in the deterioration of timber elements, including rafters, purlins, and joists, with visible signs of wet rot and mould growth.

5. Replace the existing impermeable bitumen felt with a breathable roofing membrane to allow vapour to escape. Install soffit vents or other ventilation systems to promote airflow within the loft space and reduce moisture levels, to the approval of listings officers.

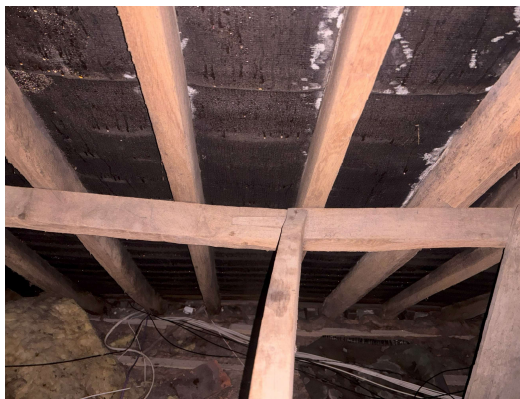
Several timber joints were observed to have separated or were in the process of pulling apart (Figure 6). Purlins were deflecting at the hips, and rafters were secured with only singular nails. Woodworm damage was noted, though the activity status remains uncertain.

*Figure 6 – Purlin joint deflecting*

6. New timber struts should be designed to provide adequate support to the purlins. Introduce additional load-bearing beams to support purlins and redistribute roof loads away from ceiling joists. Purlins will require steel plate reinforcement to limit deflection and any weakness at splice locations. Lateral restraint to the rafters at eaves level to be included to prevent roof splay and any damaged rafters to be replaced. The existing joists are inappropriately sized for the bearing and span and will require reinforcing with new joists.

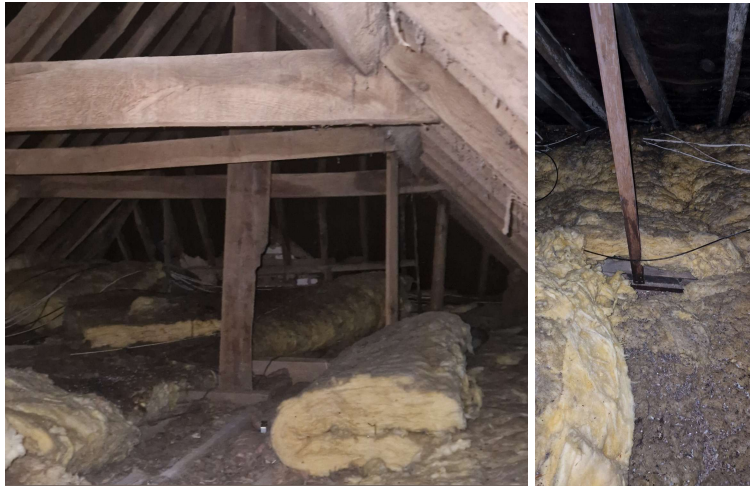
In many cases the purlins supporting the rafters are propped off the ceiling joists rather than dedicated load-bearing beams or walls. Additionally, no bracing struts were observed to provide horizontal support to the purlins (Figure 7 & 8).

*Figures 7 & 8 – Purlins supported off ceiling joists*

- ii. The roof structure relies on purlins supported by ceiling joists rather than dedicated load-bearing walls or beams. This arrangement is inadequate for the loads imposed, particularly at the hipped ends of the roof where smaller-section joists (50mm x 40mm) are notched and have minimal end bearing (Figure 10). The notching further weakens the joists, reducing their bearing capacity and leading to excessive cracks and deflection. The purlins themselves lack sufficient vertical support. In several locations they are propped directly onto ceiling joists without intermediate struts or braces, causing point loading and further stressing the joists. Unusually, having the joists not span the same direction as the rafters has led to a roof that is trying to splay. This could explain the cause of the vertical cracking above the doorways on the first floor.

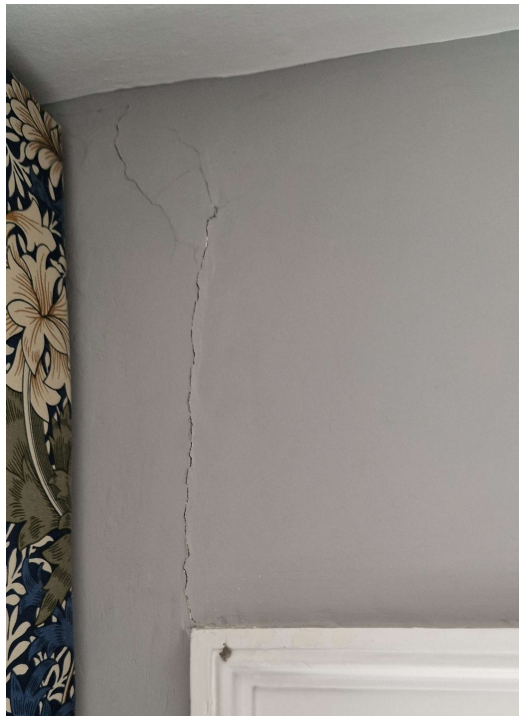
Cracks have formed above the doorways in the first-floor bedrooms, and the door frames showed signs of distortion (Figure 9).

*Figure 9 – Cracks above first floor bedroom doorways*

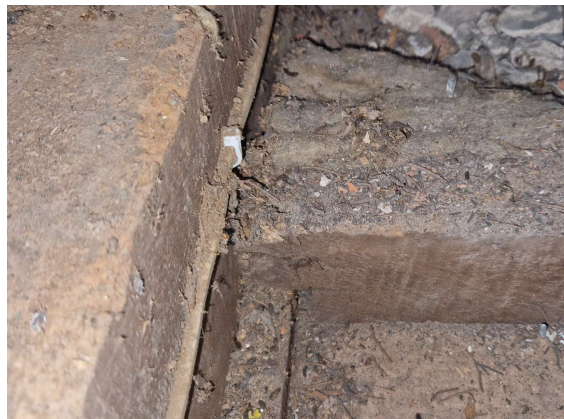
*Figure 10 – Notched ceiling joists and end bearing*
