## Eastleigh Borough Council Tree Preservation Order and Conservation Area Assessment Form

| <b>Application Number</b> | T/25/99655 |
| <b>Address</b> | 5 CLAUSENTUM CLOSE, CHANDLER'S FORD |
| <b>Proposed work</b> | <p>1no. Oak (T1, originates from No. 5) - Fell to ground level and treat stump to inhibit regrowth.</p> <p>1no. Oak (T2, originates from No. 4) - Fell to ground level and treat stump to inhibit regrowth.</p> <p>Reason: Due to subsidence, reports supplied within application.</p> |

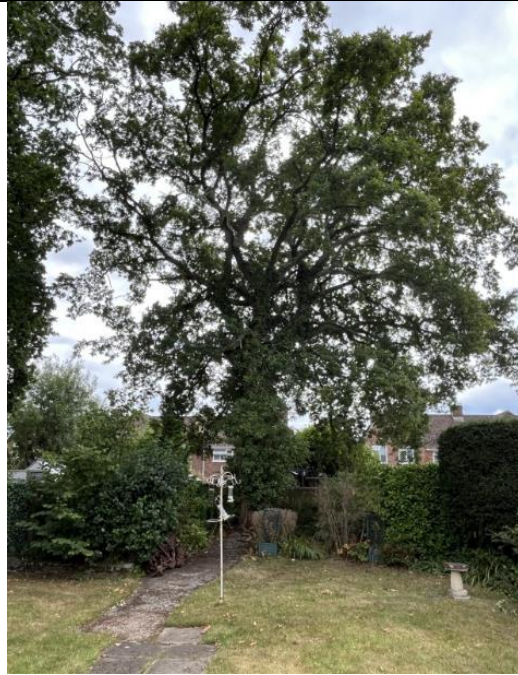
View of T1 from garden of No.5. Note the reduced crown density, particularly to the left/south-east side (18.7.25)

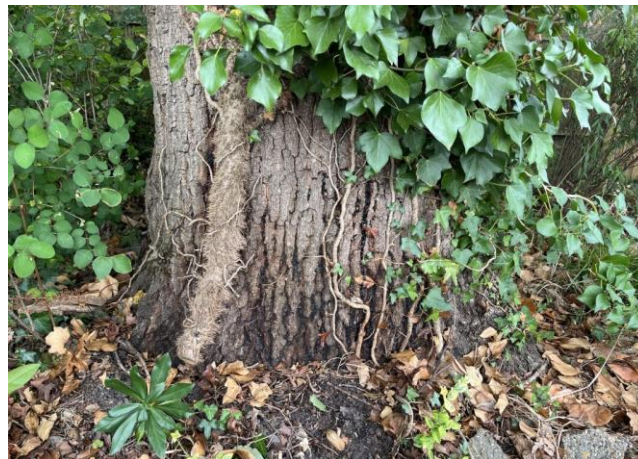
There are extensive black bleeds from the lower stem. These had not previously been noticed or described in the Arb Report. The cause is unknown. Bleeds of this nature are often attributed to infection by *Armillaria* sp. (honey fungus), *Phytophthora*, bacteria, Buprestid beetles, with symptoms exacerbated by drought.

Base of T1, showing black bleeds through bark at/above root collar (18.7.25)

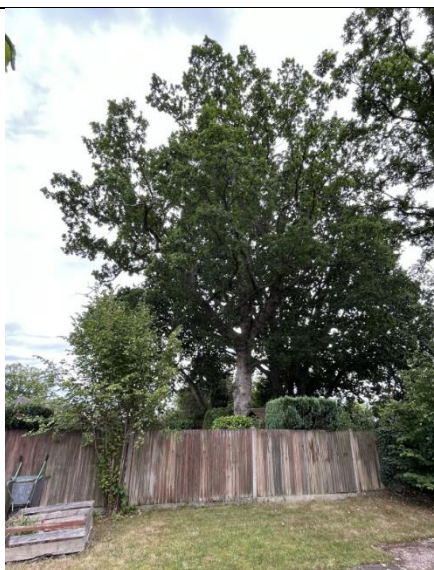
T2 is a mature oak located in the rear garden of the neighbour (No.4). It has been measured at 17m distance from the property. Vitality slightly reduced. Tree otherwise as described in Arb report.

T2, as viewed from rear garden of No.5 (18.7.25)

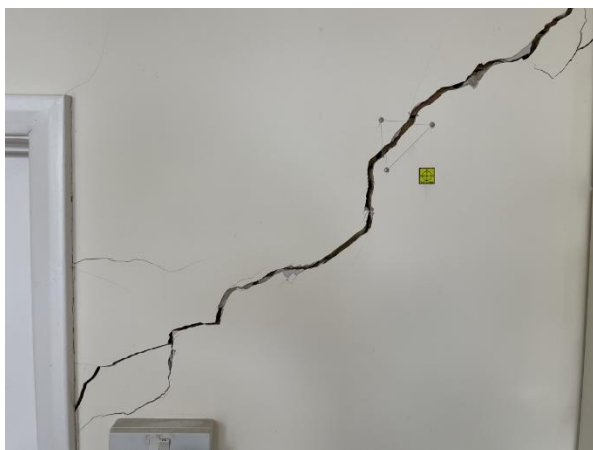
Cracks are present in various places through the property, focused in the part of the property nearest the trees. Cracks have previously been categorised in accordance with BRE guidance as *moderate* (>5 but <15mm crack widths). Having seen inside the property, it is possible between the kitchen and living room. Other cracks have been evidenced within the supporting information.

Crack between kitchen and living room (18.7.25)

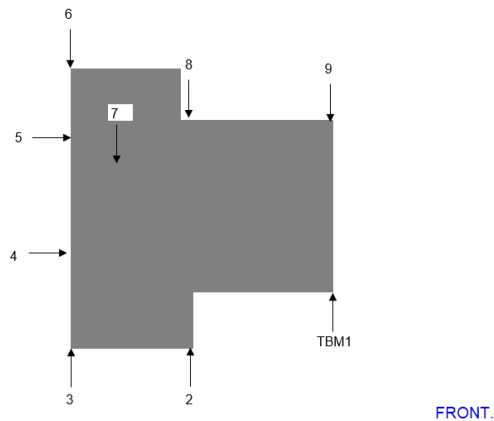
be attributable to the influence of vegetation and is therefore the most reliable method for distinguishing damage from other causes. It's noted that the entire foundation is showing signs of movement. This is understandable as they are only 550mm deep. This is considerably shallower than current NHBC guidance recommends. However, the greatest movement is found at stations 5 and 6, i.e. those nearest the oaks. The following schematic shows the position of each station...

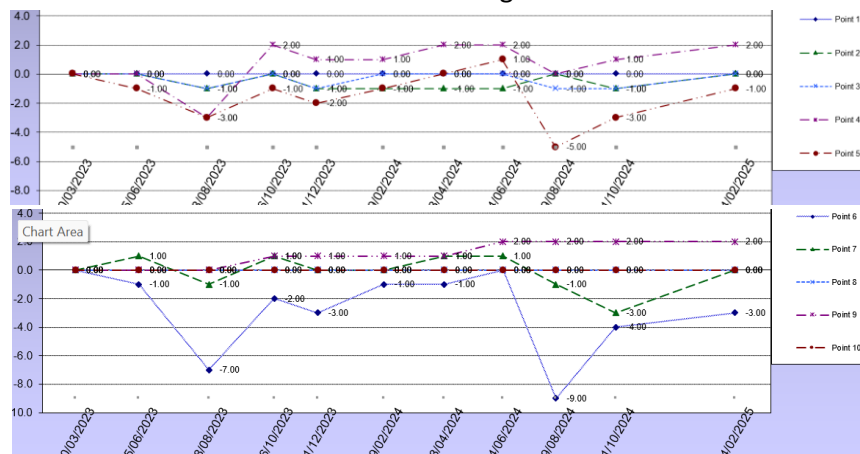
There are multiple reasons why cracks may occur in properties. However, the level monitoring shows a pattern of seasonal movement. This can only

...and the below shows the level monitoring...
