**Workdry Ltd**  
**New Headquarters Office Building**  
**Bournemouth Road, Chandlers Ford**

**Drainage Design Statement**

**Date: November 2025**  
**Project No. 304846**  
**Report Reference: 304846-SWH-ZZ-ZZ-T-C-0002**  
**Revision: 01**

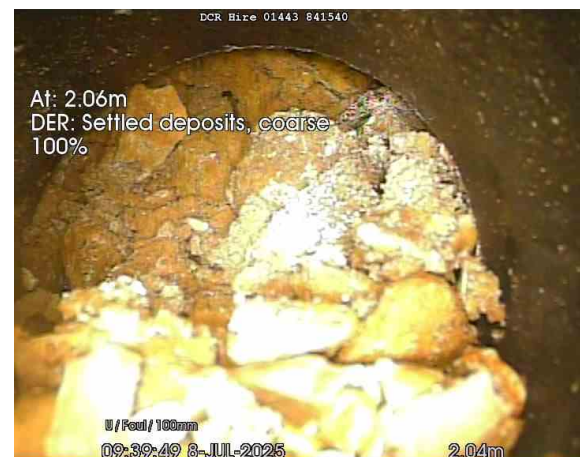
MH02 BR1\_2-00m\_094011.jpg, 00:00:12, 2.00 m  
Survey abandoned, UNABLE TO PASS DEBRIS

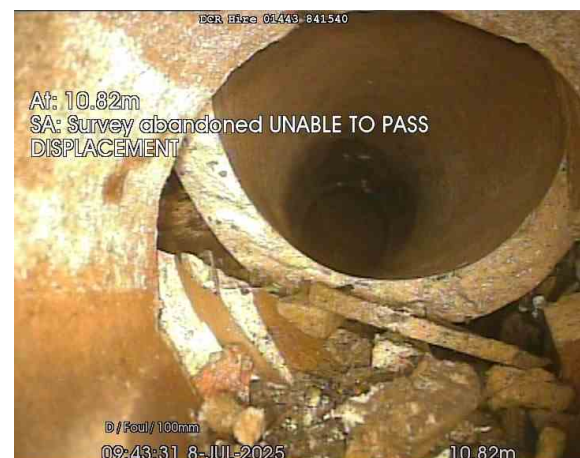
MH02 DS\_10-74m\_094305.jpg, 00:00:46, 10.74 m  
Joint displaced, large

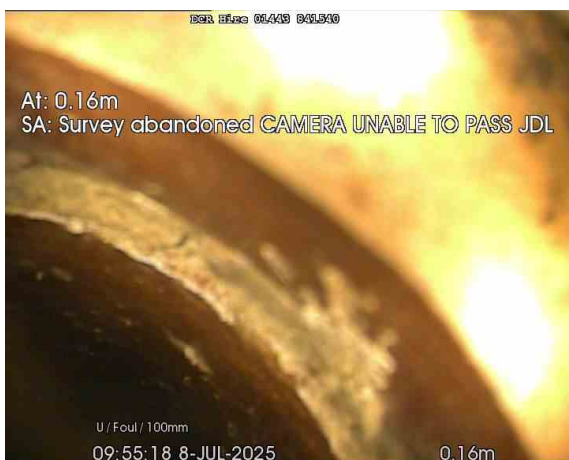
MH03 BR2\_0-16m\_095458.jpg, 00:00:16, 0.16 m  
Joint displaced, large

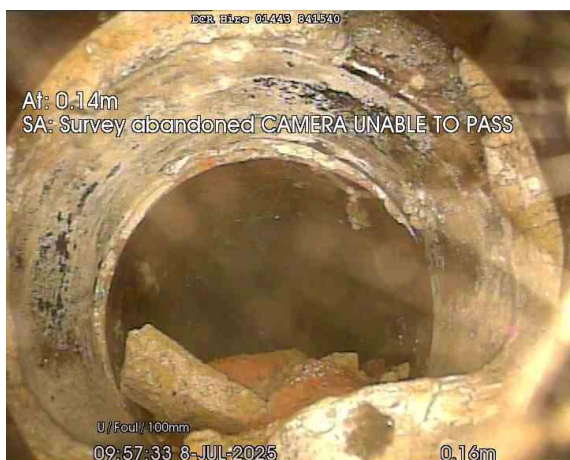
MH03 BR3\_0-14m\_095719.jpg, 00:00:33, 0.14 m  
Attached deposits, encrustation at 12 o'clock, 25% cross-sectional area loss, CAMERA UNABLE TO PASS

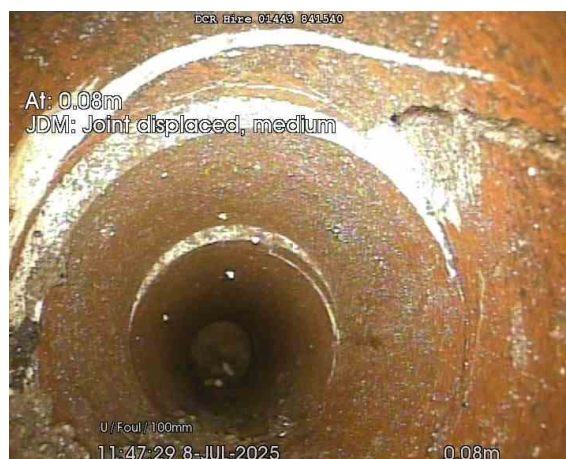
MH06 BR4\_0-08m\_114722.jpg, 00:00:05, 0.08 m  
Crack, circumferential from 8 o'clock to 3 o'clock
