October 2025  
CBA11958 v1

# DECAY DETECTION INVESTIGATION WITH MICRODRILL REPORT

Site:  
1 Kendal Close  
Chandlers Ford  
SO53 1EG

## DECAY DETECTION INVESTIGATION REPORT

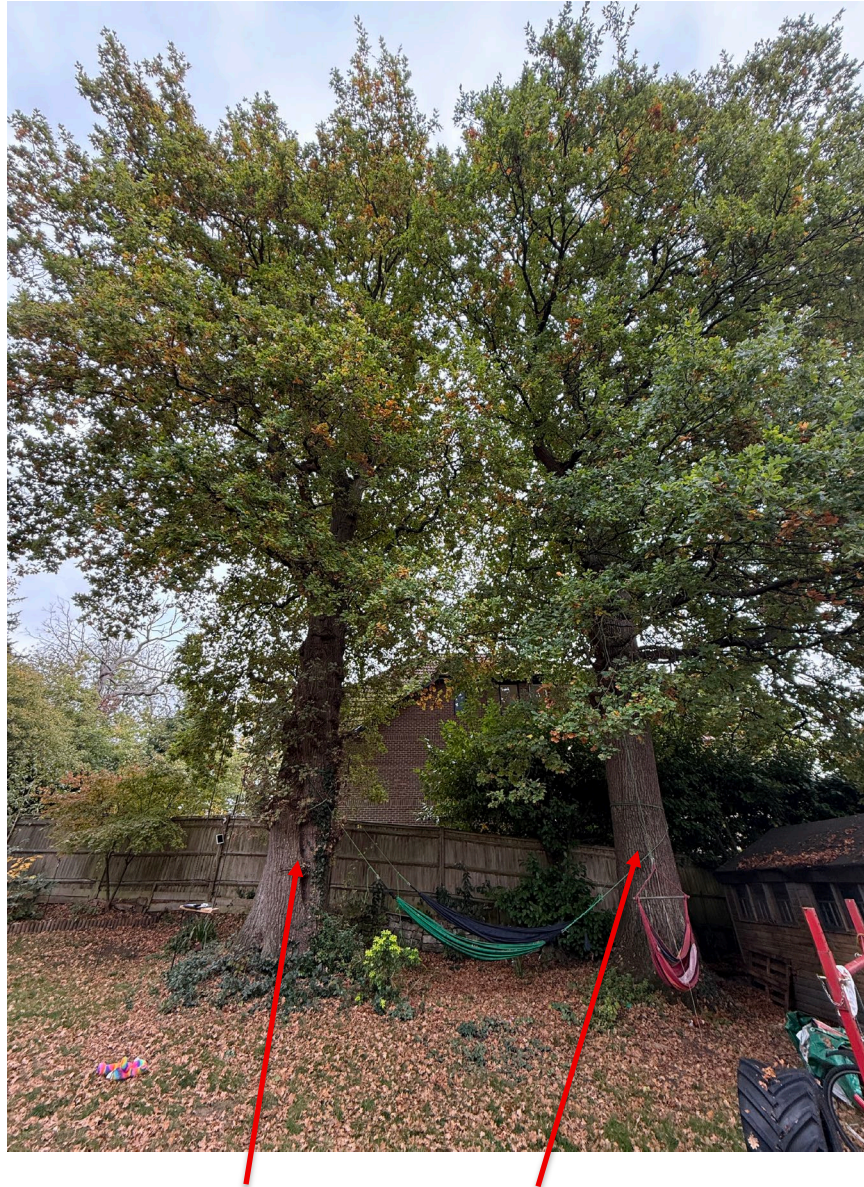
**Photograph 1:**

Showing the two Oaks viewed from the northwestern side

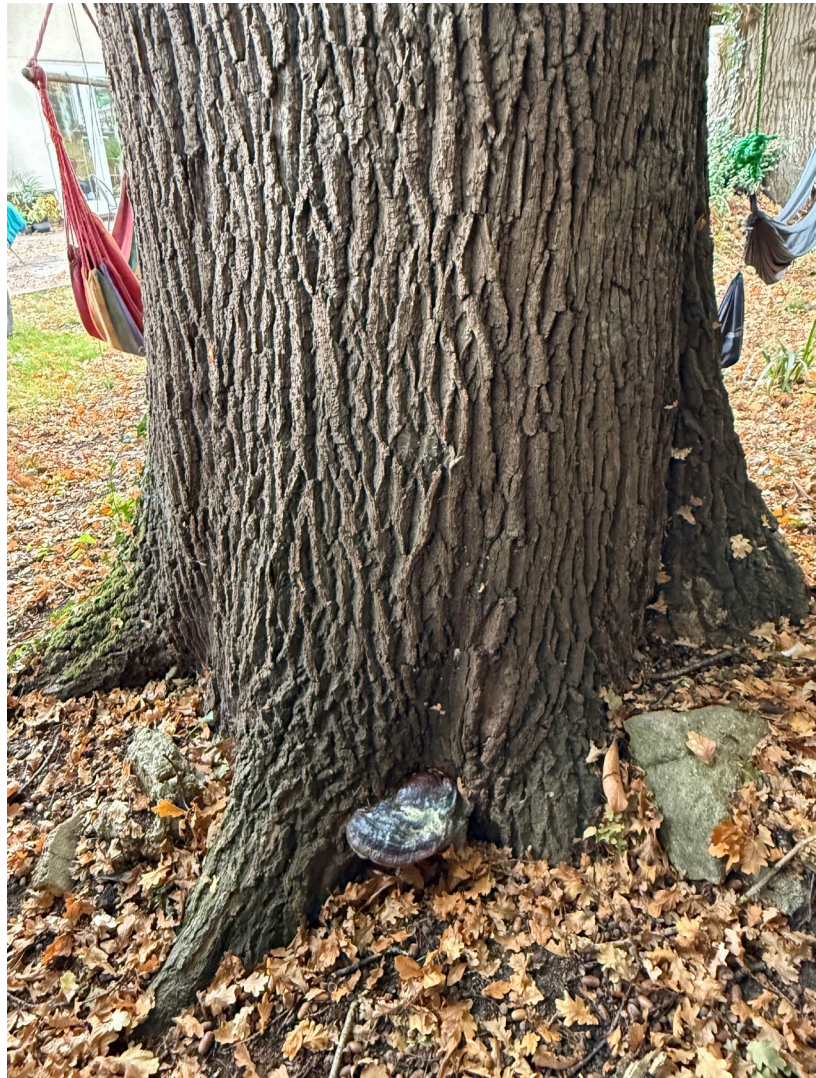
**Photograph 2:**  
Showing the  
*Ganoderma*  
*Resinaceum*  
fruiting body  
on the southern  
side of the trunk

- 5.5.3 There is a *Ganoderma resinaceum* fungal fruiting body present on the southern side of the trunk approximately 100mm above ground level and approximately 190mm wide at the time of the survey. The trunk was probed to depth of 50mm immediately beneath bracket

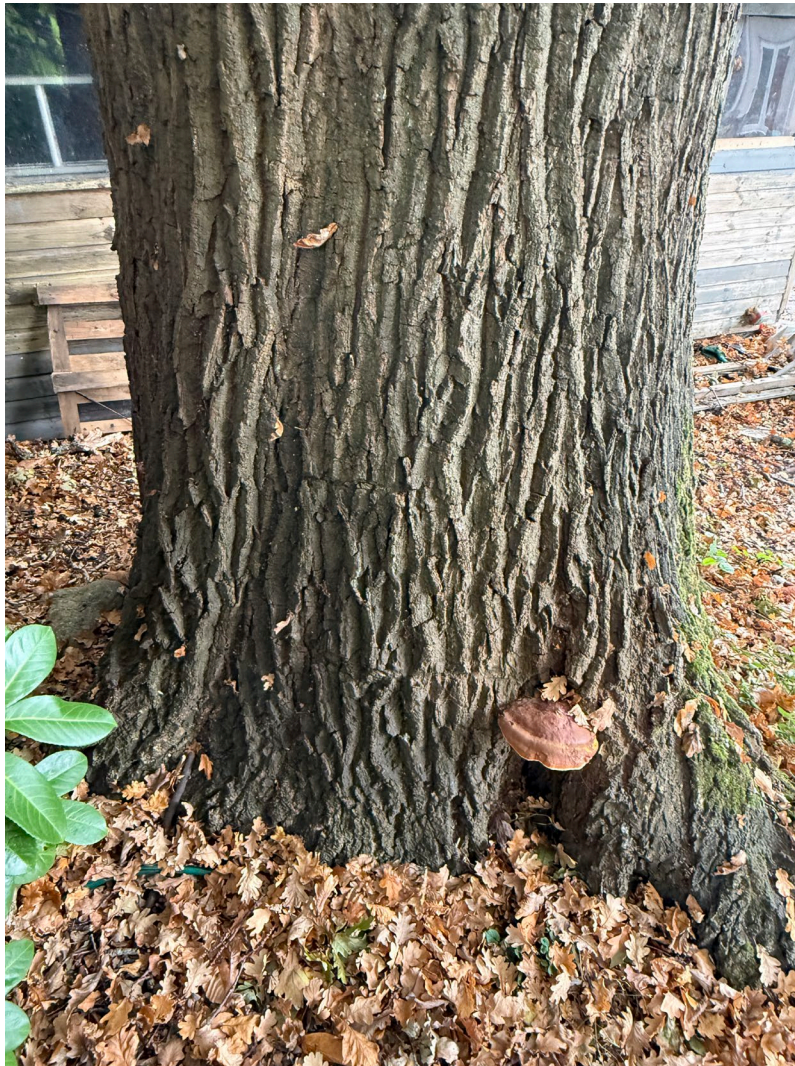
**Photograph 3:**

Showing the *Ganoderma resinaceum* to the northwestern of the trunk

- 5.5.4 There is a further *Ganoderma resinaceum* fungal fruiting body present on the southern side of the trunk approximately 350mm above ground level and approximately 240mm wide at the time of the survey. The trunk was probed to depth of 400mm immediately beneath bracket.
- 5.5.5 Principles of Tree Hazard Assessment and Management (David Lonsdale, 2001 and TMA website) attributes *Ganoderma resinaceum* to a selective white rot of wood which can cause basal cavity formation and prompts buttress development.

- 5.5.7 When the lower trunk was tapped there were no areas of distinct pockets of hollow sounding percussion other than immediately around the fruiting body on the northwestern side.

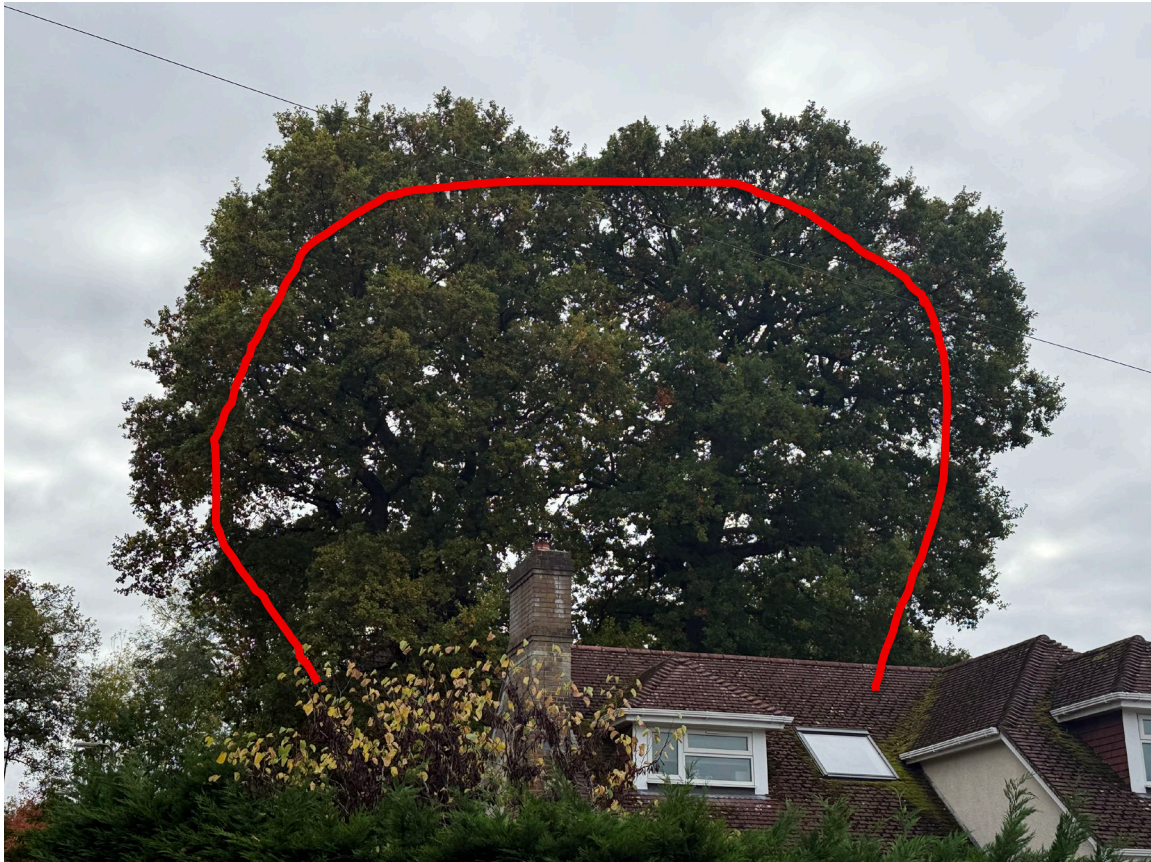
**Photograph 4:**

Indicating the approximate crown reduction (redline)

- 7.5 With the above in mind and the current visual amenity importance of the tree and its neighbouring tree, it is our view that remedial works to both trees (as they grow together) is recommended and that an application for tree works is submitted to Eastleigh Borough Council for a reduction to both trees (as detailed within the Hazard Safety Audit Schedule appended at CB2) by approximately 2m all round (with the longer protruding branches being reduced by up to 3m) to reduce the wind loading on the base of the trees.

- 7.6 This will also encourage the trees to produce new shoots and develop a smaller crown that will hopefully enable the longer-term retention and management of the

tree i.e., reduce and manage the tree so that the tree can be retained for longer as the decay spreads.

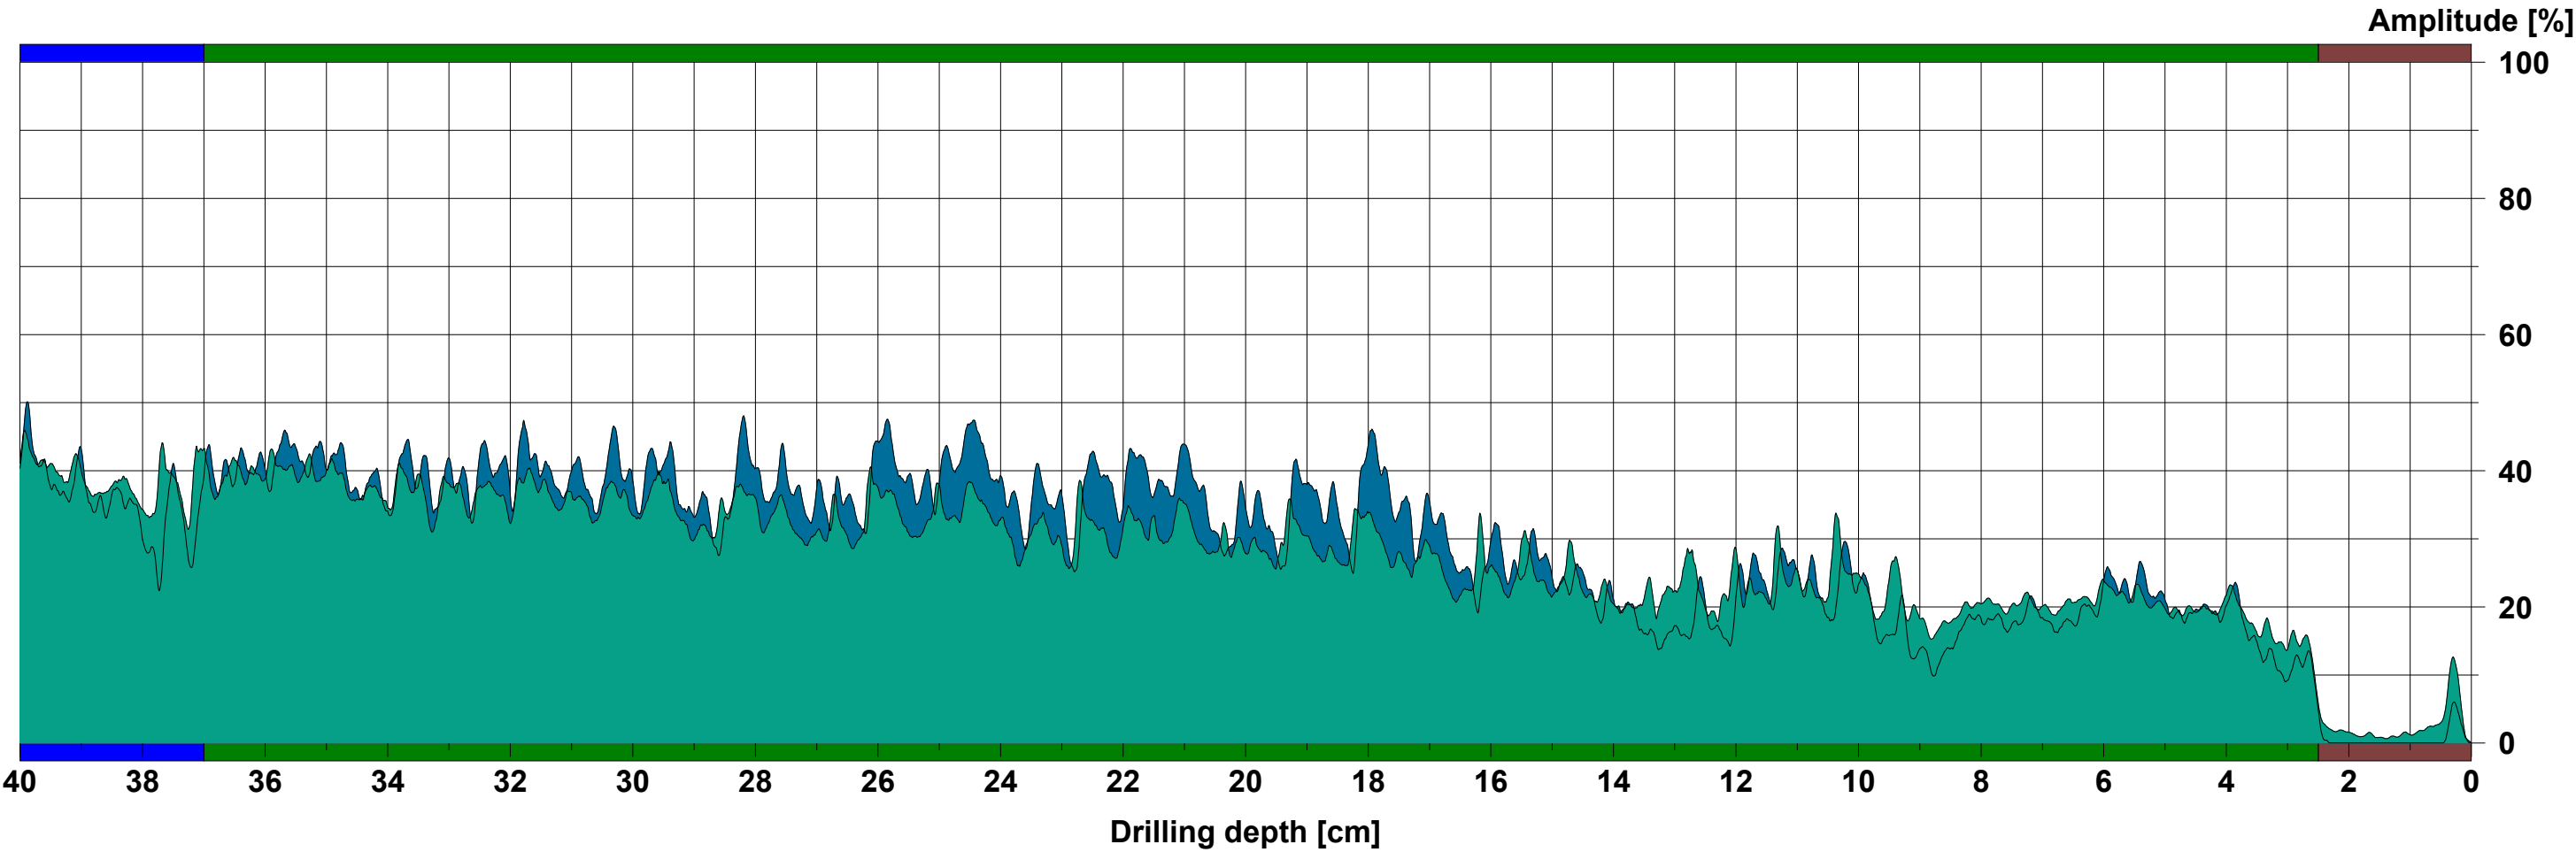
- 6.6.3 The north reading indicated that an area of potential reaction wood was present from 37-40cm depth with the remaining wood tissue being sound wood.
- 6.6.4 The southwest reading (drills behind the fungal fruiting body)0 indicates that there is decay present from 2cm to a depth of 16cm, there does not appear to be a natural barrier formed by the tree with 2cm of dysfunctional wood tissue present before sound wood is recorded to 4cm. This suggests that the decay is breaking down the tree's natural defense at this point.
- 6.6.5 Overall, the microdrill reading indicates that at the time of the assessment, there is sufficient sound wood present.

| From | 0,00 cm | to | 2,50 cm | : | Bark |
| From | 2,50 cm | to | 37,00 cm | : | Sound Wood |
| From | 37,00 cm | to | 40,00 cm | : | Reaction Wood |

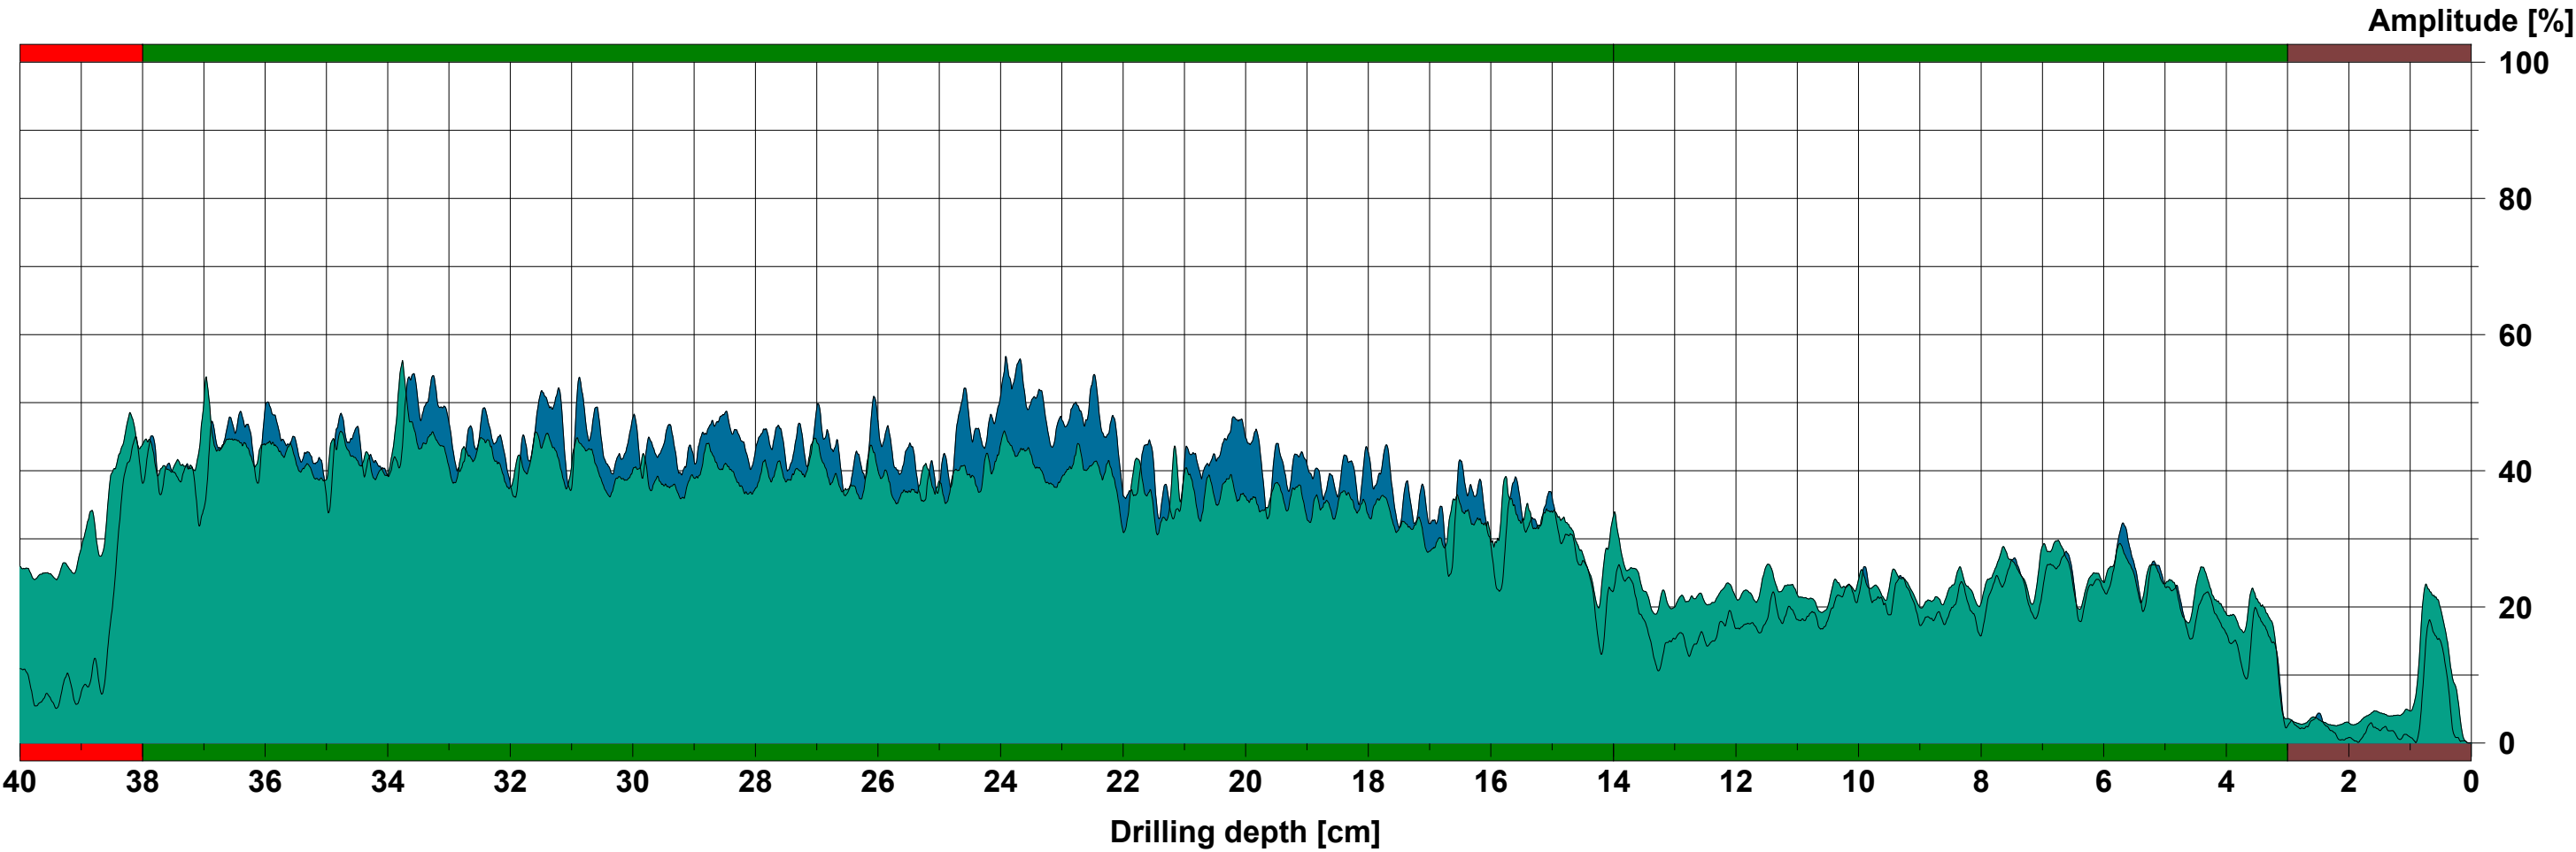
- 6.6.1 Of the five readings, the southeast and northwest readings indicated that the length of the drilling showed sound wood tissue was present.
- 6.6.2 The northeast reading indicated sound wood for a depth of 38cm and a pocket of decay from 38-40cm depth with the remaining wood tissue being sound wood.

| | From | 0,00 cm | to | 3,00 cm | : | Bark |
| | From | 3,00 cm | to | 14,00 cm | : | Sound Wood |
| | From | 14,00 cm | to | 38,00 cm | : | Sound Wood |
| | From | 38,00 cm | to | 40,00 cm | : | Decay |

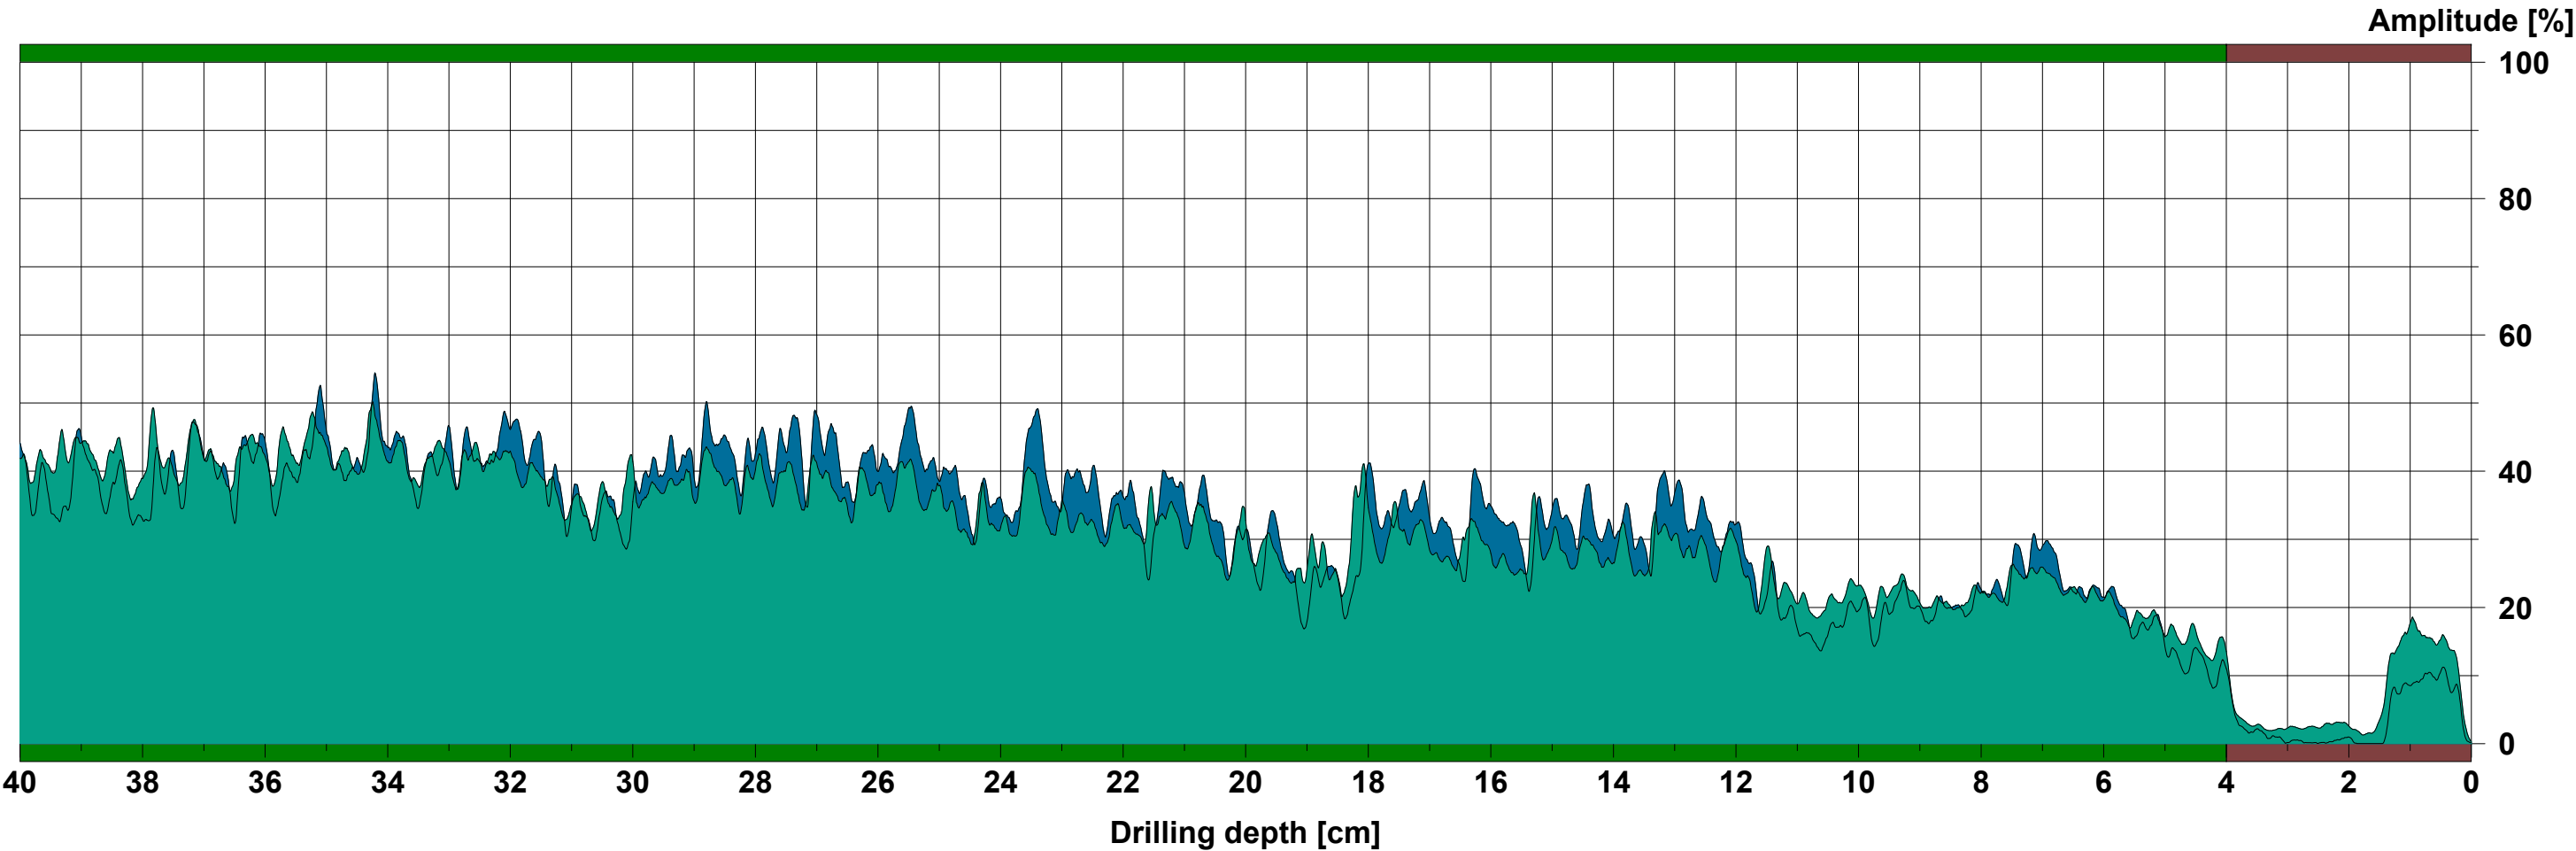
From 0,00 cm to 4,00 cm : Bark  
From 4,00 cm to 40,00 cm : Sound Wood

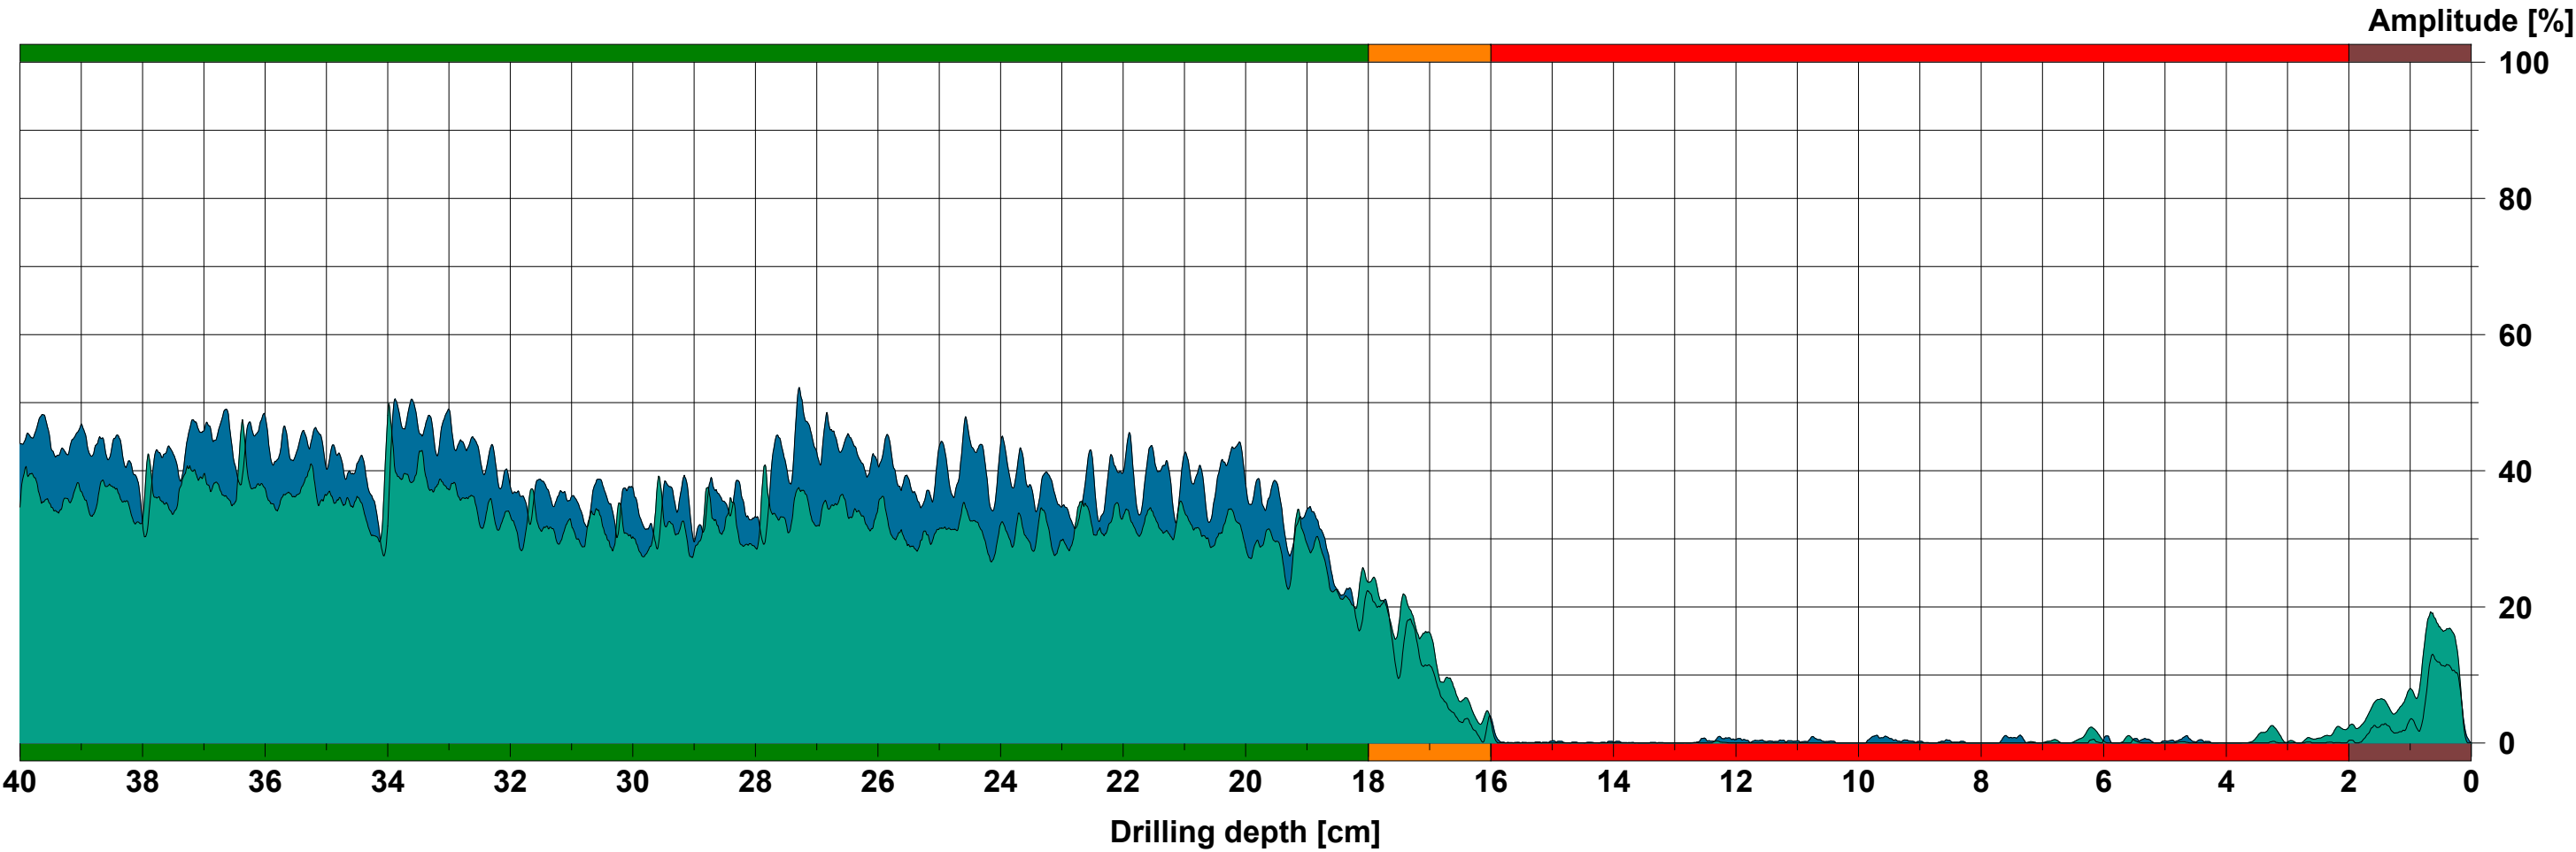
| From 0,00 cm to 2,00 cm | : Bark |
| From 2,00 cm to 16,00 cm | : Decay |
| From 16,00 cm to 18,00 cm | : Dysfunctional Wood |
| From 18,00 cm to 40,00 cm | : Sound Wood |
