| Eastleigh Borough Council Tree Preservation Order and Conservation Area Assessment Form | |
| Application Number | T/25/100112 |
| Address | 21 BEECHWOOD RISE, WEST END, SOUTHAMPTON, SO18 3PW |
| Proposed work | 1no. Beech (T1) - Remove. Tree works are proposed to stop the influence of the tree(s) on the soil below building foundation level and provide long term stability to No. 19. It is the expert opinion of both the case engineer and arboriculturist that on the balance of probabilities the supporting information demonstrates the influence of the tree(s). |

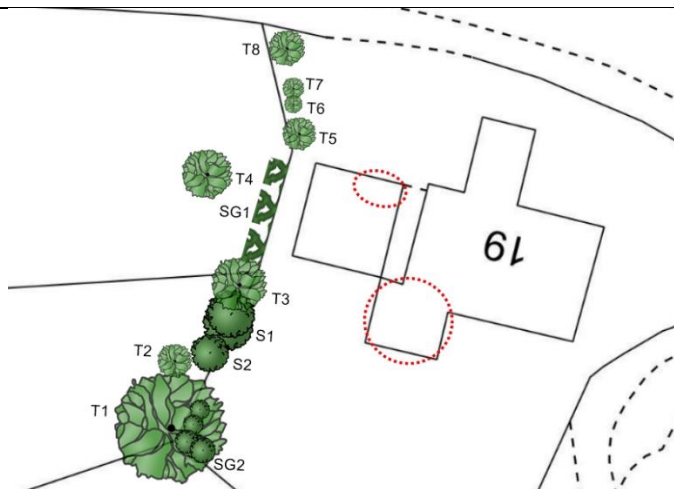
| Eastleigh Borough Council Tree Preservation Order and Conservation Area Assessment Form | |
|---|---|
| Officer comments | <p>The application beech is protected within G7, under TPO ref: 327-E, confirmed 9<sup>th</sup> May 1995.</p> <p>The tree is a large, mature beech located in the back garden of 21 but clearly visible to the public by virtue of its elevated position. It measures in excess of 20m tall and has a stem diameter of approx. 80-100cm dbh (estimated by eye). It has an asymmetric crown attributable to past competition for space with neighbouring trees since removed. There is a strip of dysfunction running from roughly shrub-height (3.5m) to 15m above ground (the height of the main V union) on the west side. Exposed ripewood is beginning to decay and there is a small cavity forming at 10m above ground level. Small fungal fruiting bodies, possibly <i>Stereum subtomentosum</i> are emerging from several locations in this dysfunctional area. The strip of dysfunction is likely due to the previous removal of mature trees to the west of T1, resulting in previously shaded bark becoming sun-scorched and dysfunctional. The large area of exposed ripewood, albeit in a narrow strip, is a long time from occlusion and it is likely that stem hollowing will follow. There is little indication that this is a near-future issue though and the application provides no advice in this respect.</p> <p>The proposal is to fell the tree on the basis that it contributes to subsidence at No.19 Beechwood Rise. This application follows T/24/98156 which was refused permission on the basis of a lack of supporting information. That application was not appealed although EBC was informed of the Insurer's intention to claim compensation.</p> <p>The below plan (from the application particulars) shows the position of T1 and the parts of the building that have become damaged (marked with red dots):</p> |

The Engineering Report states that the mechanism of damage is downward, rotational movement, towards the vegetation. This has caused step-cracking, separation between walls and ceilings and a drop in floor levels. This is consistent with the influence of trees.

BGS mapping indicates that the underlying geology is the Wittering Formation. This comprises sand, silt and clay. It is within a few tens of metres from the mapped interface with the London clay. BGS mapping is indicative only but it would seem that the underlying geology is highly likely to have significant clay component. The soil investigations find that there is a clay of medium volume change potential once the modified plasticity index has been calculated.

Level monitoring to 23<sup>rd</sup> July 2025 has been supplied. This updates evidence supplied under the previous application. There is a clear pattern of seasonal movement across all monitoring stations. The extent of movement varies across the building and demonstrates differential movement. Stations 1-5 (front right of building) show 1-4mm movement between winter and summer. Stations 6-10 (rear right of building) show up to 14mm movement between winter and summer. The greatest movement at stations 9 and 10. These stations are nearest the tree and this relationship is one which relates it to the damage. This is further reinforced by roots of *Fagus* (beech) being found in BH2, sunk adjacent to

| | <p>station 10. <i>Prunus</i> roots were also found in the borehole but the laurel which this was presumed to have originated from has since been removed.</p> <p>Alternative explanations for the damage e.g. drainage issued, have been discounted by the Engineer.</p> <p>The Agent states their intention to claim compensation under s202(e), should the application be refused permission. The stated costs are: £101,376 – to carry out repairs to the building with the tree remaining £5331 – to carry out repairs to the building with the tree removed. These figures differ considerably from what was previously warned of in the previous application (£45,000 to underpin with tree in situ, £9,500 if repaired with tree removed). It is unclear why the cost to underpin has more than doubled within the space of a year.</p> <p>The crucial evidence here is as follows:</p> <ul style="list-style-type: none"> <li>- Beech tree roots, recently alive, were found in the borehole nearest the tree;</li> <li>- There has been a pattern of seasonable movement which can only be attributable to the influence of trees;</li> <li>- There is an underlying clay subsoil, capable of volumetric change;</li> <li>- Actual damage has occurred to the property in a manner which is indicative of differential foundational movement;</li> <li>- Other potential causes have been discounted.</li> </ul> <p>In light of the above, and despite loss of amenity, it is recommended that the application is granted permission, subject to replacement planting.</p> | | | | | |
|---|---|---|---|---|---|---|
| Decision notice | Grant permission: 1no. Beech (T1) - Remove | | | | | |
| Conditions | Replacement planting (details tbc) | | | | | |
