Limewood Grange, Allington Lane, Fair Oak, SO50 7HX

Limewood Grange (Fair Oak) Man Co Lt.

2<sup>nd</sup> August 2025

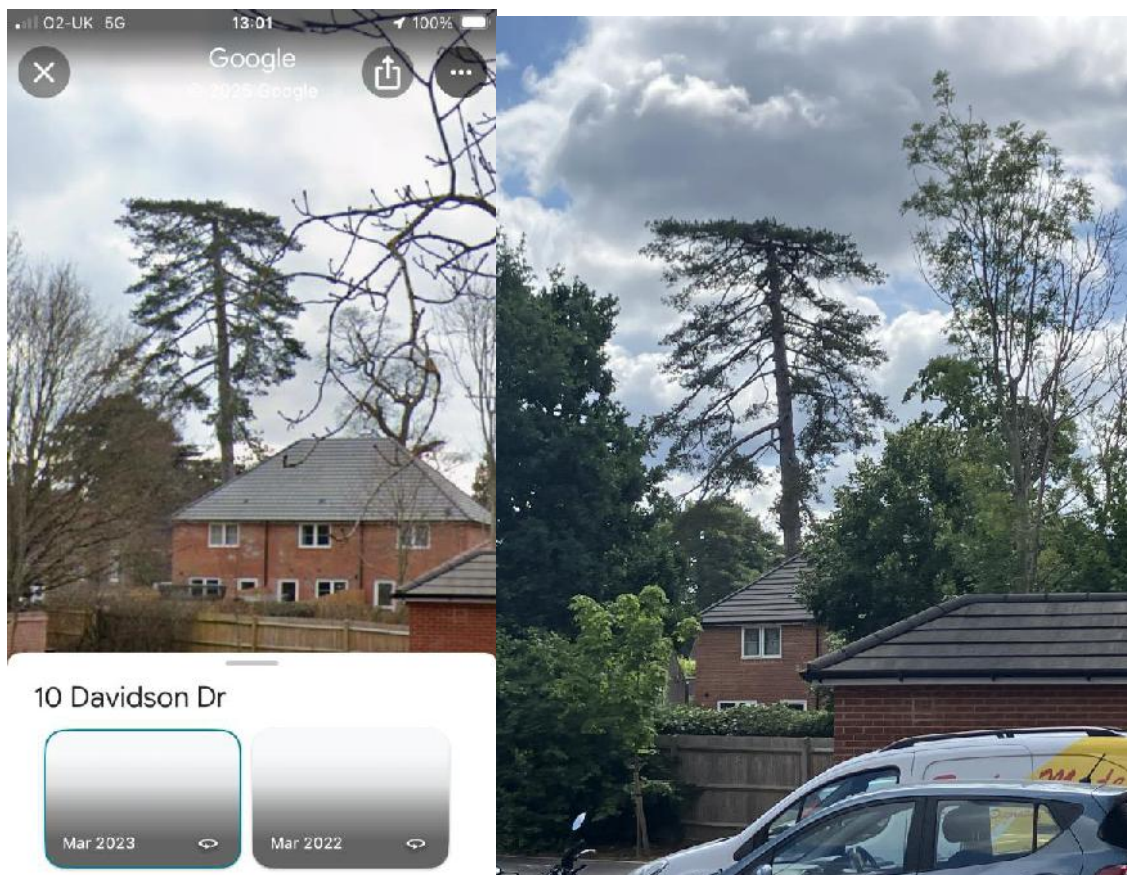
3.6. Consideration was given to the decision to remove T2 given its size and prominence. The decision was reached due to the discovery of a *Phaelous schweninitzii* fungal brackets at the base. This fungus is known to cause a loss of tensile strength, leading to brittle fractures at the stem base. A review of historic photos indicates the thinness of the crown is increasing, a sign of reducing vitality. Also, the target area should the tree fail, being a school and several houses. The reduced vitality would also mean the tree would not be able to sufficiently compartmentalize the fungi increasing its chances of failure.

**Photo 1&2: Screenshot from Google Street View taken in March 2023 (on left). Photo taken in July 2025, shown taken from approximately the same location (on right).**

| Tree Number | Species Name | Height (m) | Trunk Diameter (mm) and (stem count) | Crown Spread (m) | Physiological Condition | Structural Condition | Comments | Recommendations | Urgency |
|---|---|---|---|---|---|---|---|---|---|
| T2 | Austrian Pine (Pinus nigra) | 28 | 1200(1) | 11 | Below Average | Average | At ground level on the east side are two degraded fungal brackets measuring approximately 15cm across, both are consistent with Phaelus Schweinitzii. No indication from sounding mallet of cavitation. Multiple occluded pruning wounds on stem. Crown is sparse by 50% from normal for species, the remaining needles are shorter than normal. | Remove tree. | Within 3 Months |

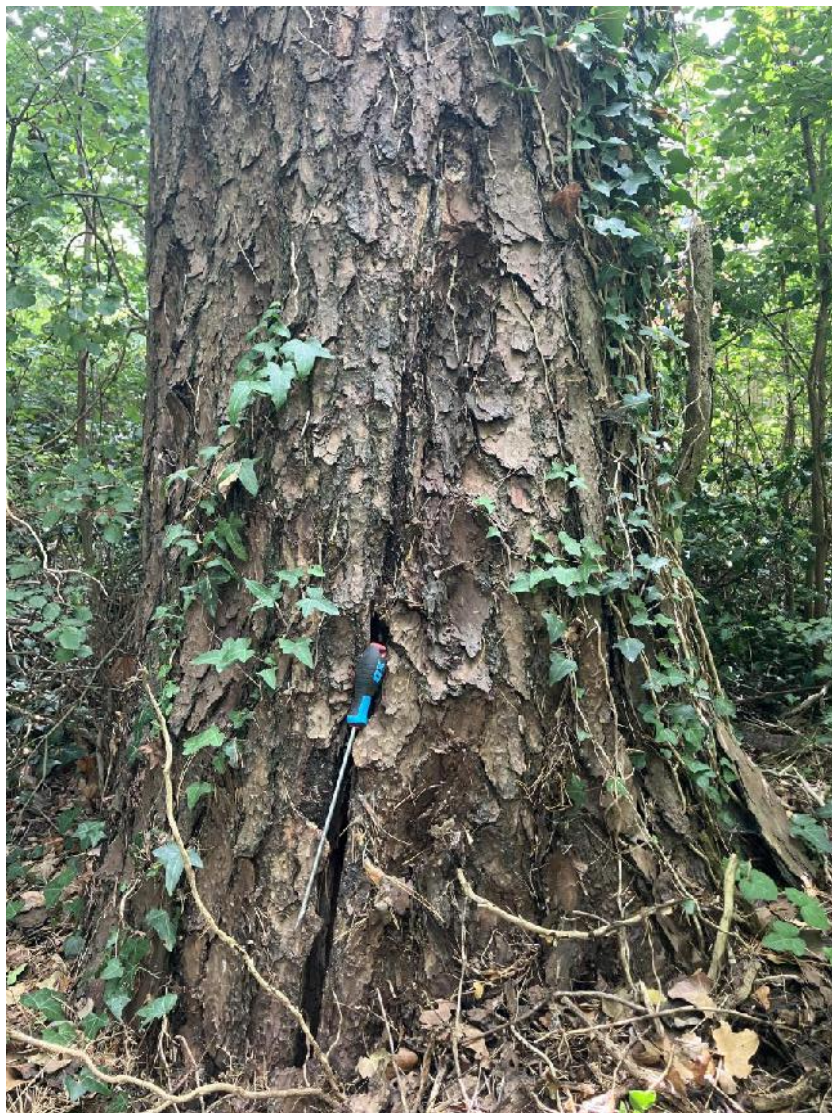
**Photo 3: Showing the split at the base of T11 – probe is approximately 60cm long.**

| Tree Number | Species Name | Height (m) | Trunk Diameter (mm) and (stem count) | Crown Spread (m) | Physiological Condition | Structural Condition | Comments | Recommendations | Urgency |
|---|---|---|---|---|---|---|---|---|---|
| T11 | Scots Pine (Pinus sylvestris) | 25 | 850(1) | 10 | Average | Poor | Large split from ground level to 1.4m on the north side of the tree. Sounding hammer indicated cavitation over 40% of stem, suggesting the crack propagates over a large area. Tree growing at an angle of 20° to the south (towards houses) with the crown completely on the south side. Slight gap between the crown and the adjacent tree suggests the tree has moved away from the neighbour in recent years, possibly when the split first occurred. | Remove tree. | Within 2 months |

3.7. The cracking noted in the lower stem, its lean towards the properties, and the very one-sided crown of T11 make its removal a high priority but it should be considered ASAP. A two-month timeframe has been suggested to allow for the TPO application process. However, the author considers this could be done under a 5-day notice.

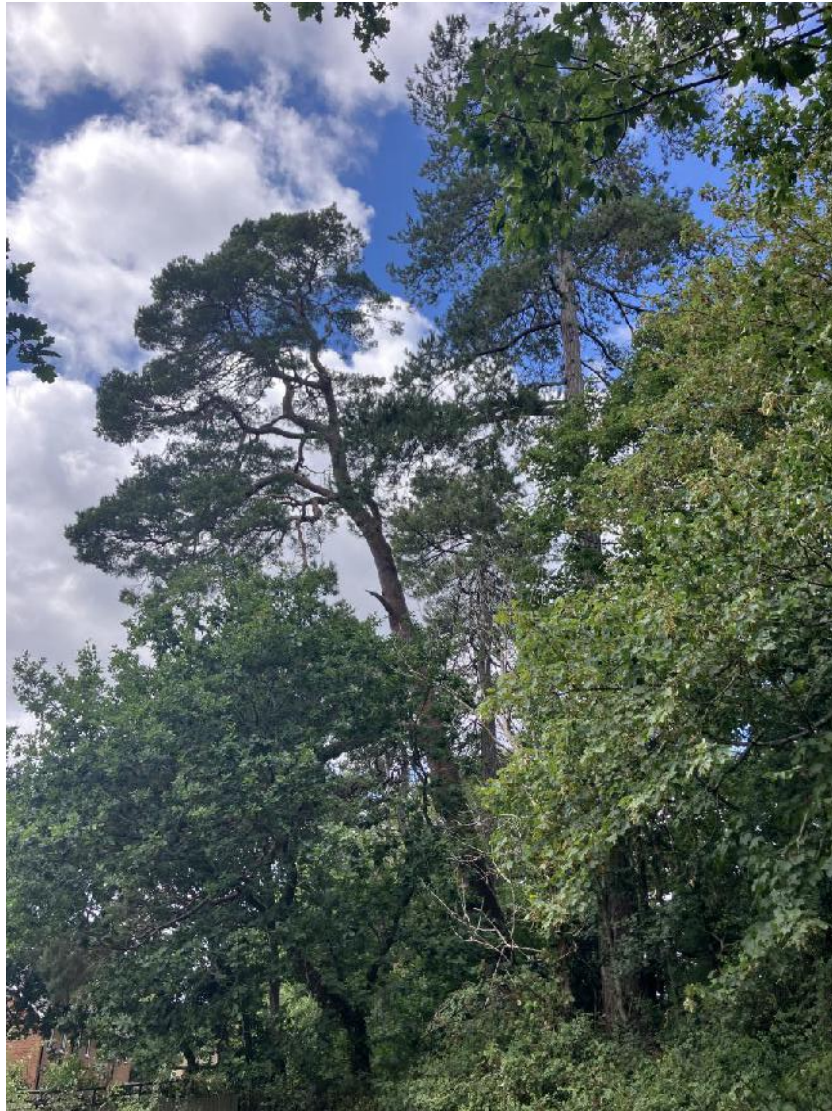
**Photo 4: Showing the lean of T11.**
