# Site Investigation Report

192760.1.USI

Auger were commissioned by Questgates to undertake a site investigation and CCTV inspection of the underground drainage within the area of concern (AOC) at the property.

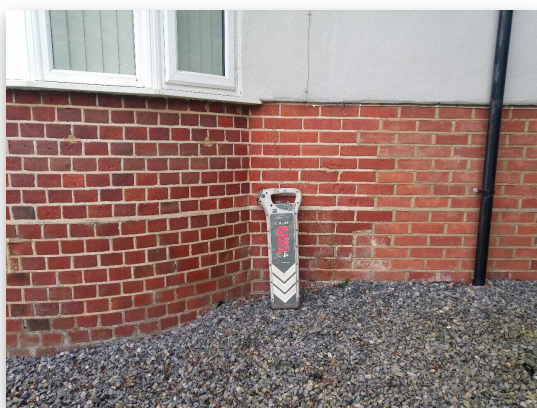
Fig 1.1: Trial Hole 1 Location

TH1 was undertaken in the desired location, we were able to expose the footings but we were unable to reach the required depth in TH1 because we encountered impenetrable ground consisting of fill material which our engineer could not auger through at 0.7m below ground level. Due to this we then carried out a borehole, stepped back from the trial hole, which our engineer was able to reach a depth of 1.1m within and we collected the requested soil and root samples from the borehole.

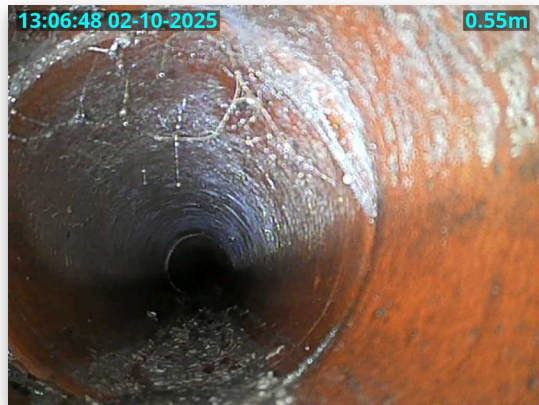
Fig 2.1: Line 2.

Our survey of line 2 revealed minor joint displacements and cracking within the 3m of 100mm pipework downstream of the manhole, within the area of concern.

| 0.6m | Crack - Circumferential |
| 0.6m | Joint Displacement - Medium |
| 2.7m | Crack - Circumferential |

| Refer Back to Client | <p>It is recommended that the following repairs are carried out to prevent an escape of water from the system:</p> <p><b>Line 2</b><br/>Install 3m of 100mm liner directly downstream of MH1 to seal the pipework within the area of concern.</p> <p><b>Line 4</b><br/>We will need to carry out root cutting and jetting to remove the roots from the line. We will then need to conduct a further CCTV investigation downstream on this line to confirm that the roots are solely growing up from the soakaway as was found in line 3 and that the pipework is in good condition.</p> <p>Please note that the further CCTV investigation may reveal additional defects to the drainage system. This will be reported whilst on-site and could potentially cause an increase in repair costs and provide further inconvenience to the customer/occupants.</p> <p>We will now refer the claim back to the client in order to progress the claim.</p> |

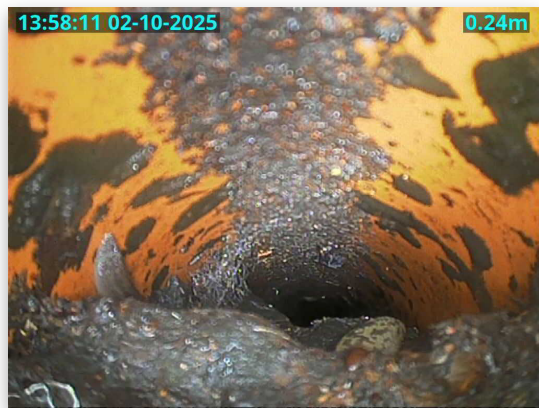
Fig 2.3: Line 4.

Our survey of line 4 revealed root ingress within the plastic pipework. We suspect that this line, like line 3, runs to a soakaway located within the front garden and that the roots have grown up from the soakaway. However, we had run out of time of site to attempt to root cut this line to confirm this. We therefore propose that this line is further investigated to confirm that the roots have not penetrated the plastic pipework and that they are solely growing up from the soakaway.

| 0.2m | Roots - Mass 80% |
| 0.2m | Survey Abandoned (UNABLE TO SURVEY. LINE NEEDS ROOT CUT) |
