# INSURANCE INCIDENT REPORT

Kintyre, Windmill Lane  
Southampton  
SO31 8BG

QG1U1366108

3rd September 2025

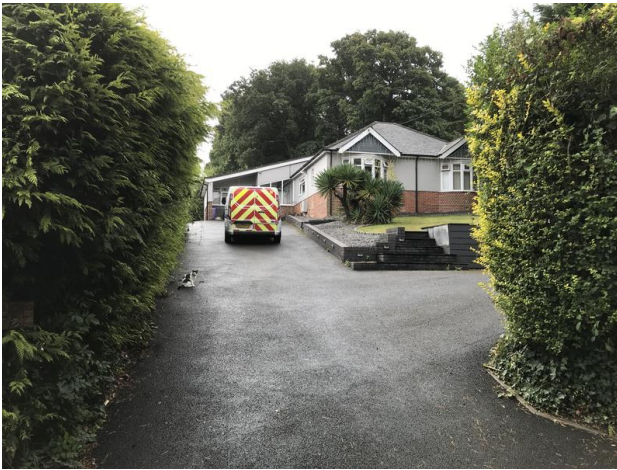
The level of the site generally falls from the rear down to the front. The variation in level is estimated to be 6 metres across the site. To accommodate the sloping site, there are retaining walls within influencing distance of the property. These retaining walls are however observed to be plumb and stable. There is considered to be no risk of slope instability of the site.

**Photo 3 - Sloping site front**

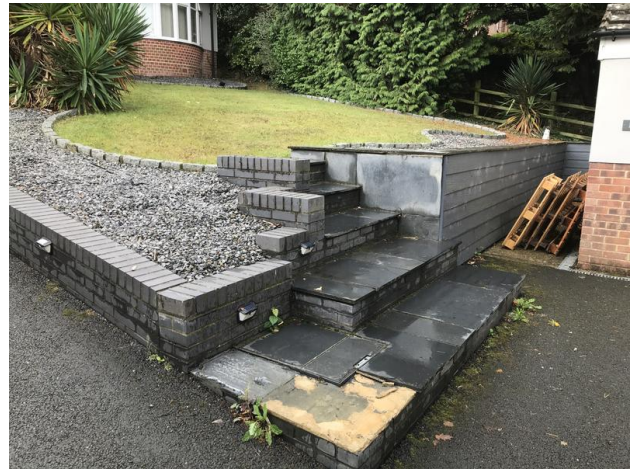
**Photo 4 - Retaining wall front**

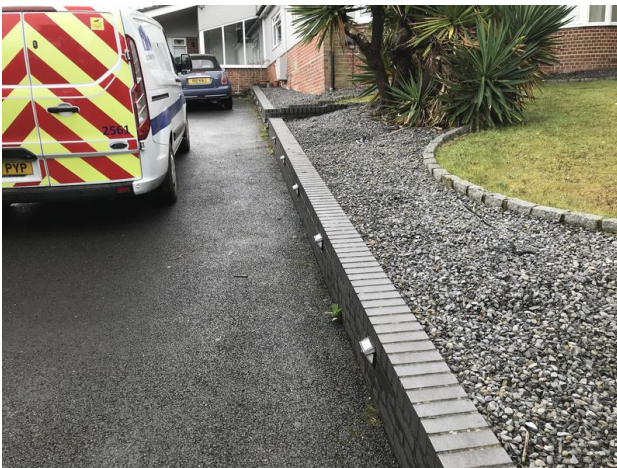
**Photo 5 - Retaining wall front**

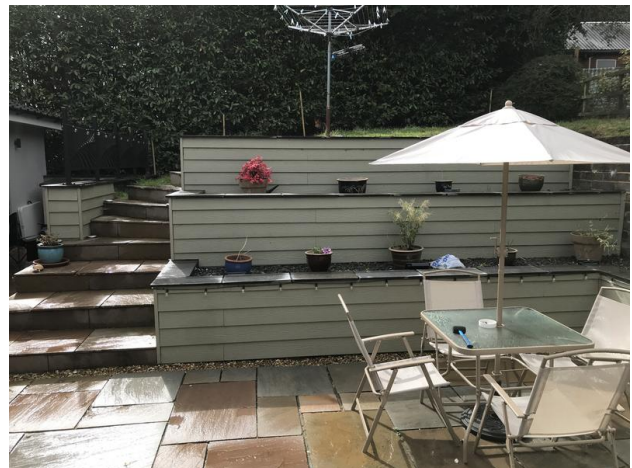
**Photo 6 - Sloping site rear**

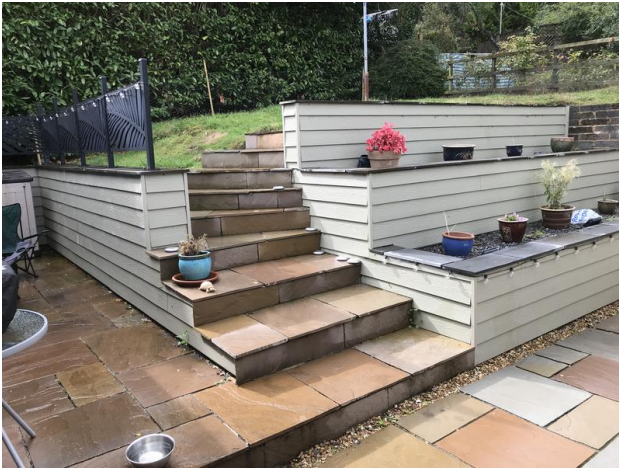
**Photo 7 - Stepped retaining wall rear**

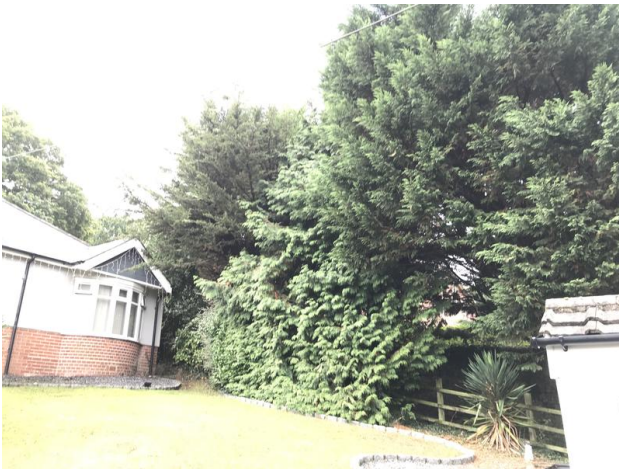
**Photo 8 - TG1**

| Name | Species | Height | Distance to property | Owner | Action |
|---|---|---|---|---|---|
| T1G1 | Conifer, cypress, holly and other species | 8 metres | Less than 2 metres | Neighbours' Property | Await arboriculturist report |

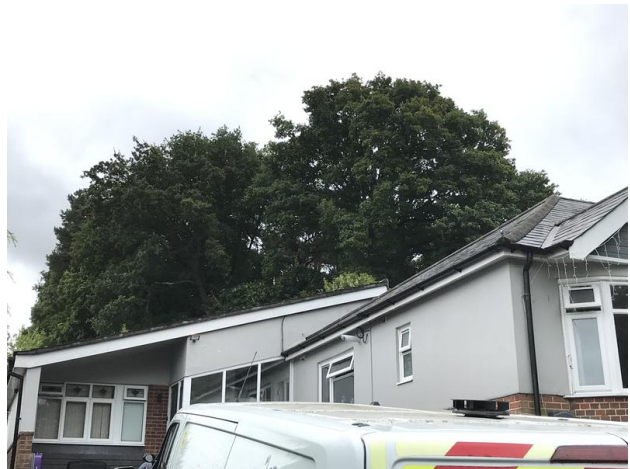
**Photo 9 - TG2**

| Name | Species | Height | Distance to property | Owner | Action |
|---|---|---|---|---|---|
| TG2 | Oak | 20 metres | 5 metres | Neighbours' Property | Await arboriculturist report |

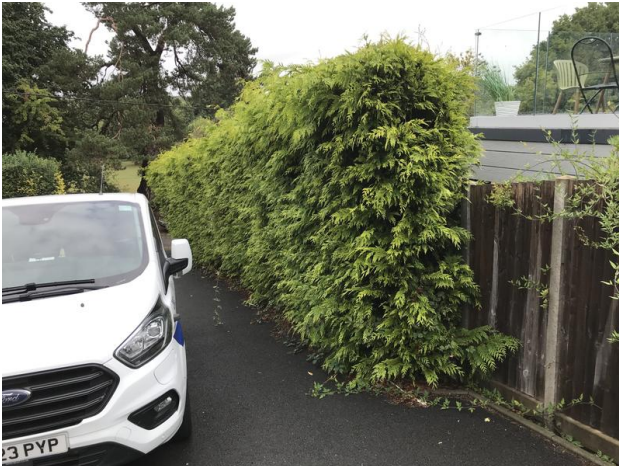
**Photo 10 - HG3**

| Name | Species | Height | Distance to property | Owner | Action |
|---|---|---|---|---|---|
| HG3 | Conifer | 3 metres | 7 metres | Subject Property | Await arboriculturist report |

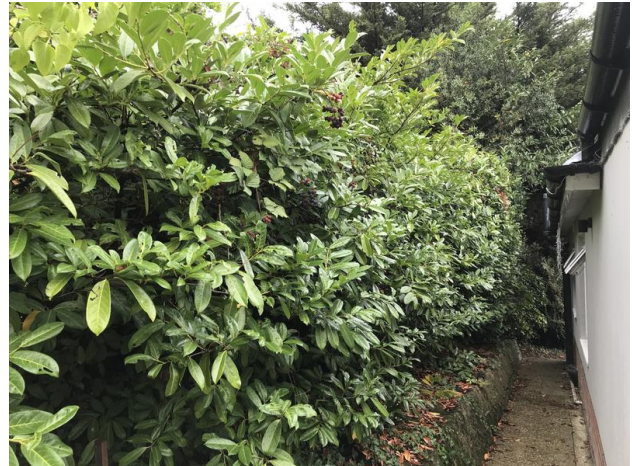
| Name | Species | Height | Distance to property | Owner | Action |
|---|---|---|---|---|---|
| HG4 | Laurel | 2 metres | Less than 1 metre | Neighbours' Property | Await arboriculturist report |

**Photo 11 - HG4 Laurel**

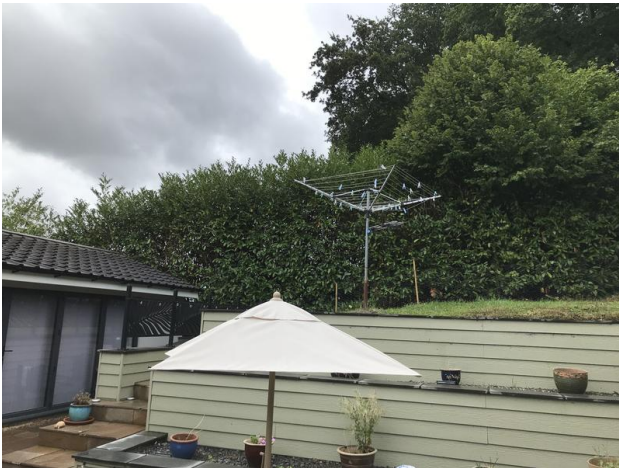
| Name | Species | Height | Distance to property | Owner | Action |
|---|---|---|---|---|---|
| HG5 | Laurel | 2 metres | 2 metres | Subject Property | Await arboriculturist report |

**Photo 12 - HG5 Laurel**

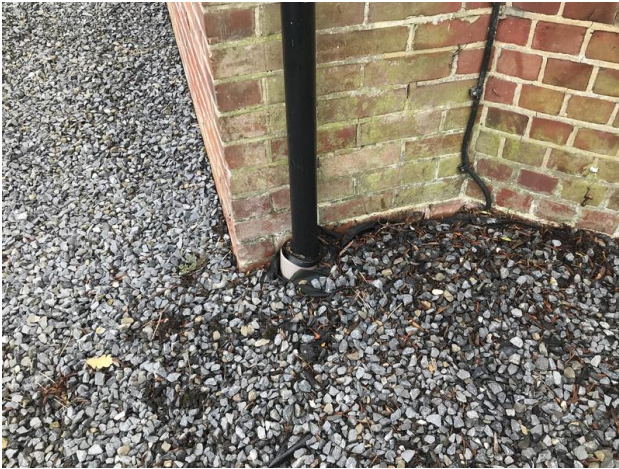
**Photo 13 - Downpipe gully FLC**

Given the potential issues with the underground drainage pipes, it would be recommended that the drainage system local to the front elevation of the building is subject to a CCTV drains survey by a specialist drainage contractor. This survey should confirm the condition and integrity of the underground pipes and determine whether any repairs are necessary.

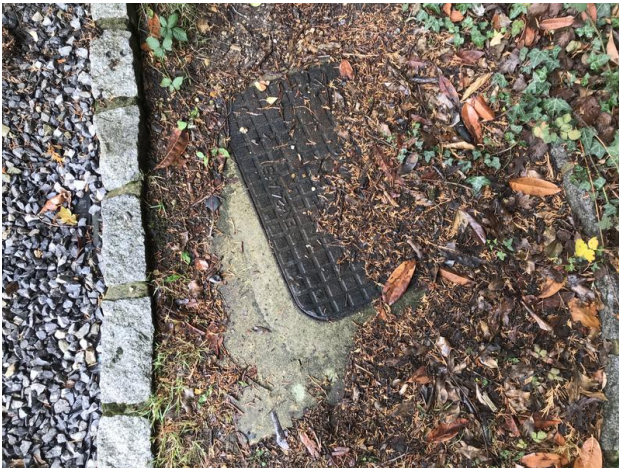
**Photo 15 - Inspection chamber FRC**

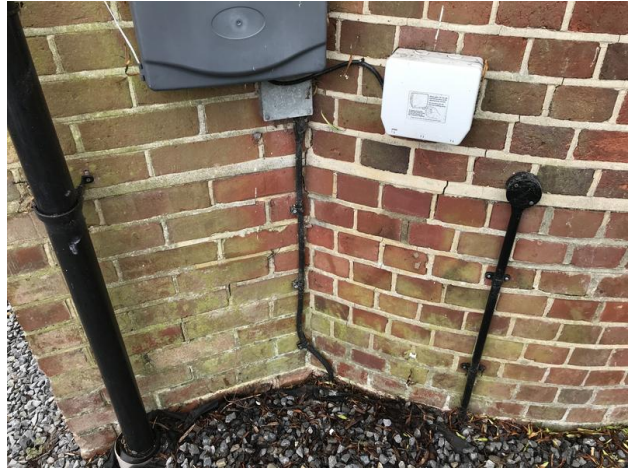
The damage is structural cracking to a front bay window. This cracking is consistent with rotation of the front bay window in relation to the front elevation of the bungalow most likely through subsidence foundation movement. (Please refer to further commentary in this regard below).

In this instance the damage is Category 2 - Slight

Upon the front elevation are two semi-circular bay windows. There is observed to be cracking within the dado facing brick of the left-hand bay window which continues into the left-hand junction between the bay and front elevation. Distortion then continues into the uPVC framing of the window with an open joint having formed at the juncture of the window frame and masonry surround.

The pattern of cracking is indicative of rotation of the front bay window in relation to the front elevation of the bungalow.

Photo 19 - Cracking LHS of front bay window

(i) To establish the exact cause of structural movement, a trial pit/borehole excavation upon the front right corner of the left-hand bay window. The trial hole to be used to establish the foundation depth of both the front bay and front elevation of the bungalow. The trial hole extended by hand auger up to 3.0 metres inclusive of shear vane, probe tests, soil sampling/analysis and tree root identification.

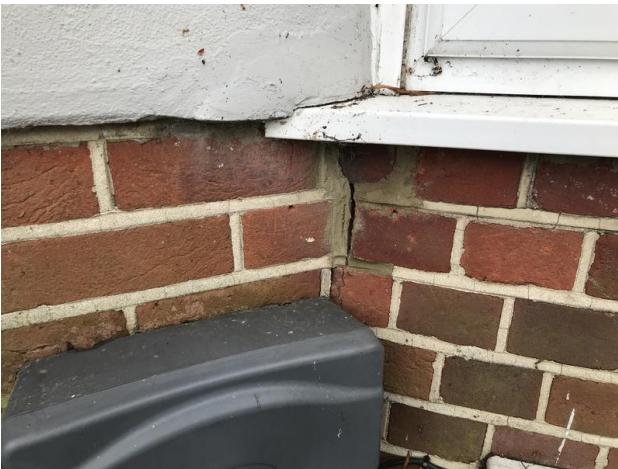
Photo 20 - Open joint at junction with front elevation

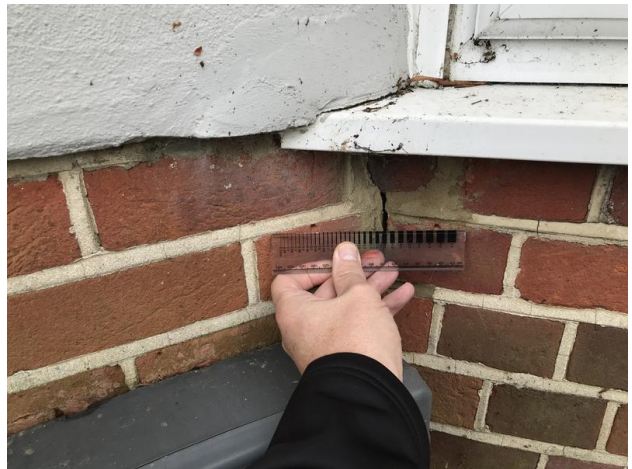
Photo 21 - Joint width 3.5 mm

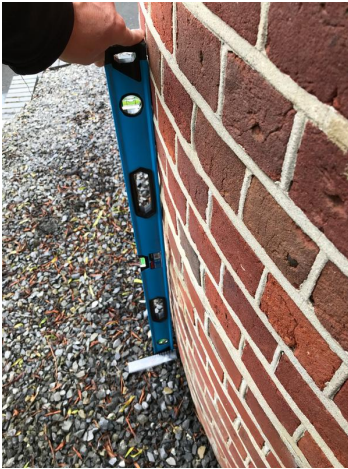
Spirit level measurements confirm that there is slight rotation to the bay dado wall in relation to the front elevation which remains reasonably plumb and within tolerance since original construction.

**Photo 22 - Slight tilt and rotation of dado wall**

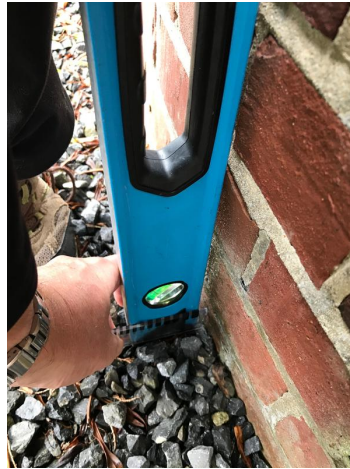
**Photo 23 - Rotation 10 mm over 1 metre height**

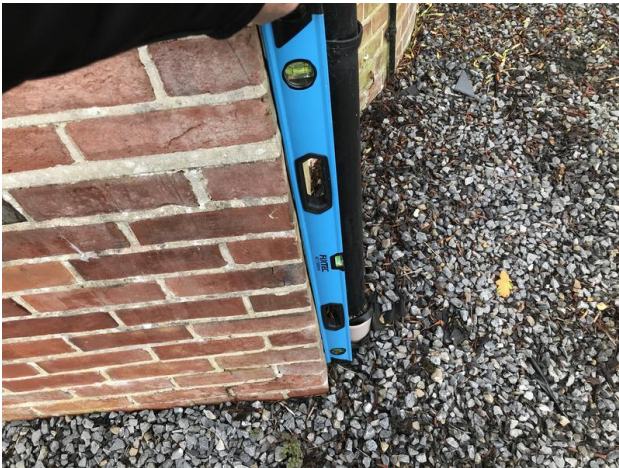
**Photo 24 - Front elevation remains plumb**

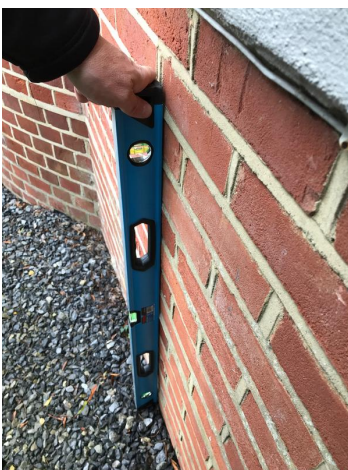
**Photo 26 - Front elevation remains plumb**

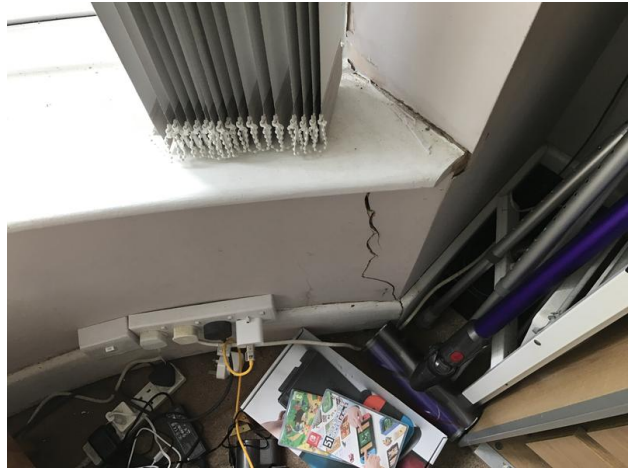
Internal observations from within the front left-hand bedroom show a tapering crack of up to 5 mm in width to the inner leaf of the cavity wall at the junction of the bay window and front elevation mirroring the cracking observed externally.

Photo 28 - Tapering crack LHs of bay window

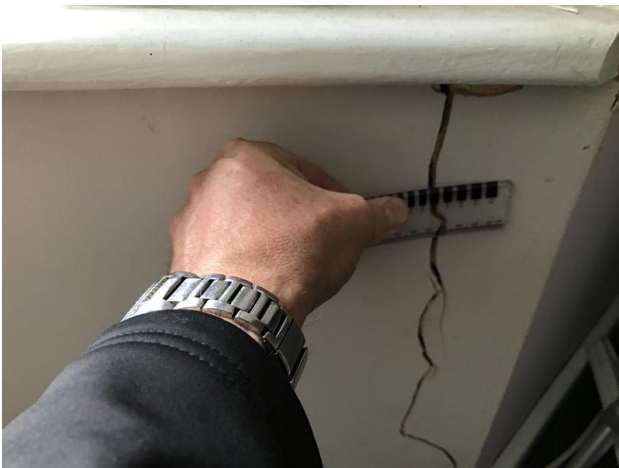
Photo 29 - Crack width 5 mm

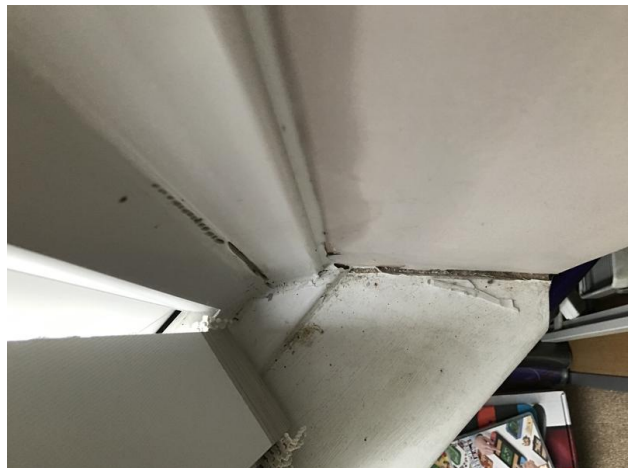
Photo 30 - Distortion continues into window frame

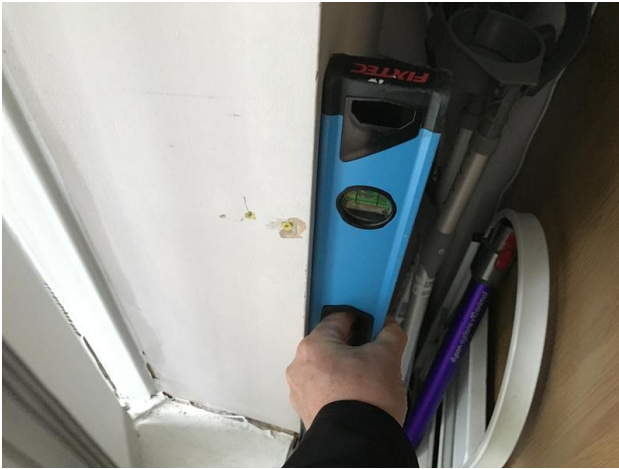
**Photo 31 - Front elevation plumb**
