## **Arborist Report – Tree Root Damage Assessment**

Property Address: 61 Ullswater Avenue, Southampton, SO18 3QS

Date: 12 August 2025

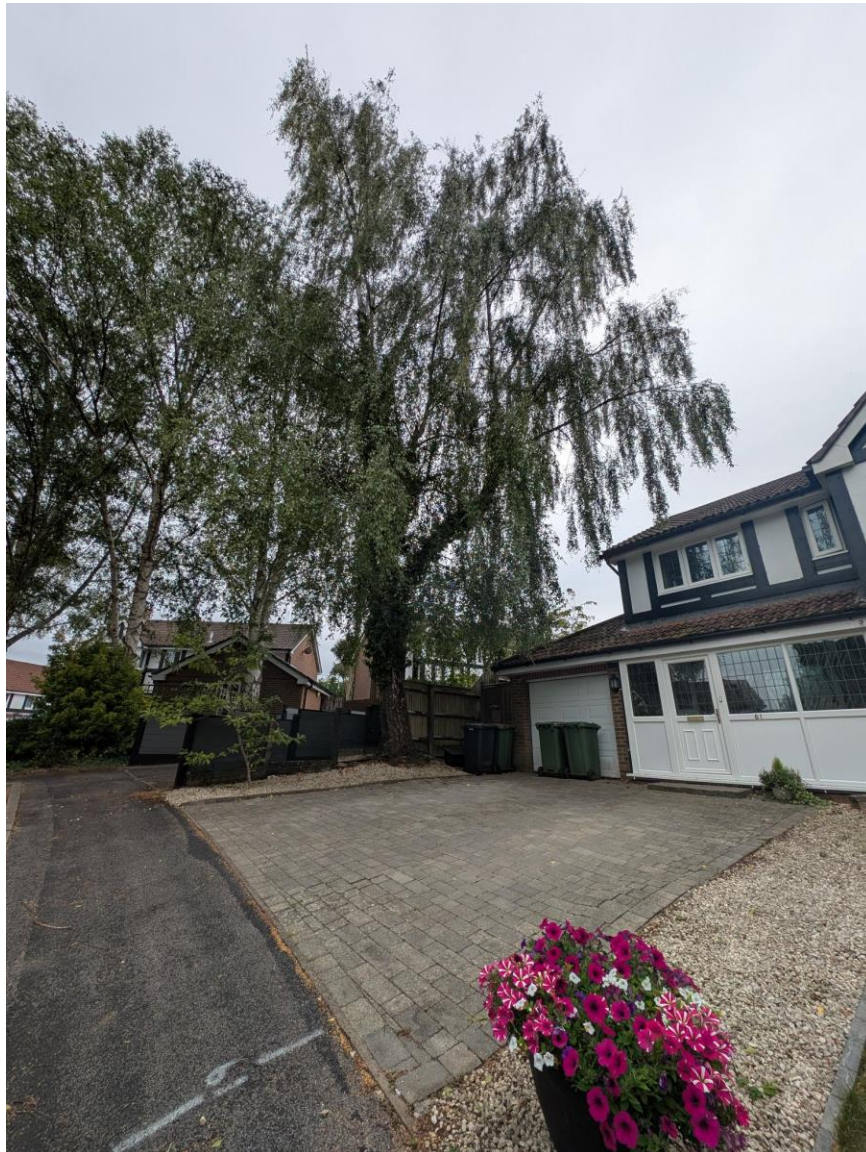
T1 Silver Birch – Location adjacent to driveway & property

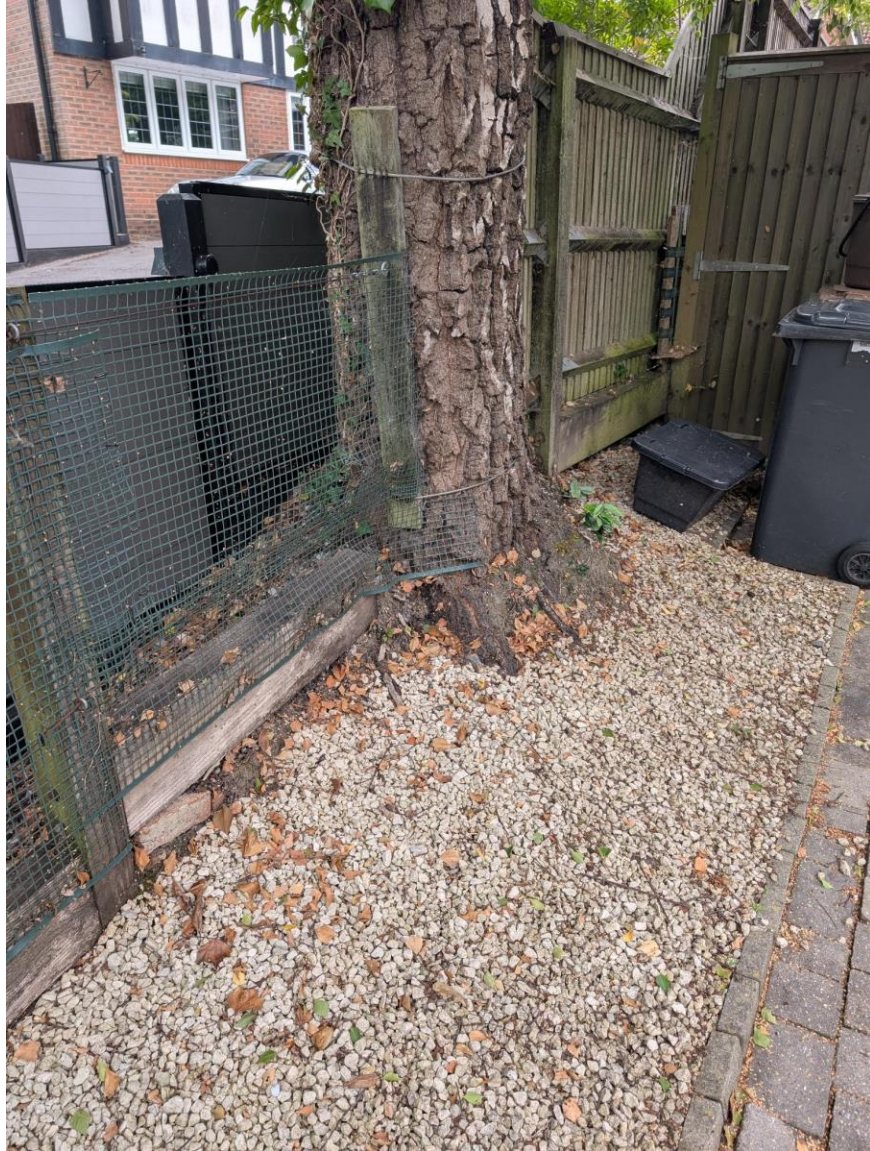
T1 - Basal flare & raise surrounding ground

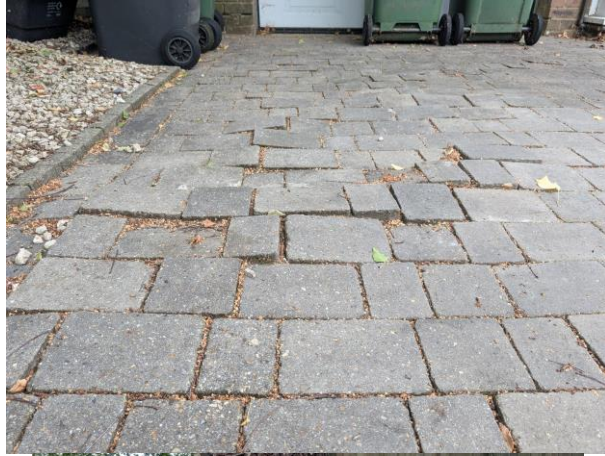
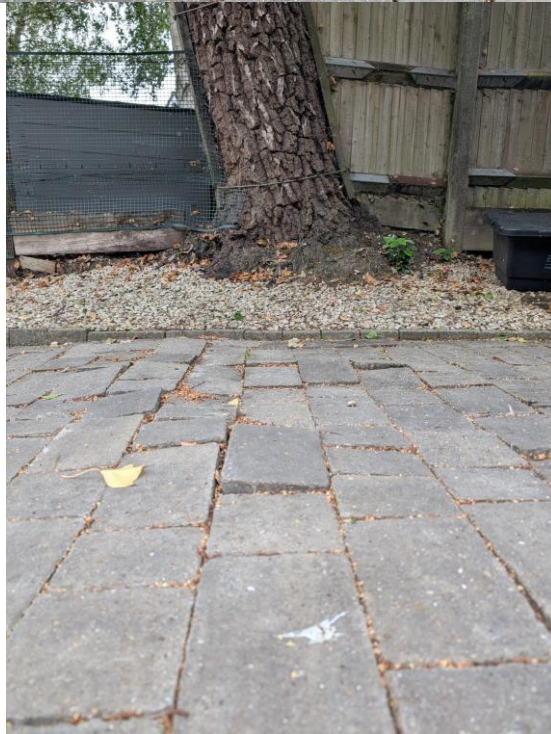
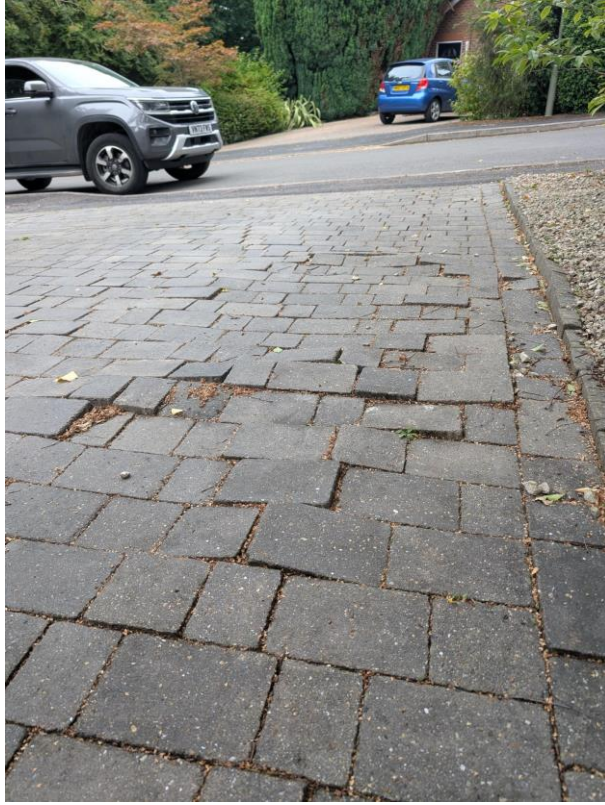
- Root growth has exerted upward pressure on the driveway structure, compromising its integrity lifting driveway paving stones.
- The damage is progressive and likely to worsen as the tree continues to grow without intervention.
- Repairing the driveway without addressing the root cause would be ineffective as this would continue to progress over time.
- The trees size and proximity to the property make alternative mitigation measures such as root pruning impractical and potentially harmful to the trees health.

T1 – Driveway immediately adjacent to T1 displaying raised and uneven paving stones.

- Tree Removal: Due to the extent of root damage and lack of alternative mitigation options that preserve both the tree and driveway, removal is recommended.
- Replacement Planting: A suitable replacement tree may be planted in a suitable location that avoids future conflict with built infrastructure.

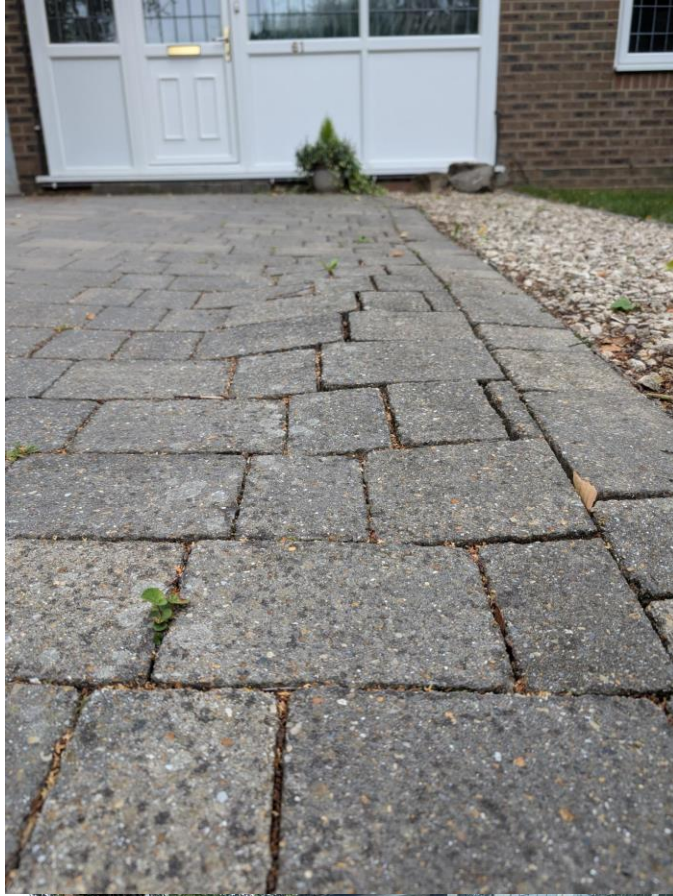
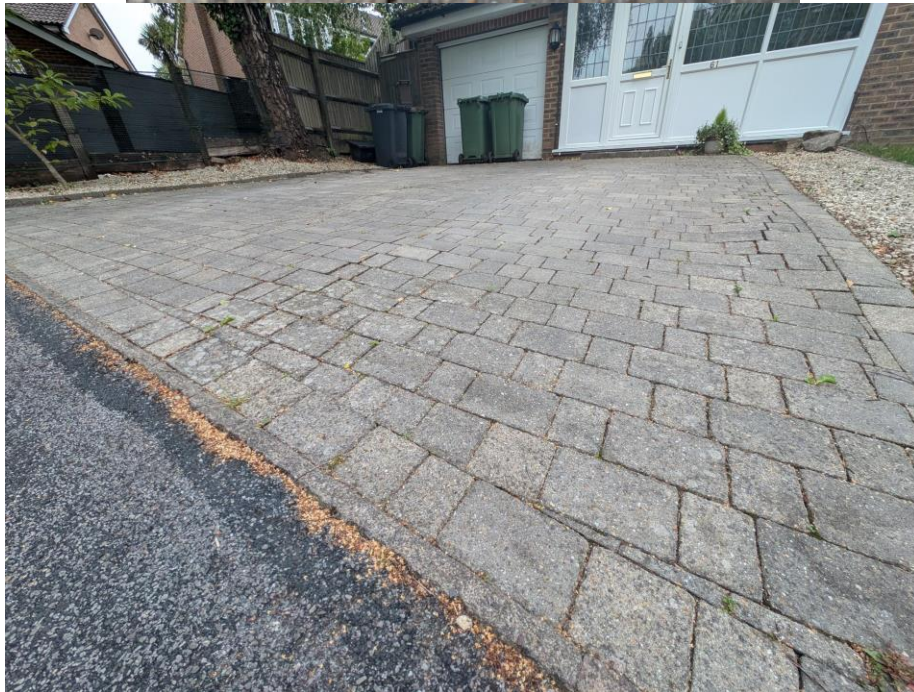
T1 – Area of raised & uneven paving stones approx. 6m away from tree location.

The tree, while of good amenity value, is causing demonstrable damage to the driveway at the property and presents ongoing risks with current root damage measured at approx. 6m away from the trees location. Given the extent of the damage, the trees position, and the lack of viable alternatives, removal of the Silver Birch and replant of a suitable alternative species would appear to be the only reasonable course of action.
