## **Arboriculture Single Tree Report**

174 Hiltingbury Road  
Chandlers Ford  
Eastleigh,  
Southampton,  
SO53 3NS

Prepared by: Bradley Street, Dip Arb I4 (ABC)  
Consultant Arborist

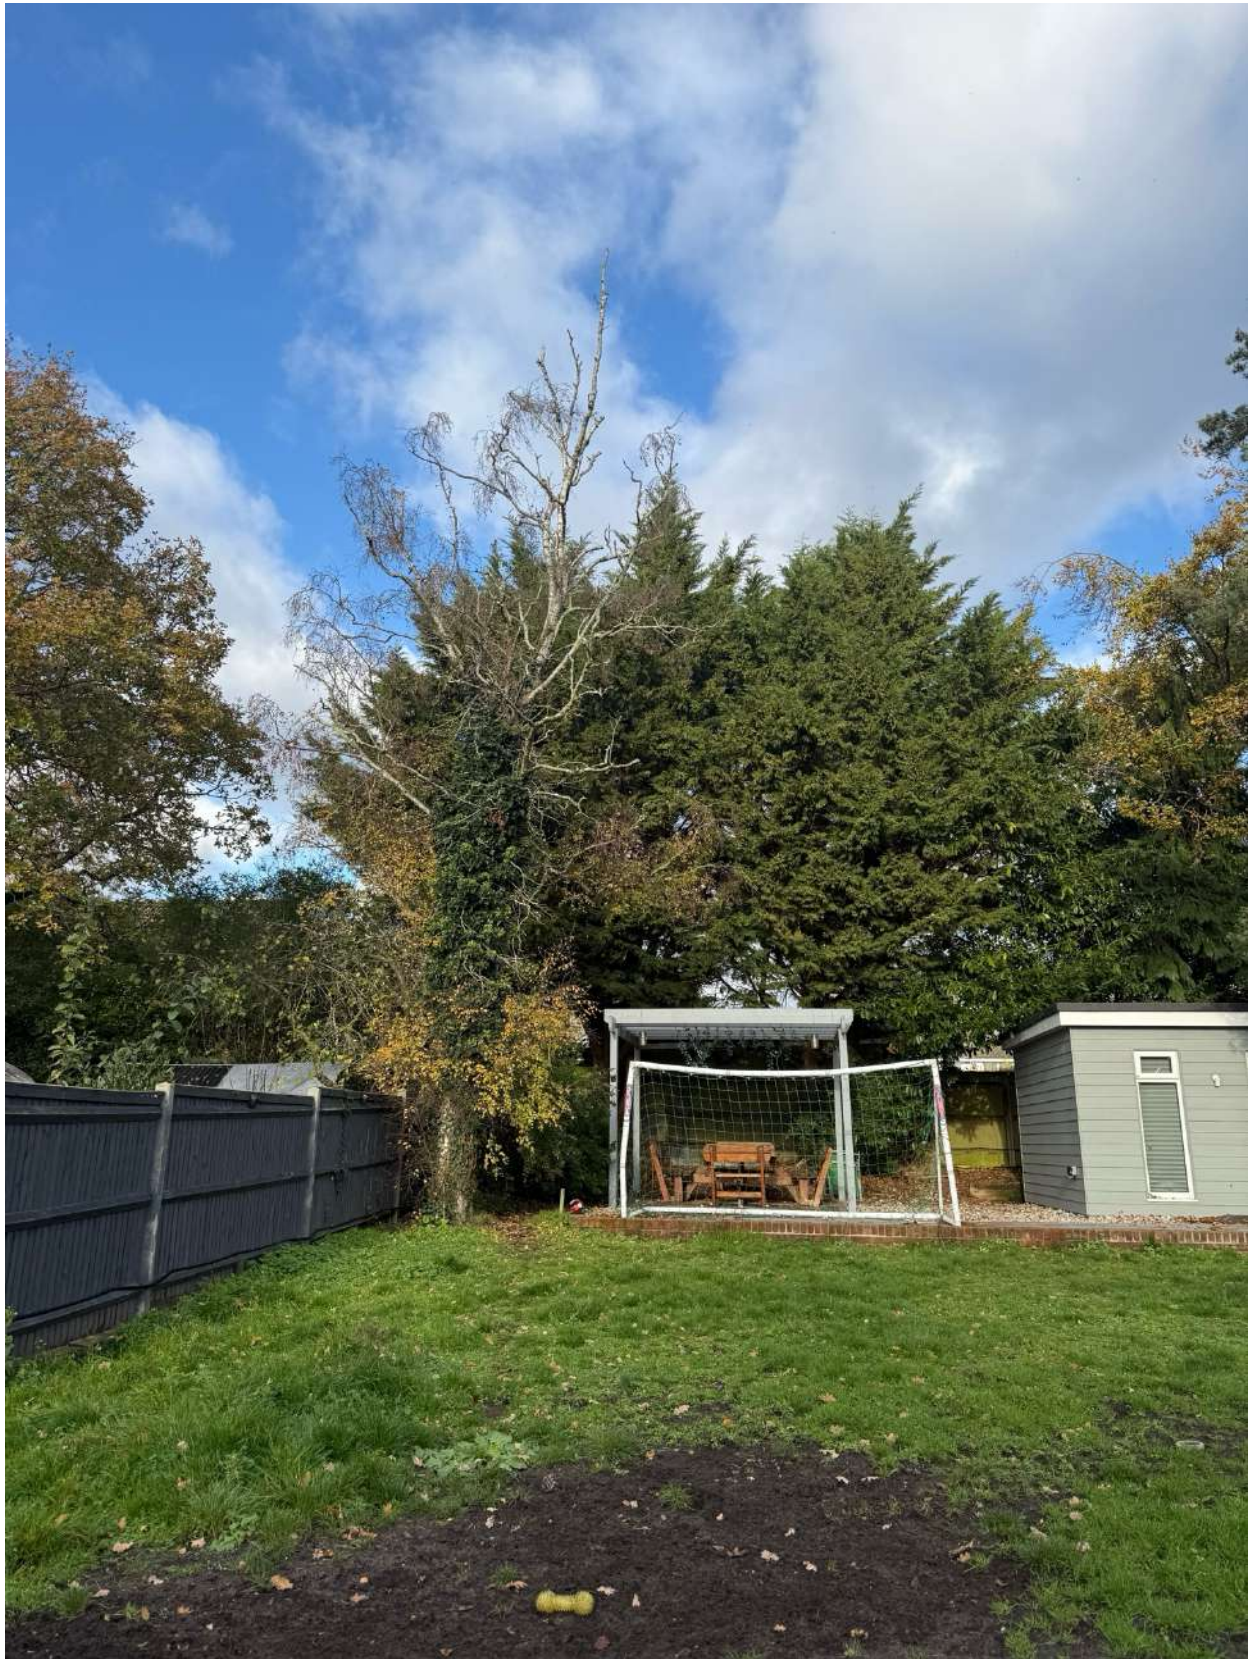
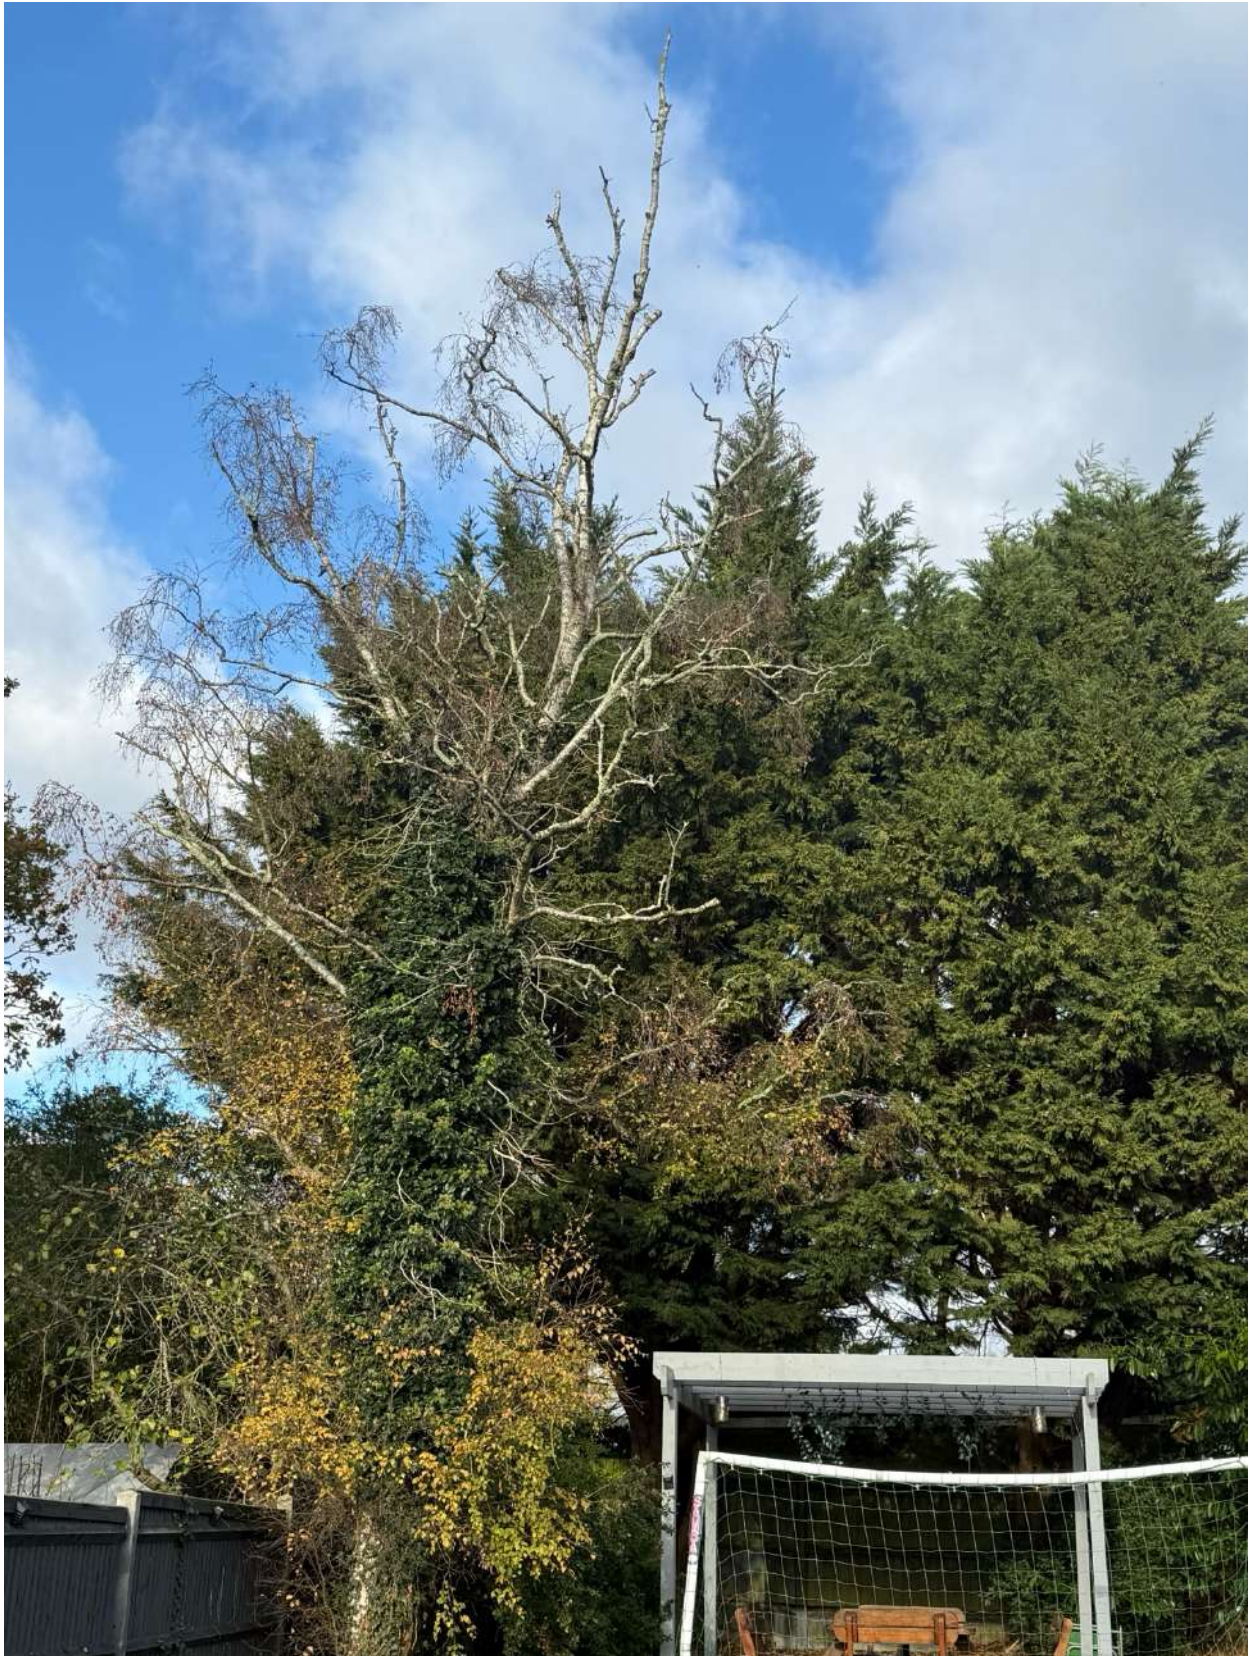
| Health | Tree is in a state of deep decline, with the majority of the canopy consisting of deadwood. |
| Structure | The tree is in severe decline, and the structure may be compromised due to the extent of dead and dying timber. |
| Comment | Tree is in very poor condition and should be felled on safety grounds. |
| Target | If it were to fail, it could damage the seating area and the garden room. |
| Risk rating | High |

| Recommendation | Given its location within a garden used by a person with special needs, the tree presents an increased safety risk. Recommend urgent consideration of removal. |
