## Arboricultural Appraisal Report

### Subsidence Damage Investigation at:

38 Fircroft Drive  
Chandler's Ford  
Eastleigh  
SO53 2HE

| MWA REF: | SUB251029-17086 |

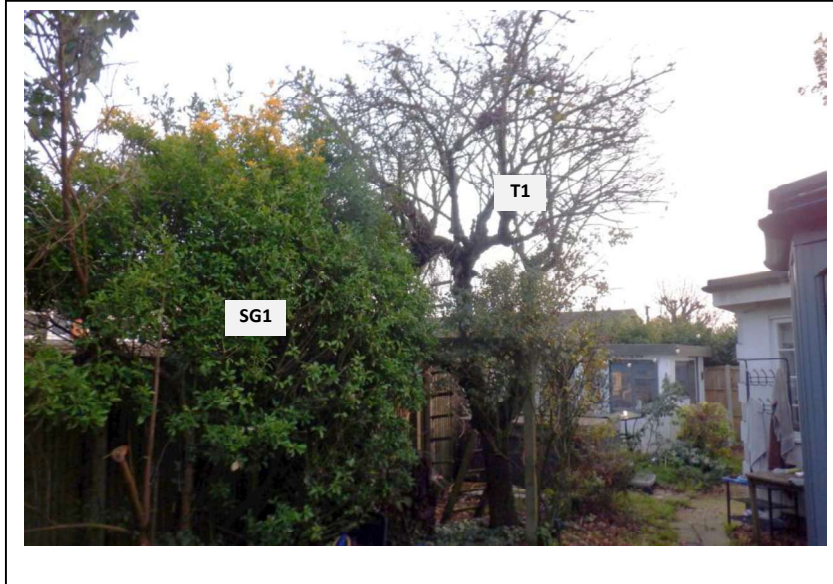
| Tree No. | Species | Height (m) | Dia (mm) | Crown Spread (m) | Dist. to building (m) | Age Classification | Ownership |
|---|---|---|---|---|---|---|---|
| T1 | Apple | 6 | 300 | 5.4 | 3.1 | Younger than Property | Policy Holder |

View of T1 & SG1

| Tree No. | Species | Height (m) | Dia (mm) | Crown Spread (m) | Dist. to building (m) | Age Classification | Ownership |
|---|---|---|---|---|---|---|---|
| Recommendation | | Do not allow to exceed current dimensions. | | | | | |

| Tree No. | Species | Height (m) | Dia (mm) | Crown Spread (m) | Dist. to building (m) | Age Classification | Ownership |
|---|---|---|---|---|---|---|---|
| Recommendation | | Maintain broadly at no more than current dimensions by periodic pruning. | | | | | |

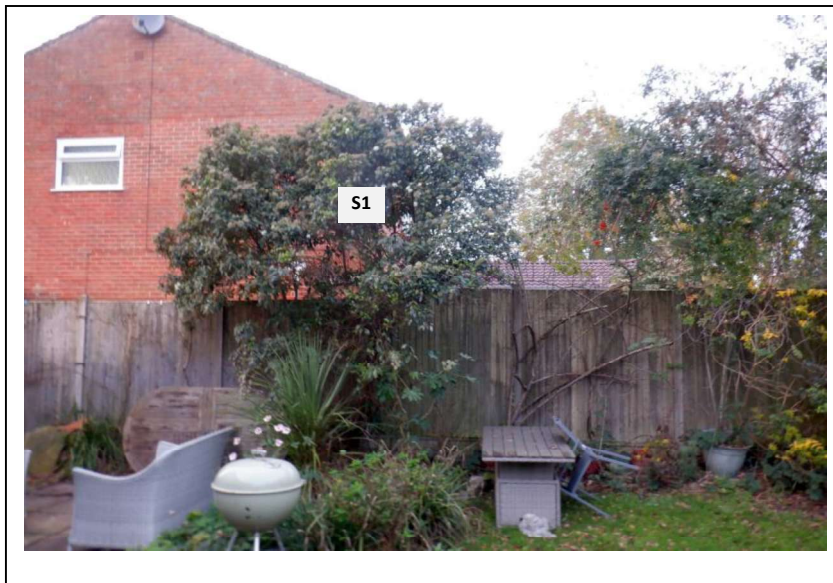
| Tree No. | Species | Height (m) | Dia (mm) | Crown Spread (m) | Dist. to building (m) | Age Classification | Ownership |
|---|---|---|---|---|---|---|---|
| S1 | Viburnum | 4.4 | 65 Ms * | 1.75 | 3.5 | Younger than Property | Policy Holder |

View of S1

| Tree No. | Species | Height (m) | Dia (mm) | Crown Spread (m) | Dist. to building (m) | Age Classification | Ownership |
|---|---|---|---|---|---|---|---|
| Recommendation | | Maintain broadly at no more than current dimensions by periodic pruning. | | | | | |

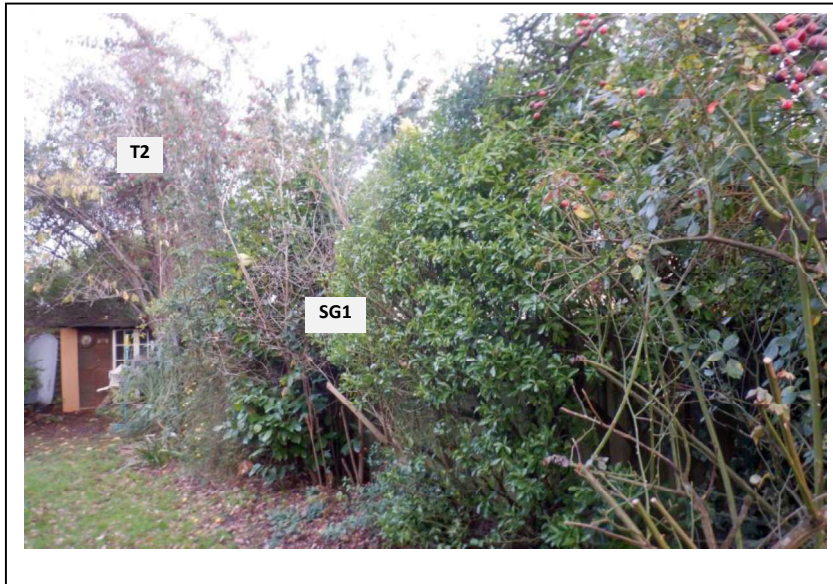
| Tree No. | Species | Height (m) | Dia (mm) | Crown Spread (m) | Dist. to building (m) | Age Classification | Ownership |
|---|---|---|---|---|---|---|---|
| T2 | Cherry (Prunus sp.) | 8.75 | 400 Ms * | 9 | 10 | Younger than Property | Policy Holder |

View of T2 & SG1

| Tree No. | Species | Height (m) | Dia (mm) | Crown Spread (m) | Dist. to building (m) | Age Classification | Ownership |
|---|---|---|---|---|---|---|---|
| Recommendation | | None at present. | | | | | |

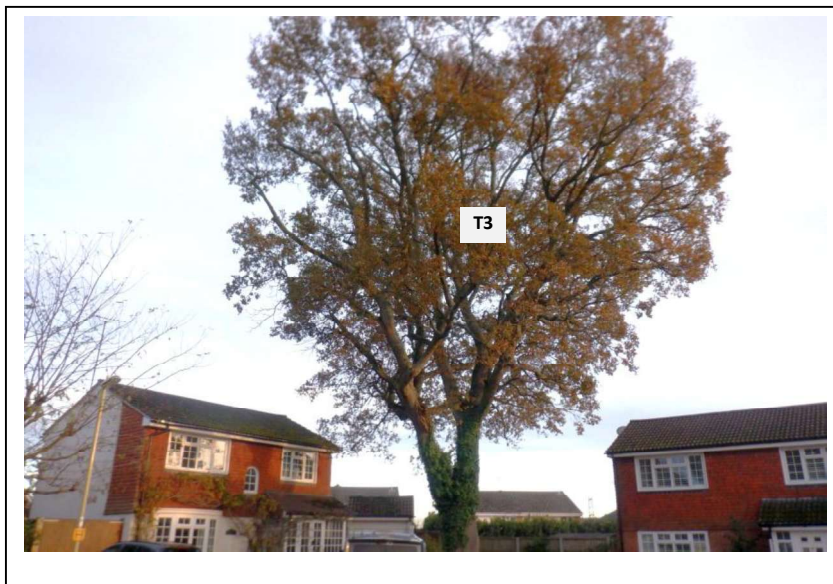
Based on the information currently available, engineering opinion and our own site assessment we conclude there is damage potentially consistent with shrinkage of the clay subsoil exacerbated by the soil drying effects of vegetation. It is our opinion that the Oak (T3) will be the principal cause of or will be contributing to any building movement and damage related to clay shrinkage subsidence.

| Tree No. | Species | Height (m) | Dia (mm) | Crown Spread (m) | Dist. to building (m) | Age Classification | Ownership |
|---|---|---|---|---|---|---|---|
| T3 | Oak (Quercus sp.) | 20.75 | 1080 | 21 | 5.85 | Older than Property | Unclear Boundary<br>Policy Holder &/or<br>39 Fircroft Drive<br>SO53 2HE |

View of T3

| Tree No. | Species | Height (m) | Dia (mm) | Crown Spread (m) | Dist. to building (m) | Age Classification | Ownership |
|---|---|---|---|---|---|---|---|
| Recommendation | | Remove (fell) to near ground level and treat stump to inhibit regrowth. | | | | | |

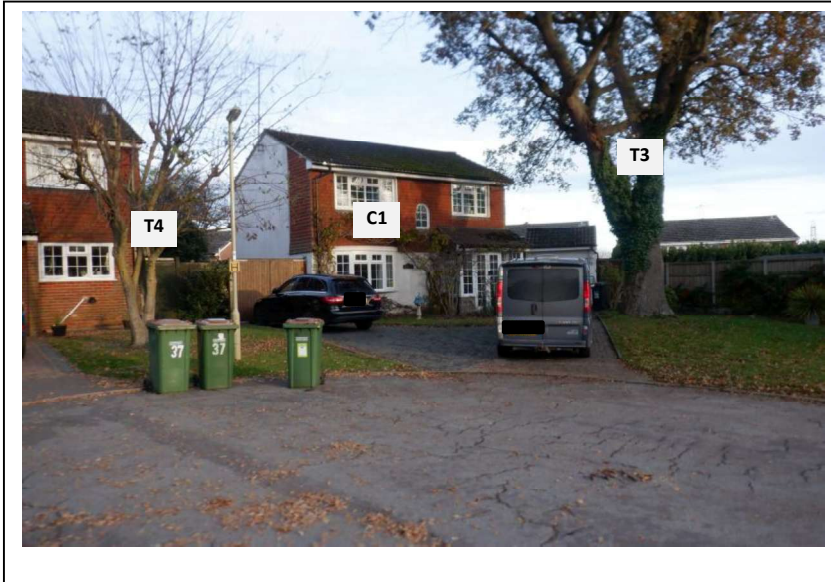
| Tree No. | Species | Height (m) | Dia (mm) | Crown Spread (m) | Dist. to building (m) | Age Classification | Ownership |
|---|---|---|---|---|---|---|---|
| T4 | False Acacia (Robinia) | 9.7 | 250 Ms * | 8.5 | 7.5 | Younger than Property | Third Party |

| Tree No. | Species | Height (m) | Dia (mm) | Crown Spread (m) | Dist. to building (m) | Age Classification | Ownership |
|---|---|---|---|---|---|---|---|
| C1 | Wisteria | 3.3 | 60 Ms * | 8.5 | 0.1 | Younger than Property | Policy Holder |

View of T3, T4 & C1

| Tree No. | Species | Height (m) | Dia (mm) | Crown Spread (m) | Dist. to building (m) | Age Classification | Ownership |
|---|---|---|---|---|---|---|---|
| Recommendation | | Do not allow to exceed current dimensions. | | | | | |

| Tree No. | Species | Height (m) | Dia (mm) | Crown Spread (m) | Dist. to building (m) | Age Classification | Ownership |
|---|---|---|---|---|---|---|---|
| Recommendation | | Do not allow to exceed current dimensions. | | | | | |

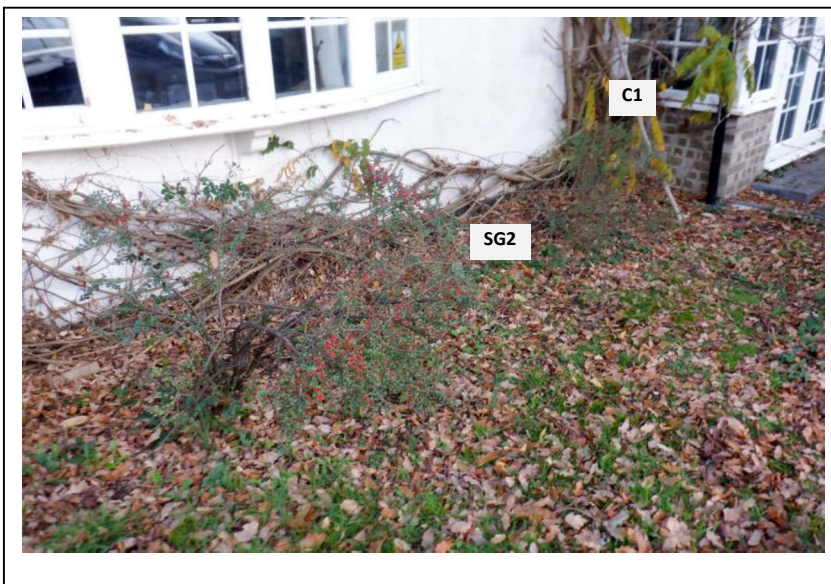
| Tree No. | Species | Height (m) | Dia (mm) | Crown Spread (m) | Dist. to building (m) | Age Classification | Ownership |
|---|---|---|---|---|---|---|---|
| SG2 | Cotoneaster x 2 | 0.75 | 5 Ms * | 0.75 | 0.5 | Younger than Property | Policy Holder |

View of SG2 & C1

| Tree No. | Species | Height (m) | Dia (mm) | Crown Spread (m) | Dist. to building (m) | Age Classification | Ownership |
|---|---|---|---|---|---|---|---|
| Recommendation | | Maintain broadly at no more than current dimensions by periodic pruning. | | | | | |

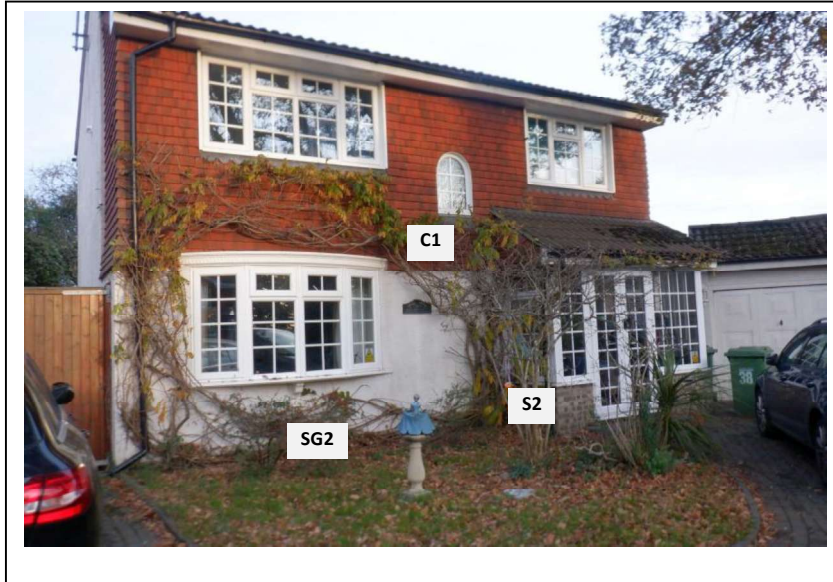
| Tree No. | Species | Height (m) | Dia (mm) | Crown Spread (m) | Dist. to building (m) | Age Classification | Ownership |
|---|---|---|---|---|---|---|---|
| S2 | Magnolia | 2 | 25 Ms * | 1.5 | 2.6 | Younger than Property | Policy Holder |

View of C1, S2 & SG2

| Tree No. | Species | Height (m) | Dia (mm) | Crown Spread (m) | Dist. to building (m) | Age Classification | Ownership |
|---|---|---|---|---|---|---|---|
| Recommendation | | Maintain broadly at no more than current dimensions by periodic pruning. | | | | | |

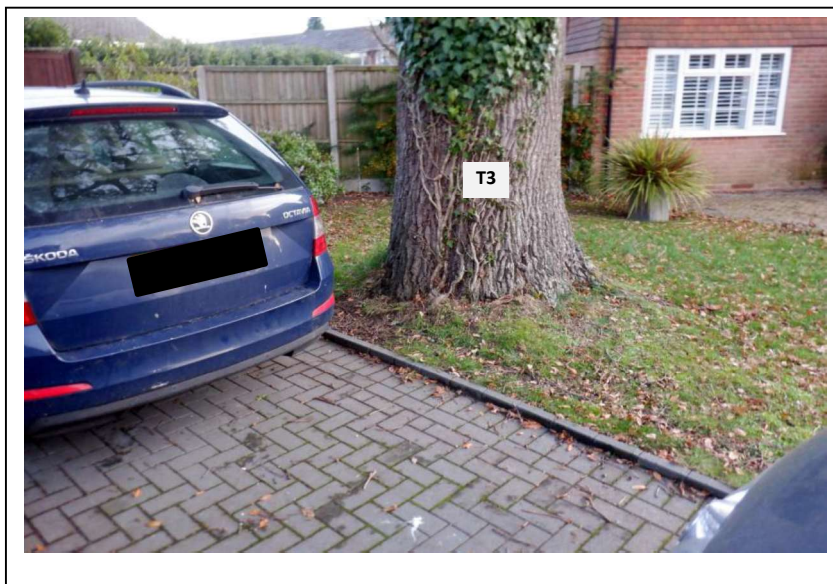
View of T3
