## **Tree Hazard Assessment**

White Trees Farm Site Number: 050  
White Tree Close  
Fair Oak  
Eastleigh  
SO50 7FE

| <b>Location:</b> White Trees Farm, White Trees Close,<br>Fair Oak, Eastleigh, SO50 7FE. | <b>Arborcare Ref:</b> 12345 |
| <b>Survey Inspector:</b> Brian Cole | <b>Date of Inspection:</b><br>05/01/2026 |

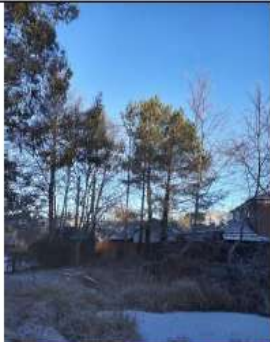
| Ref. | Tag | Species | Variety | Target | Age | Height (m) | Structural Condition | Vitality | Life Expectancy | SurveyNotes | Recommendations | Priority | Photo |
|---|---|---|---|---|---|---|---|---|---|---|---|---|---|
| T01 | 108 | Mixed species<br>(Mixed species) | 1 Alder, 2 Ash, 4 Pine, 3 Sorbus | Building<br>Fence<br>Footpath<br>Highway | Early Mature | 10 to 15 | Good | Normal | 50+ | * Load Factors<br>Wind Exposure: Partial.<br>Crown Size: Medium.<br>Crown Density: Normal.<br>Interior Branches: Normal.<br>* Trunk<br>Codominant stems.<br>Included bark.<br>* Crown and Branches<br>Pruning history - Raised. | None at present. | N/A | |

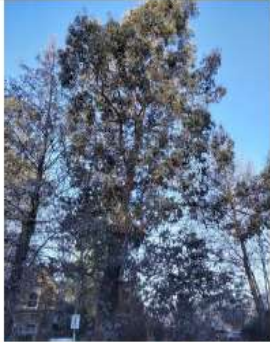
| Ref. | Tag | Species | Variety | Target | Age | Height (m) | Structural Condition | Vitality | Life Expectancy | SurveyNotes | Recommendations | Priority | Photo |
|---|---|---|---|---|---|---|---|---|---|---|---|---|---|
| T02 | 109 | Eucalyptus<br>(Eucalyptus sp.) | | Fence<br>Footpath<br>Highway<br>Overhead wires<br>Street light | Mature | 15 to 20 | Good | Normal | 50+ | * Load Factors<br>Wind Exposure: Full.<br>Crown Size: Medium.<br>Crown Density: Normal.<br>Interior Branches: Normal.<br>* Crown and Branches<br>Pruning history - Raised.<br>* Trunk<br>Included bark | None at present. | N/A | |

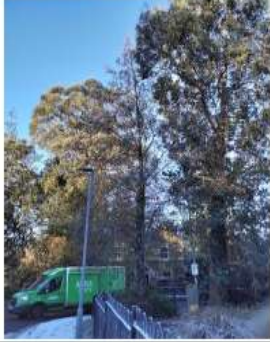
| Ref. | Tag | Species | Variety | Target | Age | Height (m) | Structural Condition | Vitality | Life Expectancy | SurveyNotes | Recommendations | Priority | Photo |
|---|---|---|---|---|---|---|---|---|---|---|---|---|---|
| T03 | 110 | Common alder<br>(Alnus glutinosa) | | Fence<br>Footpath<br>Highway<br>Street light | Early Mature | 10 to 15 | Good | Normal | 50+ | * Load Factors<br>Wind Exposure: Partial.<br>Crown Size: Medium.<br>Crown Density: Normal.<br>Interior Branches: Normal.<br>* Trunk<br>Included bark. | None at present. | N/A | |
