**GREEN EARTH**  
**ARBORICULTURAL & ENVIRONMENTAL CONSULTANCY**

**TREE SURVEY AT CROFT FARM,  
WINCHESTER ROAD, BOTLEY,  
HAMPSHIRE, SO32 2BX.**

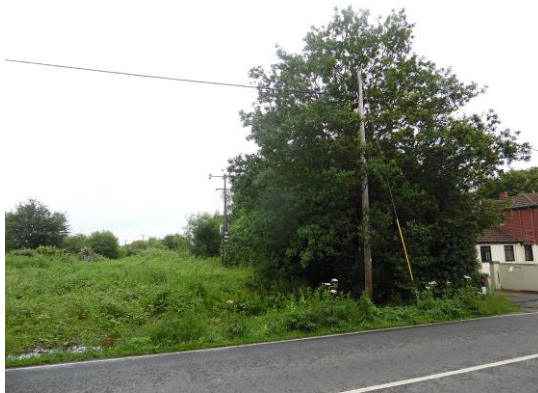
Oak, T6.

This is a large mature tree growing near the frontage of the site. It is in the south east corner and on the eastern boundary. It appeared to be in good condition and creates a valuable feature in the corner on the road frontage. It should be well away from the proposed development.

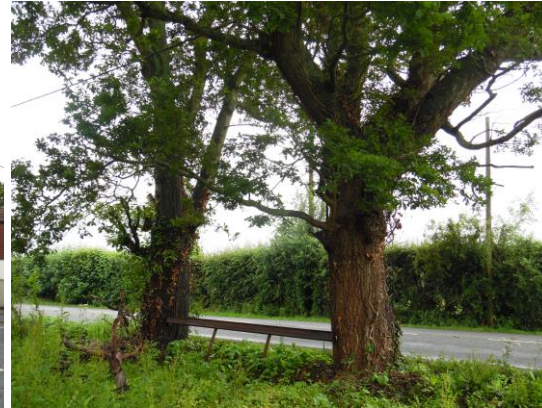
Oaks, T3 & T4.

This is a large mature tree growing near the frontage of the site. It appeared to be in an excellent condition and is an A class tree. There is a considerable amount of ivy growing up the tree which should be removed before the canopy is affected.

This is a large mature tree growing. There is dead wood throughout the canopy and evidence of dieback. It appeared to be in a reasonable condition for a mature Oak. It may be a highway authority tree. It should have all deadwood with a diameter of 25mm removed by a competent contractor.

The Root Protection Area of the Oak, T4, is encroached by the new driveway and therefore a fence will be difficult to erect as there is insufficient space. The driveway could be relocated slightly to the west to avoid the RPA of this tree. The driveway, if it cannot be relocated, would need to be constructed with care ensuring no excavation and the new road would remain non compactable and porous. The access to the site must be protected from compaction, access within RPAs, must be protected from compaction by using boards laid onto a layer of 100 mm bark or wood chips. This area must be laid before any other construction work commences.

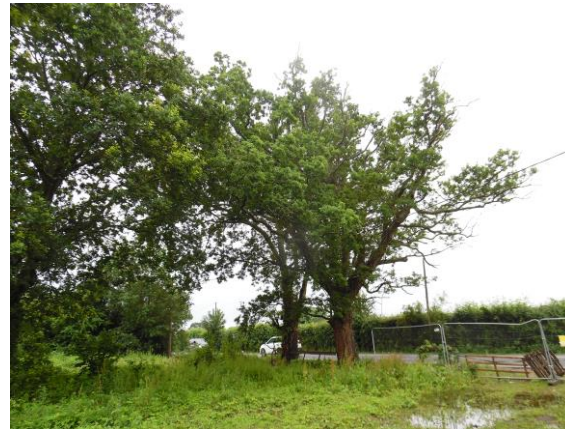
Oaks, T3-&5.

This is a large mature tree growing on the front boundary. It appeared to be in good condition although a number of branches on the south east side have been cut back due to electricity wires leaving truncated branches and an unbalanced canopy. It may be a highway authority tree. There is some deadwood in the canopy, all deadwood with a diameter of 25mm should be removed by a competent contractor. The tree otherwise creates a valuable amenity on the road frontage.

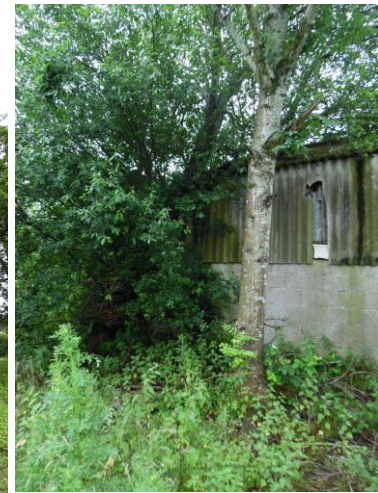
Ash, T2.

This is a semi-mature tree growing adjacent to the barn on the west side. The canopy spreads over the site by approximately 5 metres and into the adjoining Willow. It appeared to be in a reasonable condition but is showing some signs of dieback.

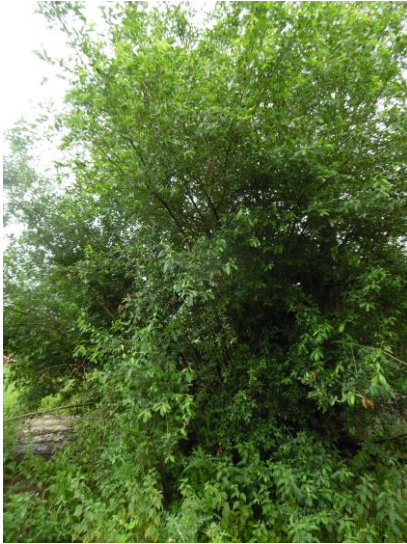
Willow, T1.

This is a large mature tree growing adjacent to the barns north west corner. It has two trunks one of which has split and fallen. The standing trunk had a girth of 1.0 metre and a height of approximately 13 metres. There is a considerable amount of epicormics growth from the base. The canopy spreads over the barn and into the adjoining Ash. It is in poor condition and has little value.

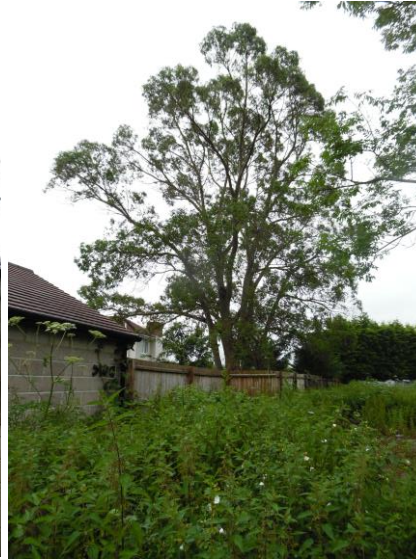
Blue Gum, T7.

This is a large mature tree growing in the adjoining property to the west. It has a number of trunks and a height of approximately 16 metres. Complete assessment was not possible as the tree was behind a fence in private property. There appeared to be three main trunks and the girths are estimated. It is protected by a Tree Preservation Order.

The new bungalow is away from the RPA of the Blue Gum and care must be taken to keep all works away from the RPA.
