# Arboricultural Method Statement

20 Steele Close

20 Steele Close, Chandlers Ford,  
Eastleigh, SO53 3AA

Aug 2022  
JFA0104

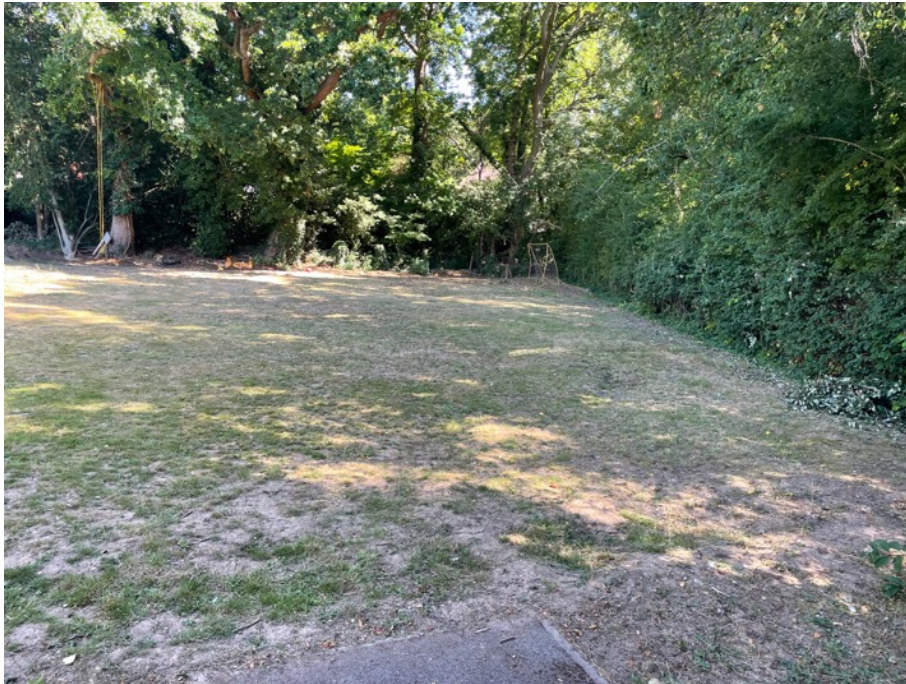
- 3.2 **Photograph 1:** A view of the site from the south

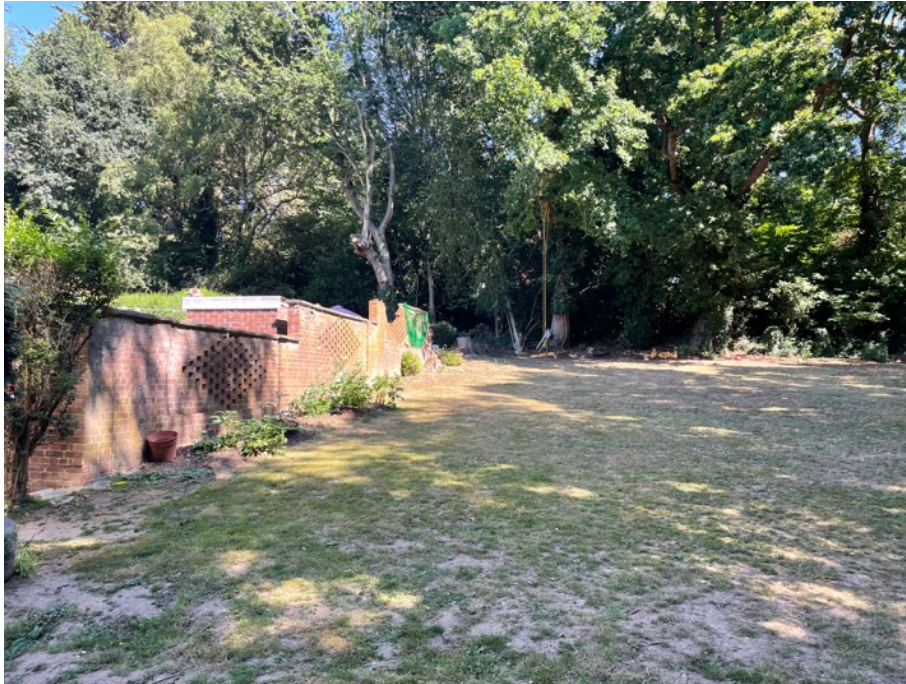
#### **3.3 Photograph 2: A view of the site from the south**

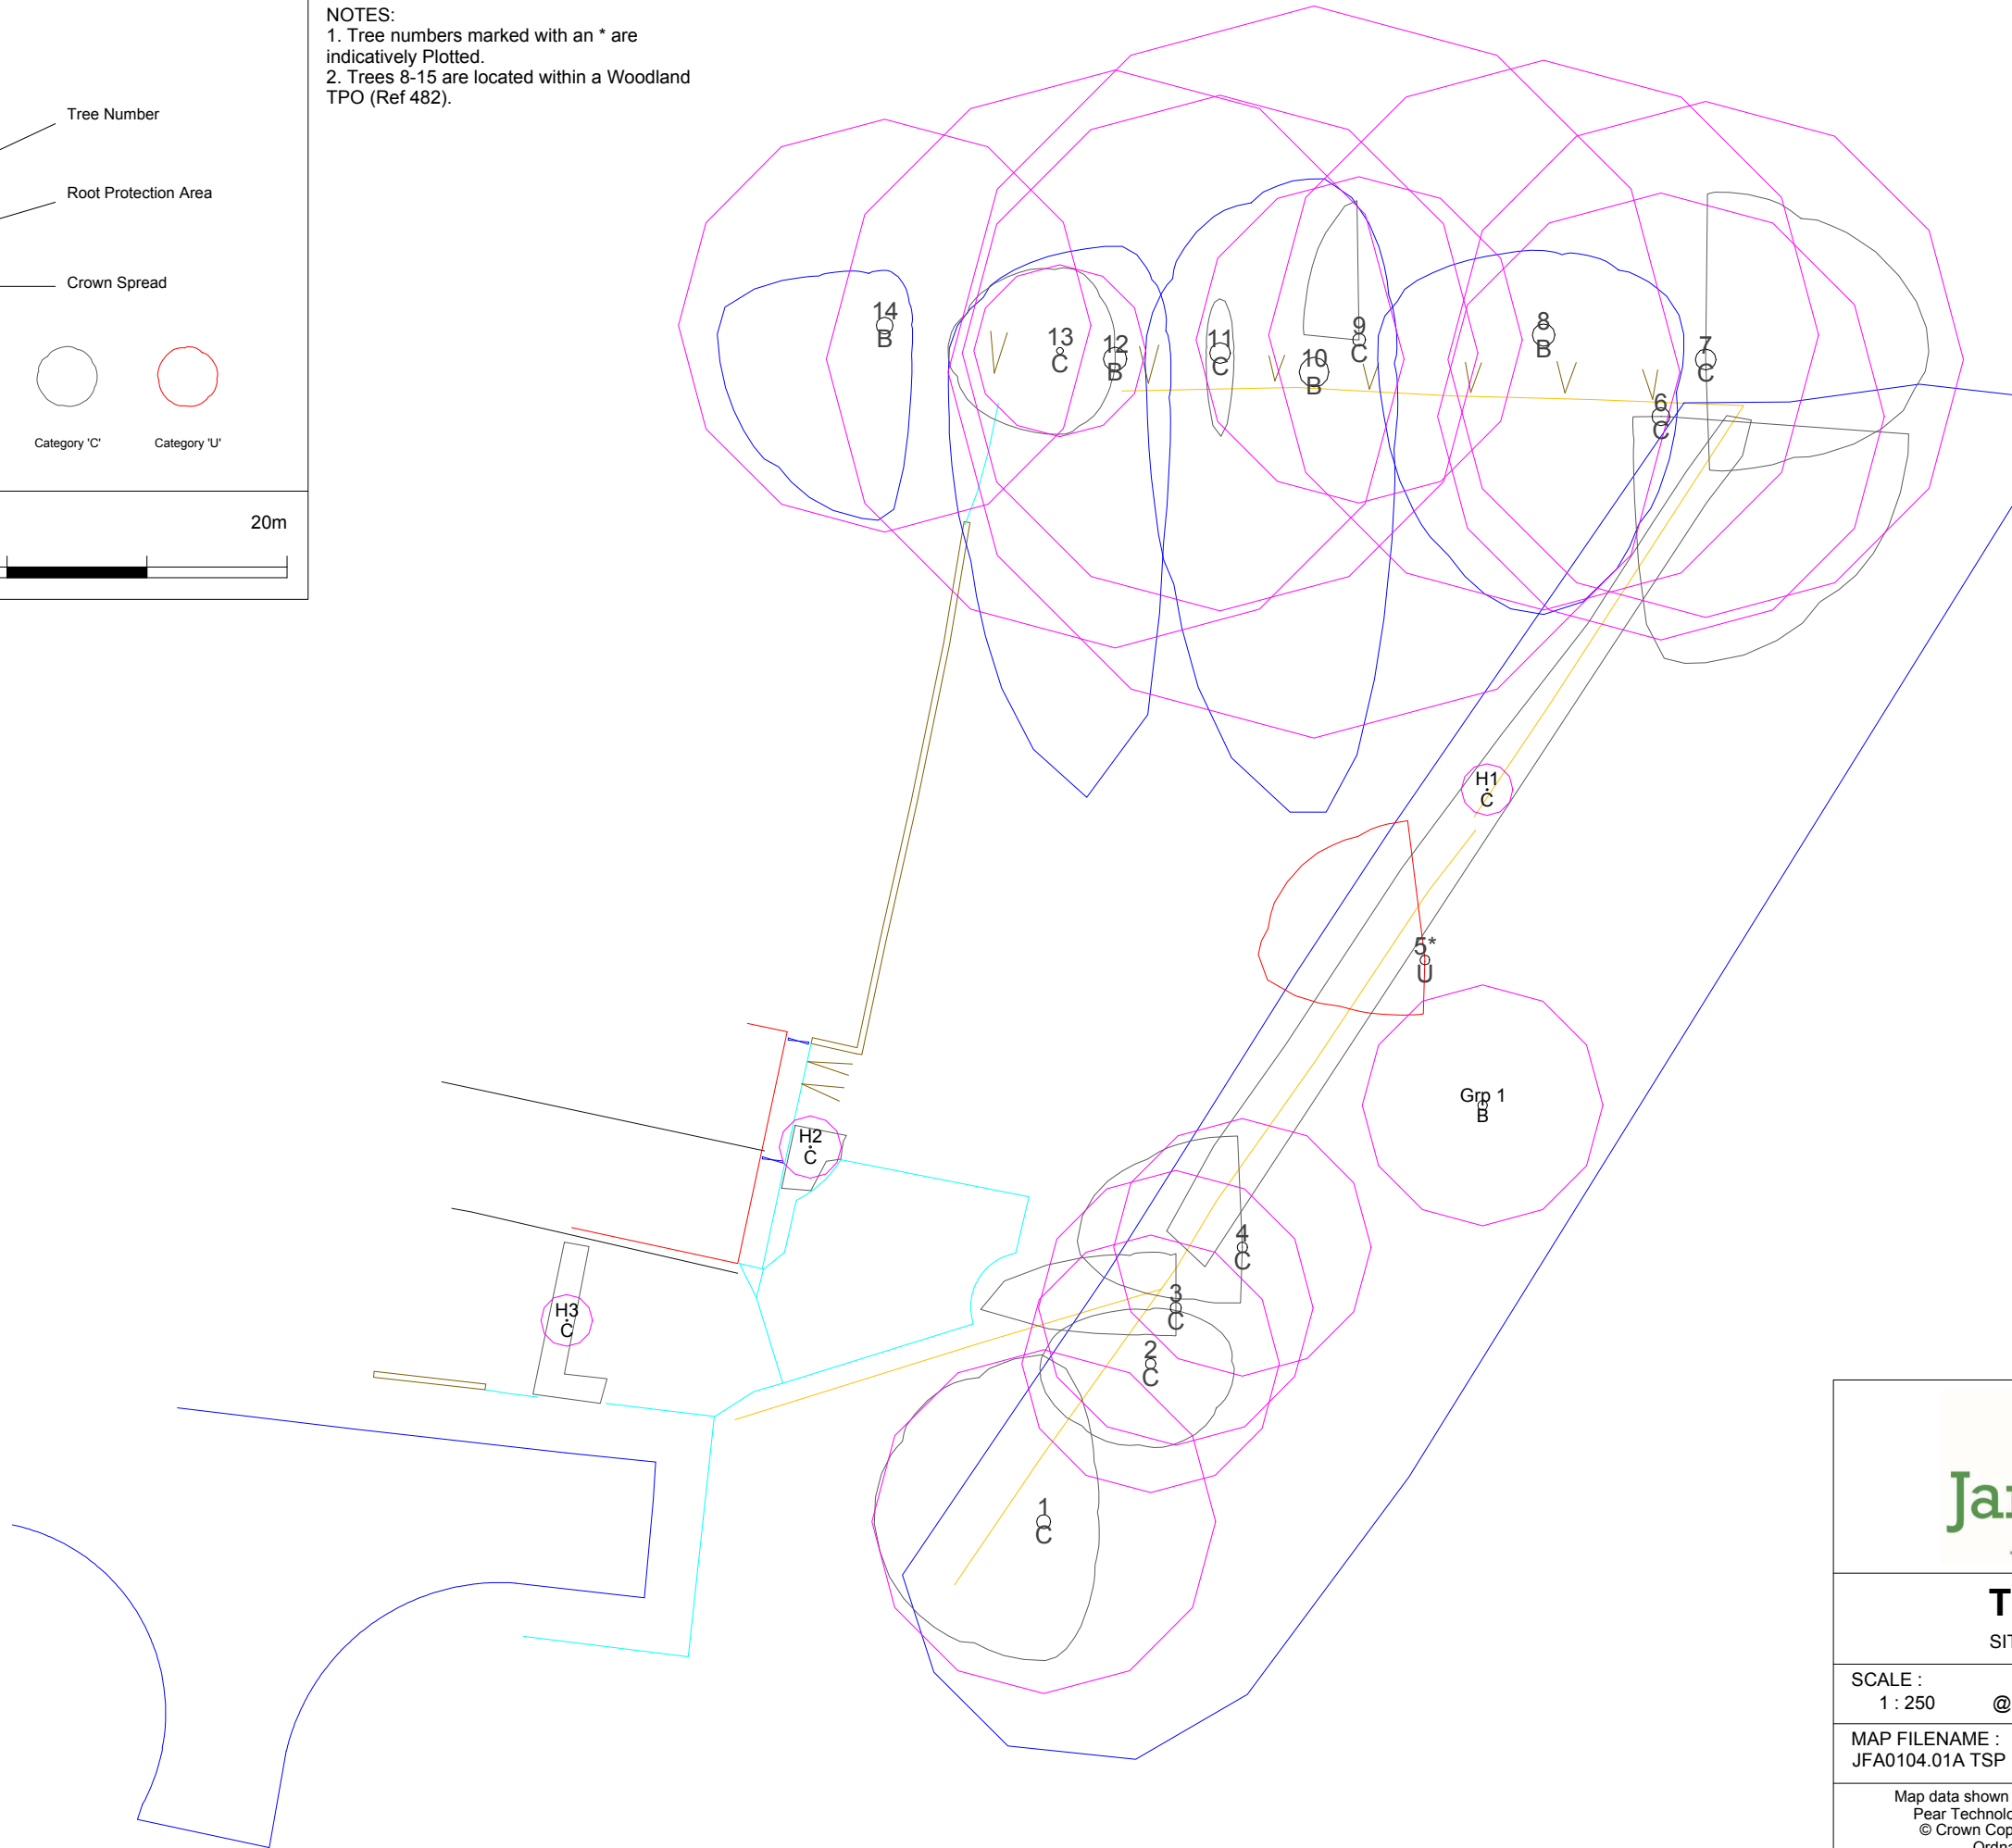
### Tree Survey Plan

NOTES:  
1. Tree numbers marked with an \* are  
indicatively Plotted.  
2. Trees 8-15 are located within a Woodland  
TPO (Ref 482).
